Mine Surface Structures - Identifying Unsafe Conditions & Avoiding Failures

Plants, Conveyors, & Bins

Terence M. Taylor, P.E.

April 4, 2017

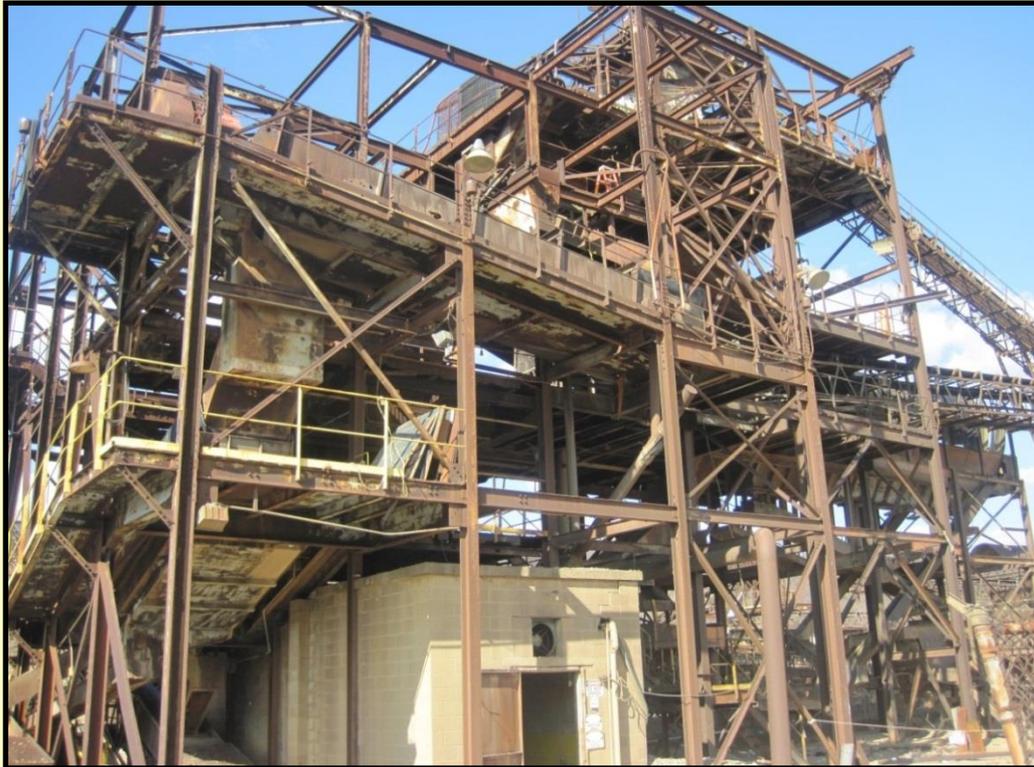
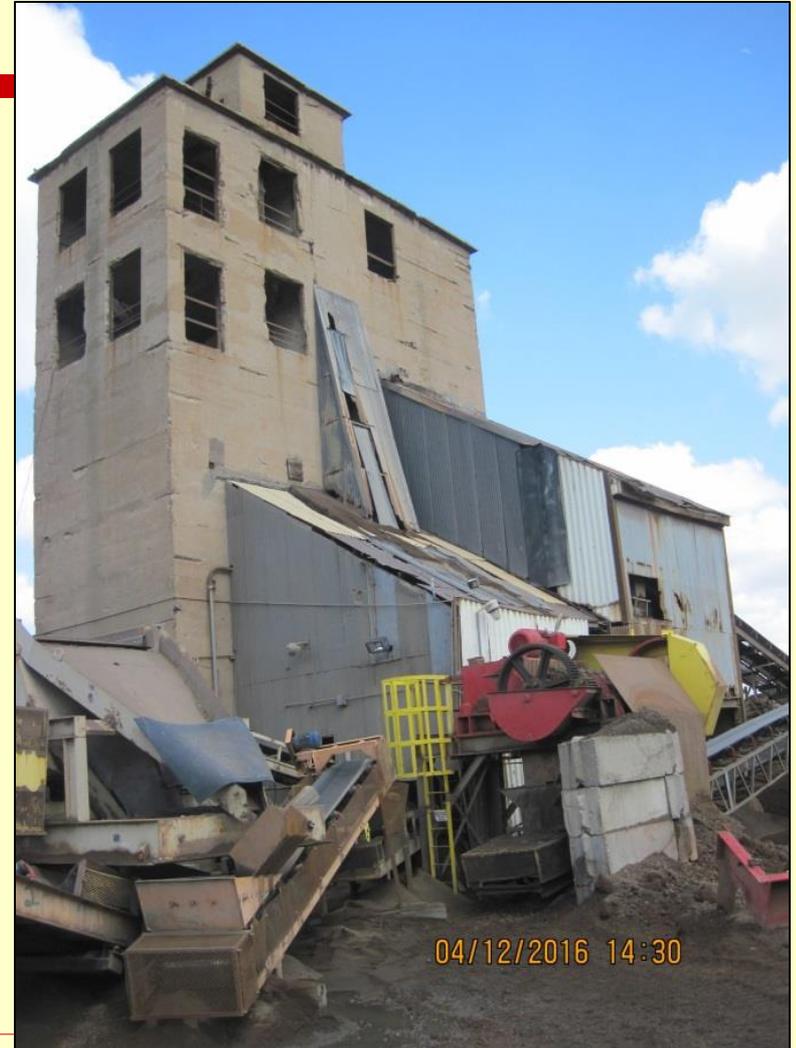
Corrosion holes and delamination of beams

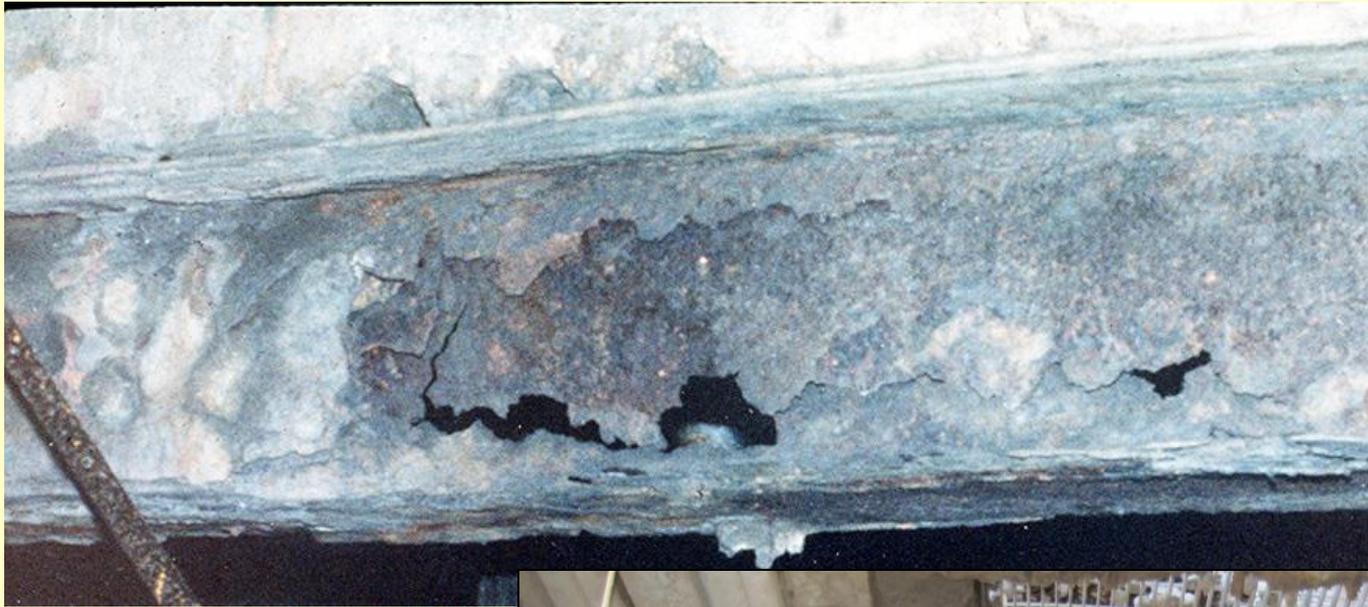
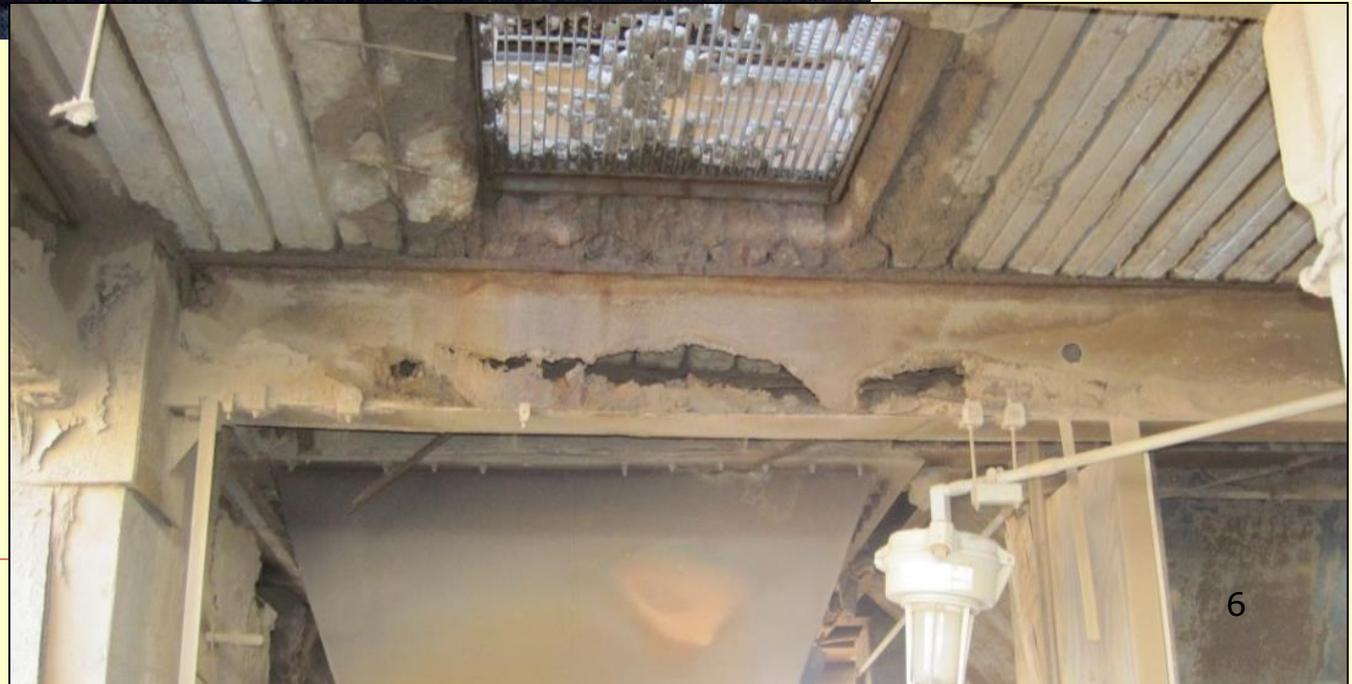
Corrosion hole/notch near the beam end connection

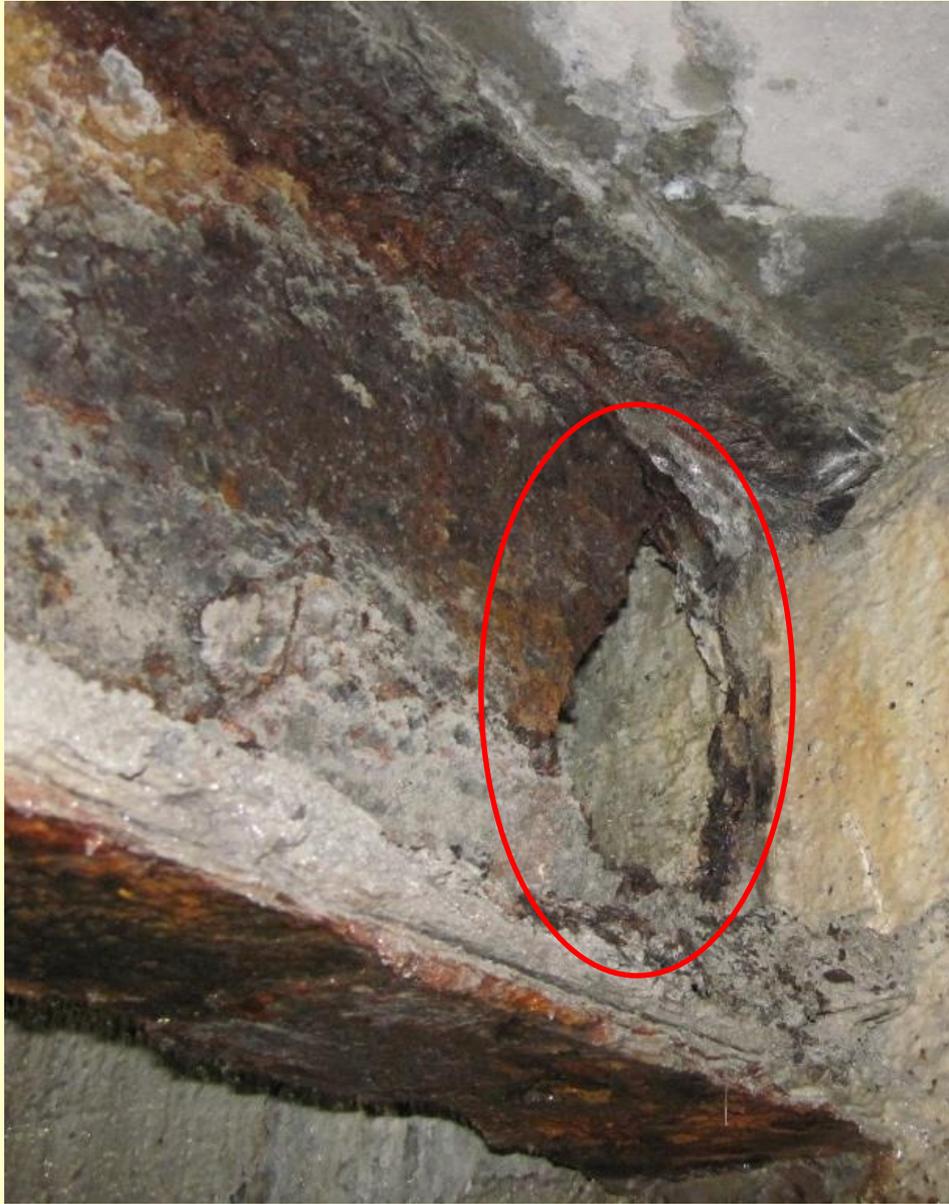
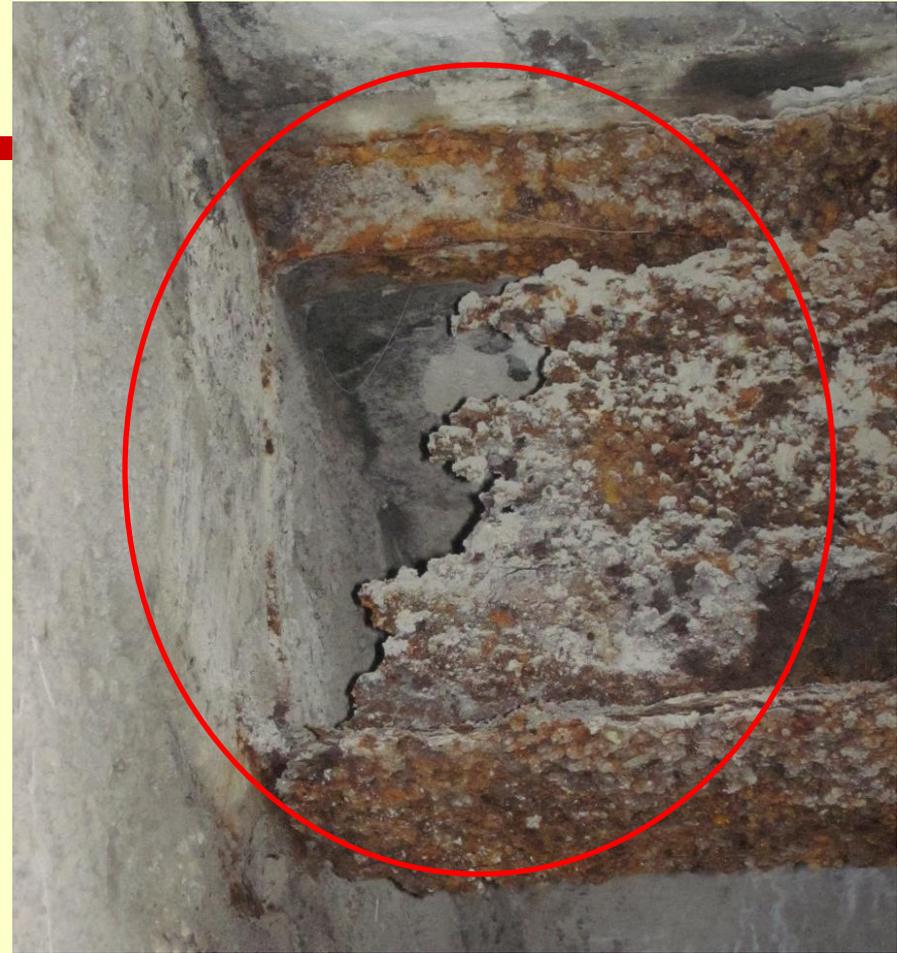
Corrosion holes resulted in web collapse of the back beam.

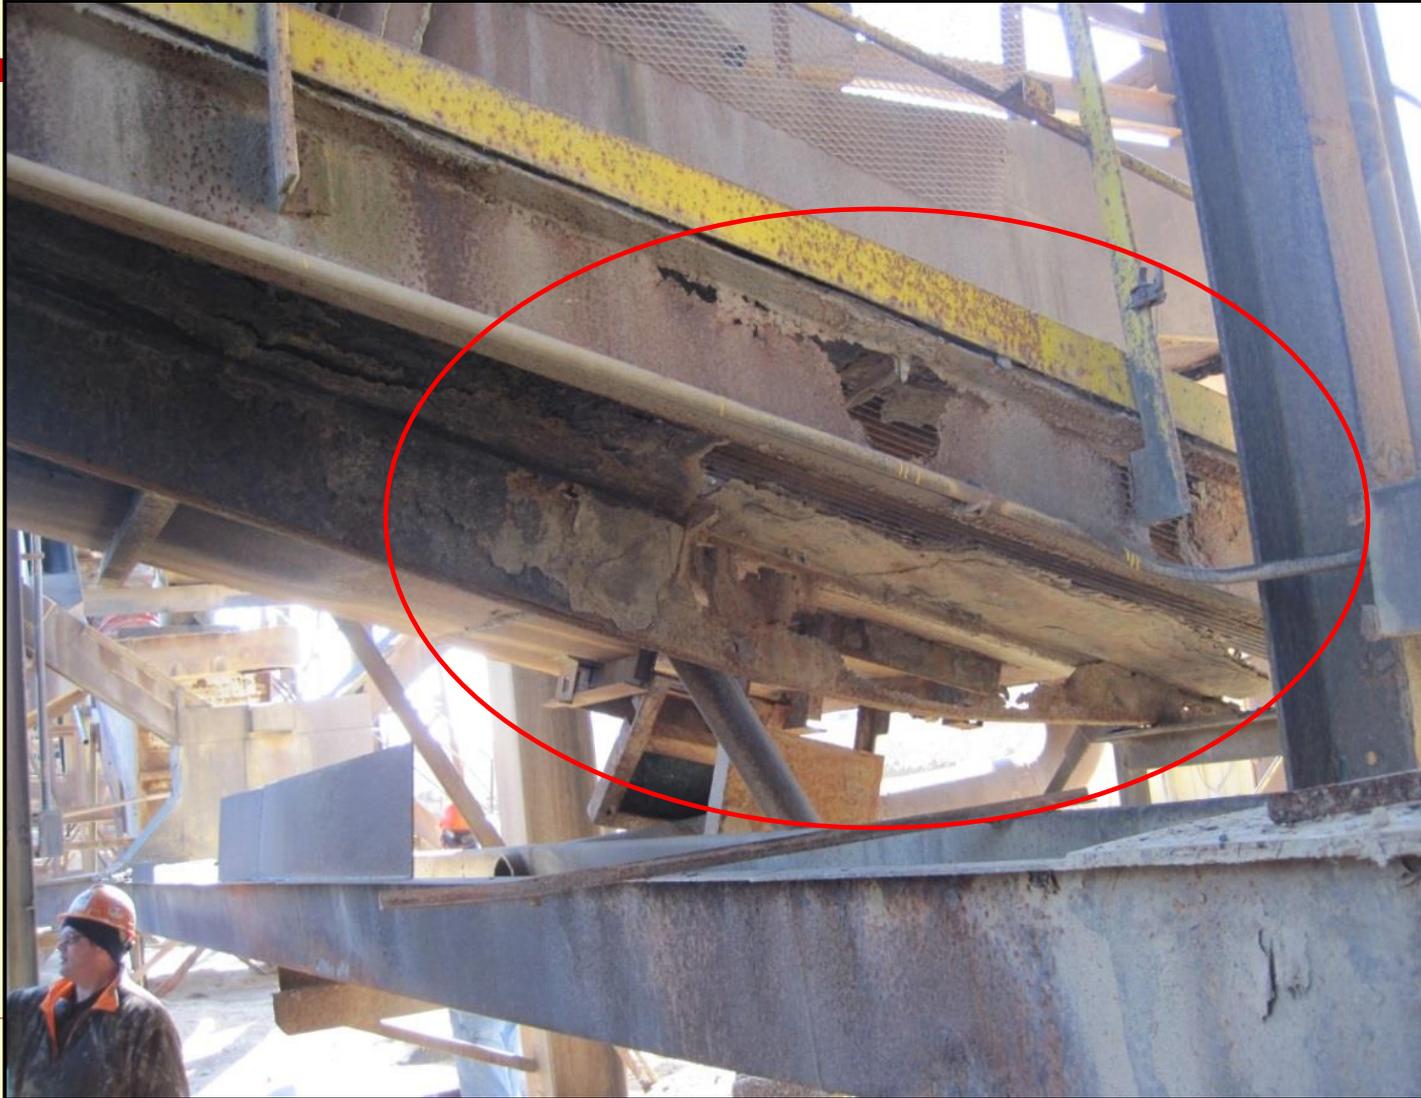
Overloading! Beam w/ a buckled web

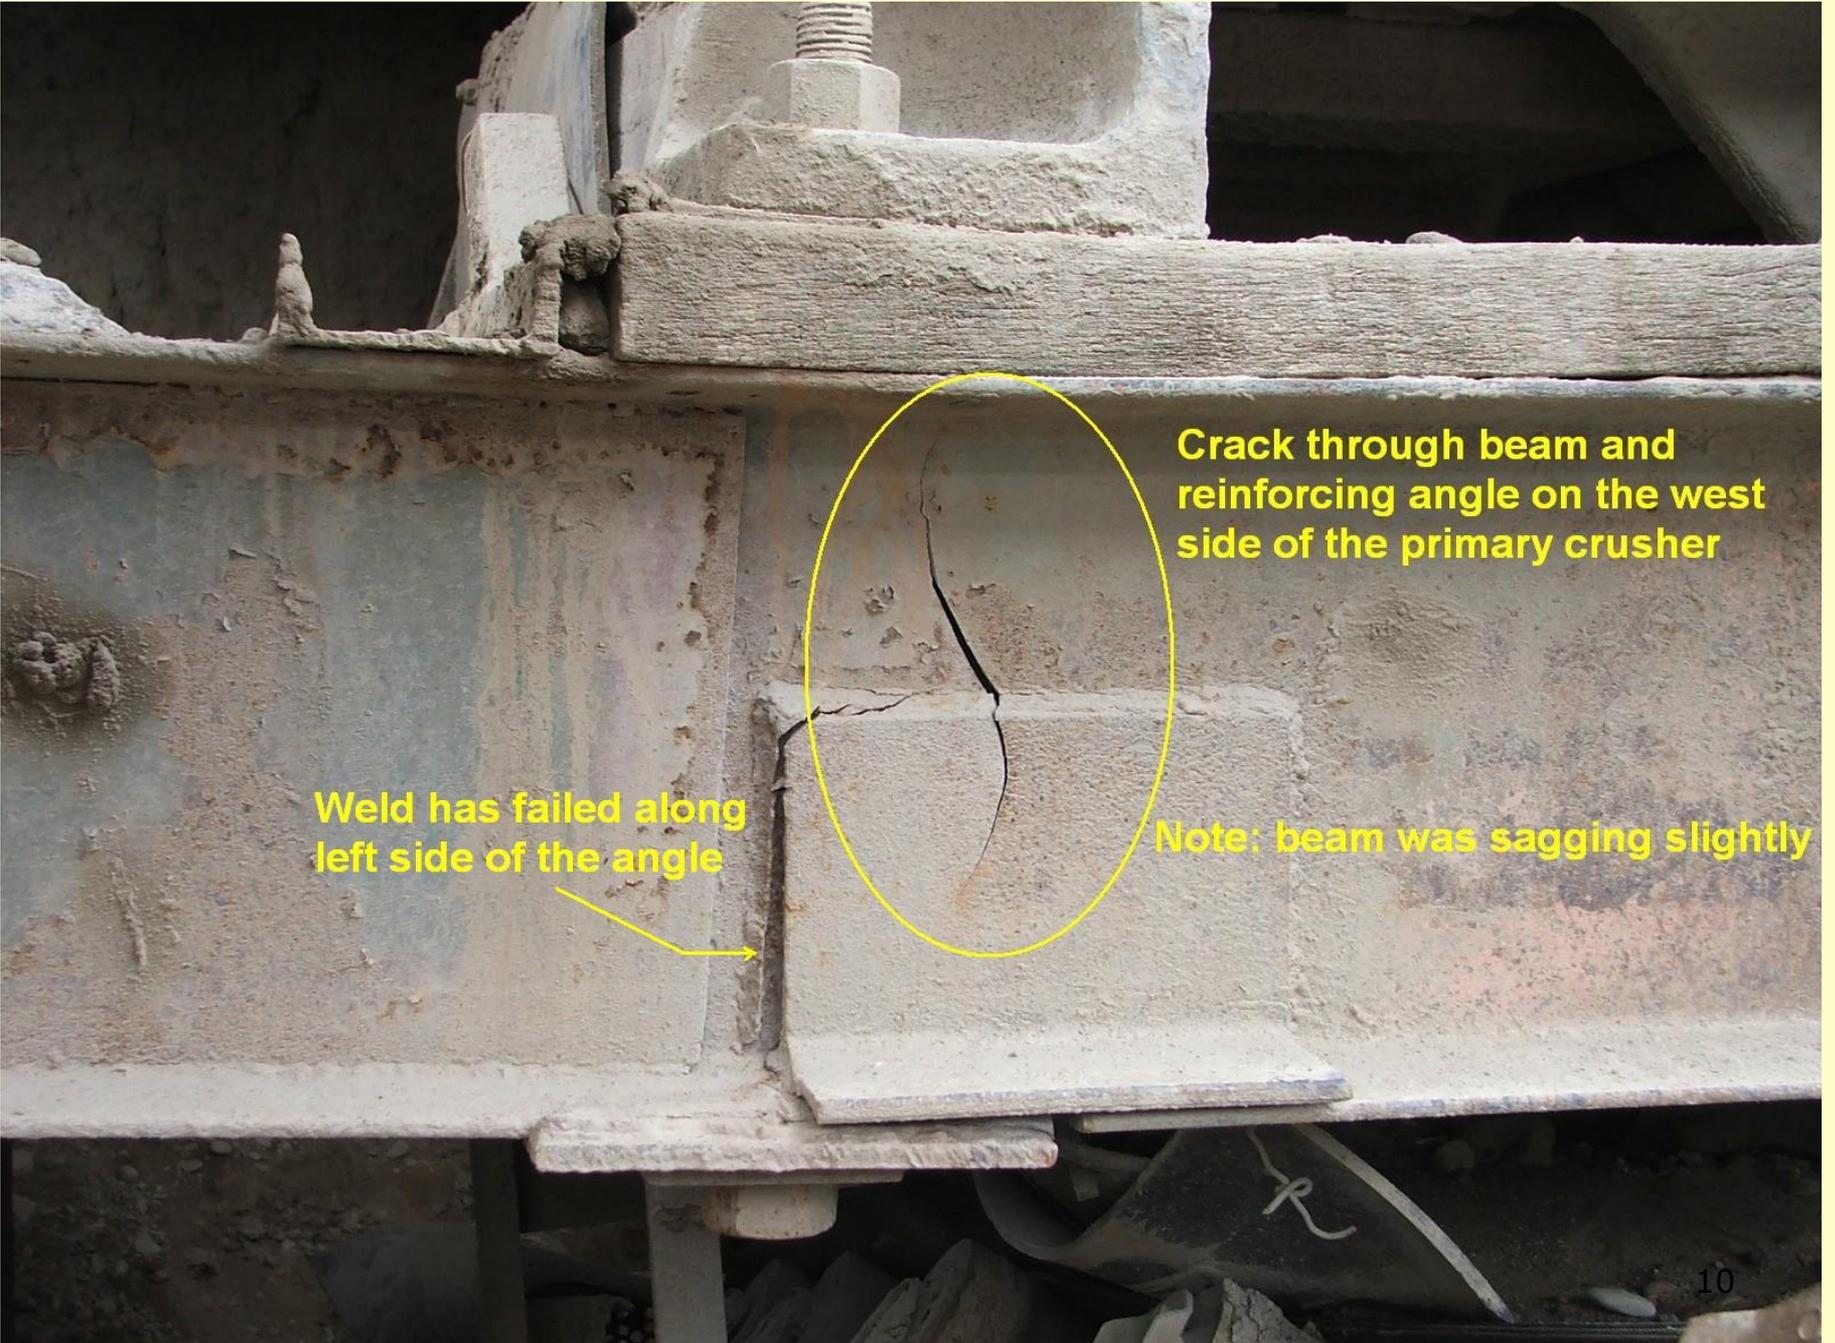
Crack through beam and reinforcing angle on the west side of the primary crusher

Weld has failed along left side of the angle

Note: beam was sagging slightly

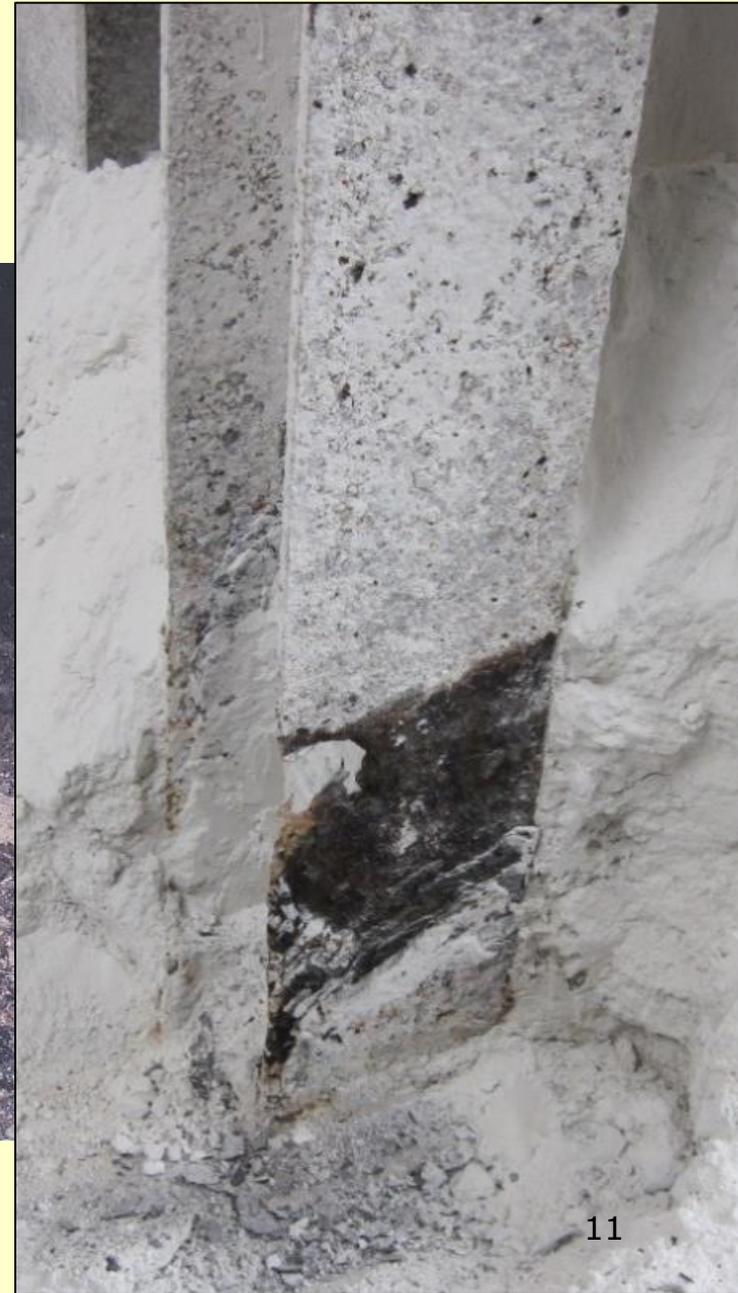
Hole in a column web – well above floor level

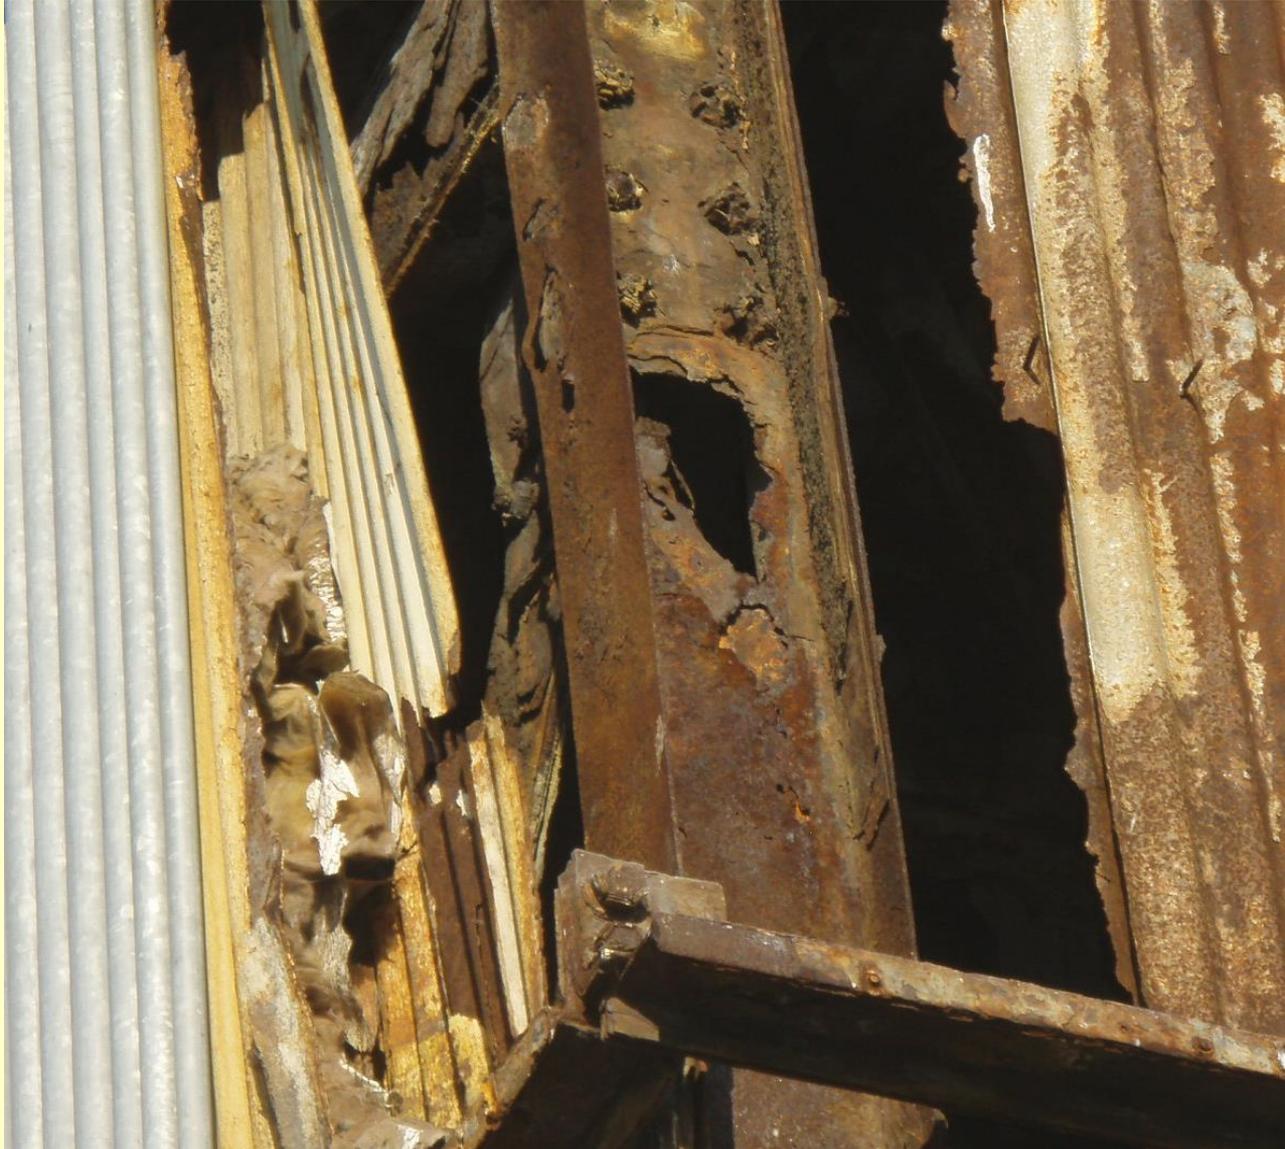
Corroded diagonal braces (and sometimes intentionally removed braces to accommodate equipment changes or access) should be repaired or replaced. Braces are necessary to resist lateral loads such as wind, earthquake, and vibration.

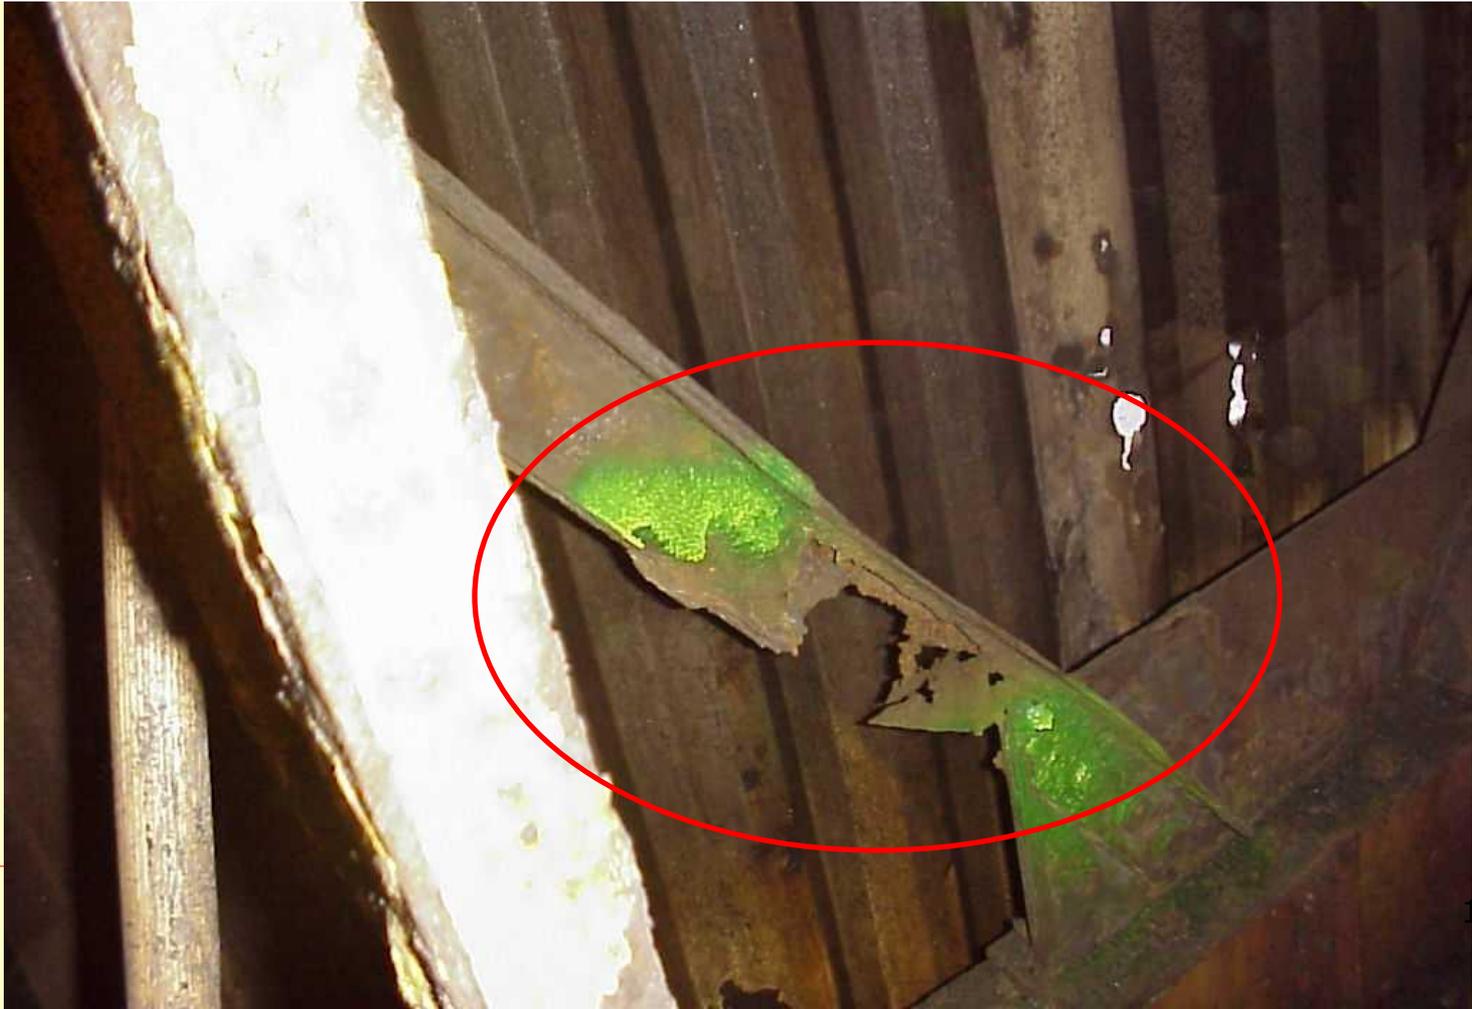
Lines of 100% corrosion along the edges of a floor plate

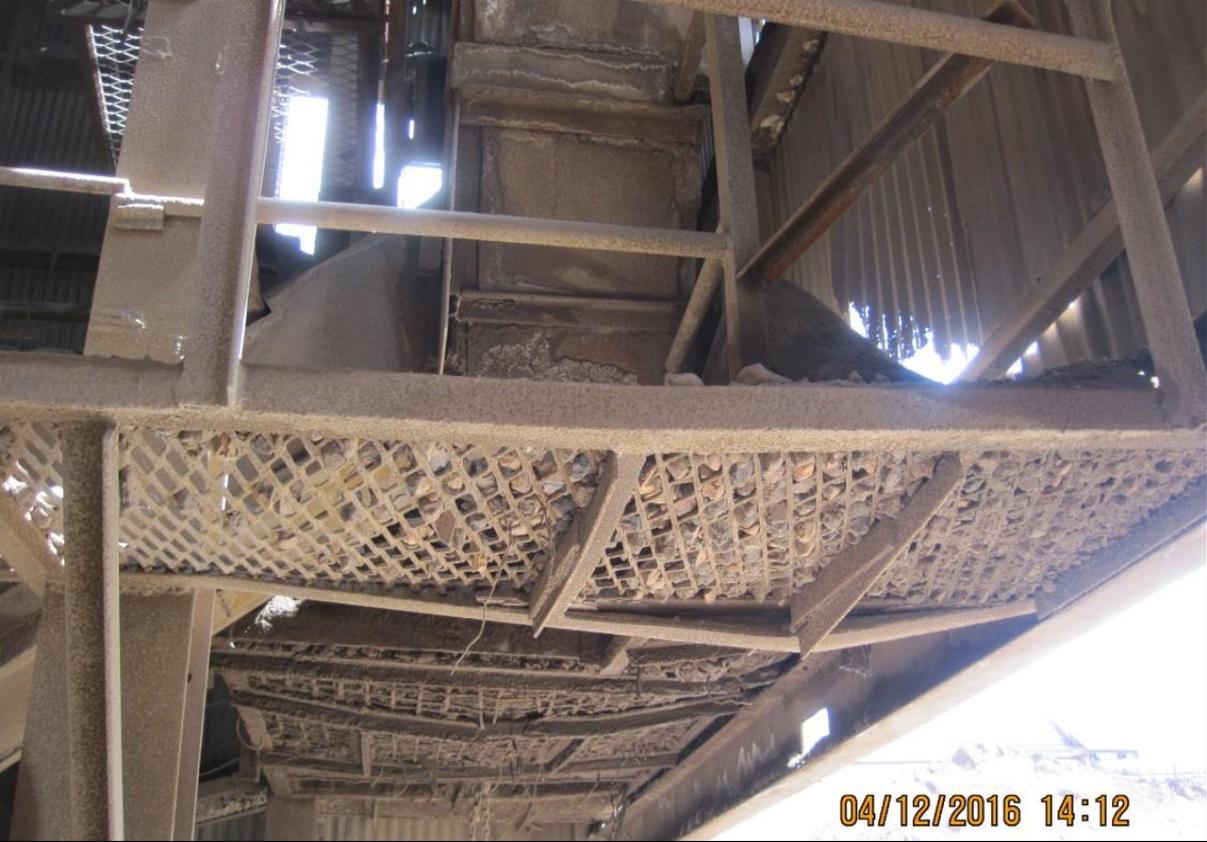
Material build up
and sagging
flooring

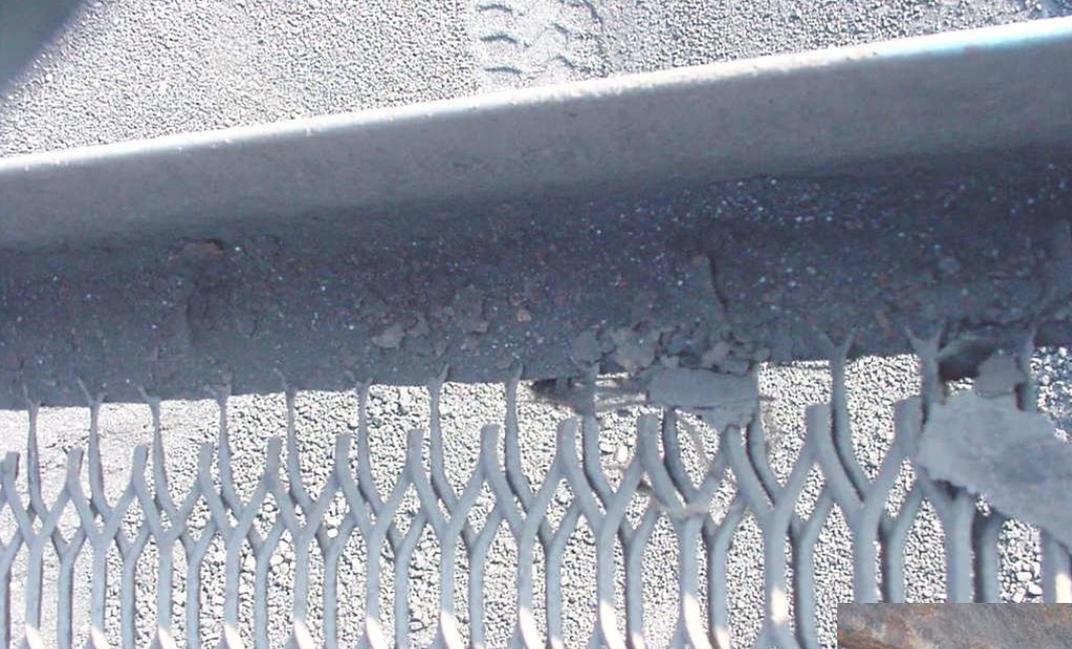
Corrosion at support edge of walkway grating, corrosion holes in a stairway channel stringer, and holes in an angle supporting a tread.

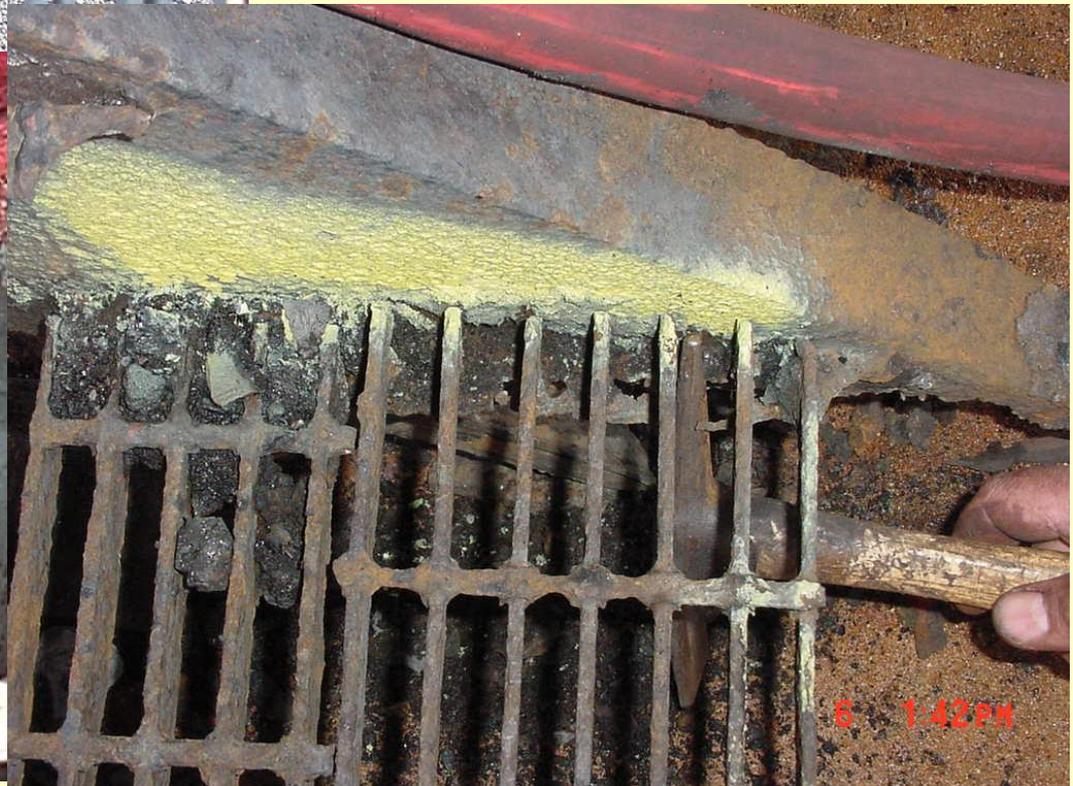
A miner was seriously injured at a limestone mine when the expanded metal walkway suddenly failed. He fell 10 feet to the ground. The expanded metal walkway was covered with conveyor belt to aid in shoveling spillage. The belting allowed corrosive material to accumulate and accelerated the deterioration of the expanded metal. Also the belting masked the signs of deterioration making examination difficult.

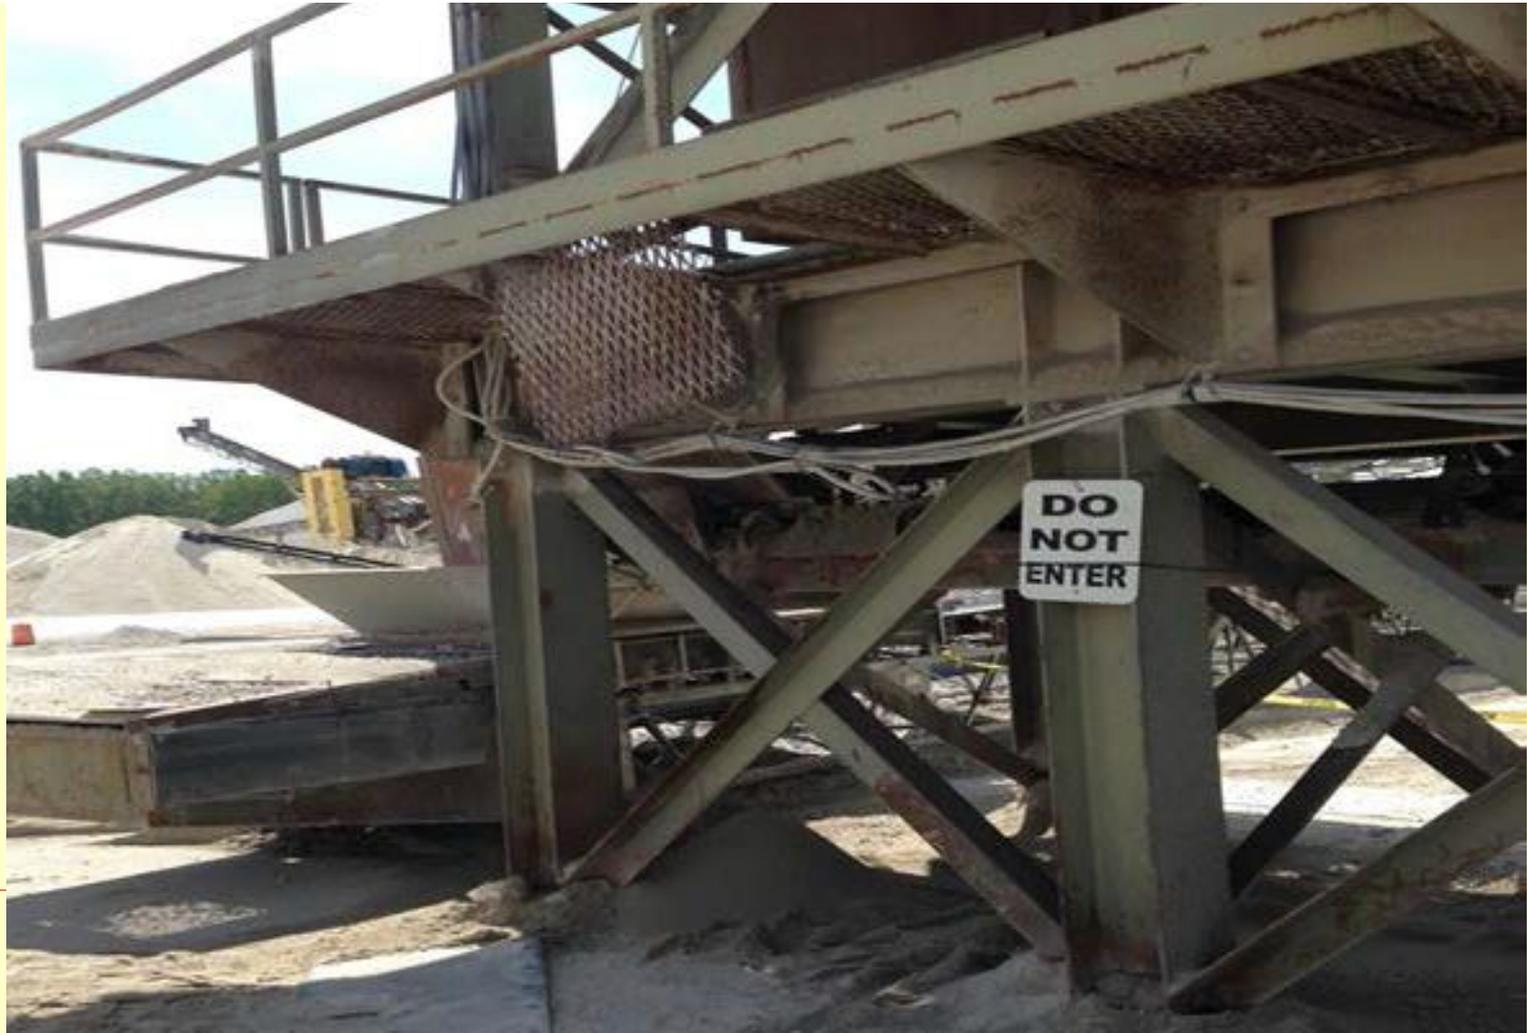
Buckled column

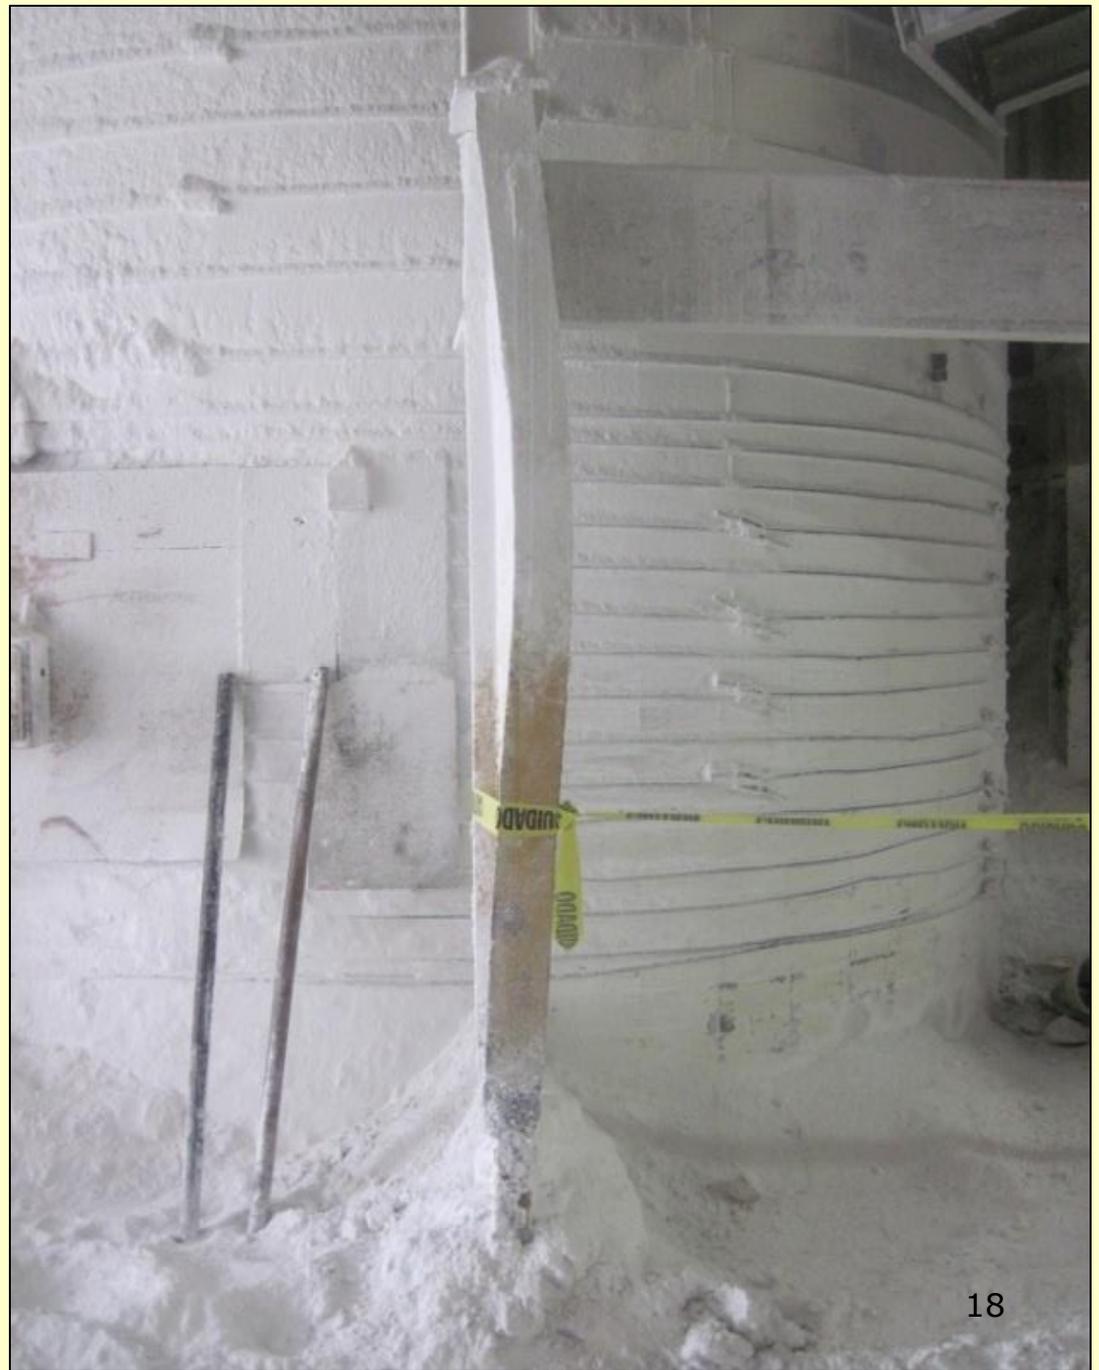
Equipment impact damage to columns

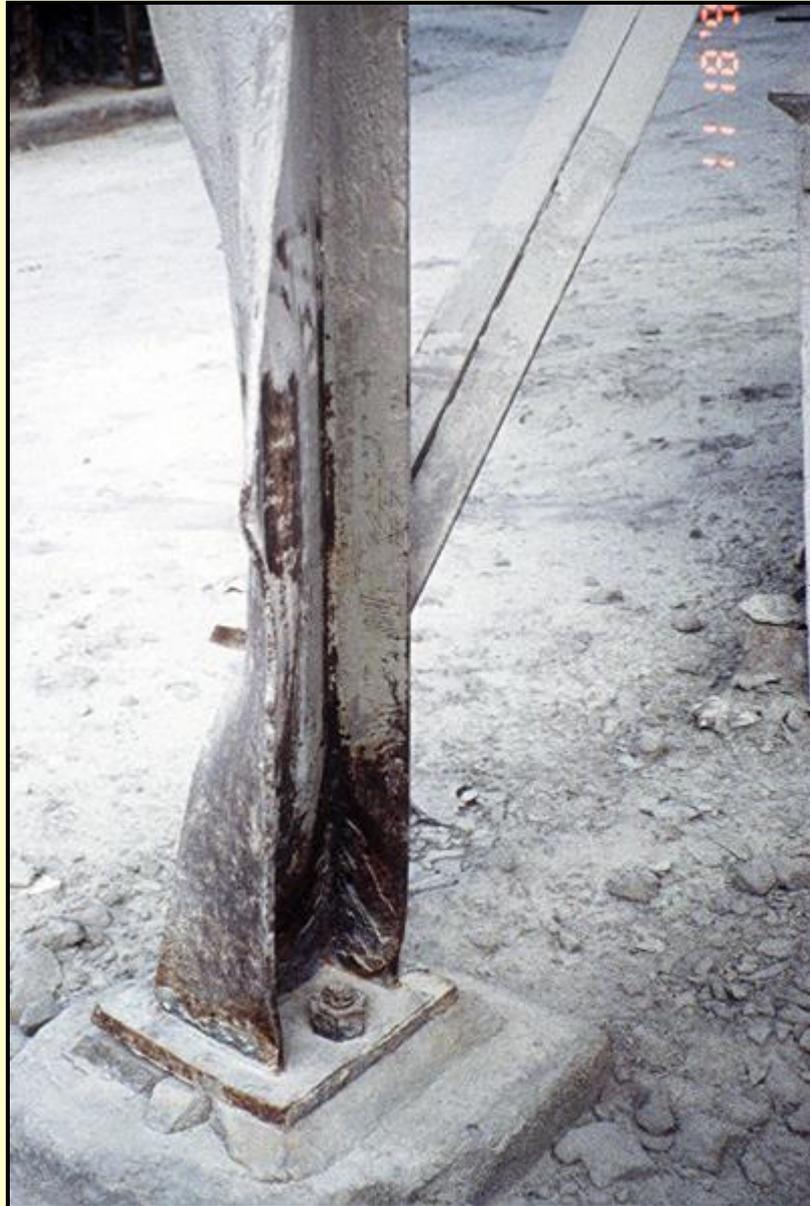
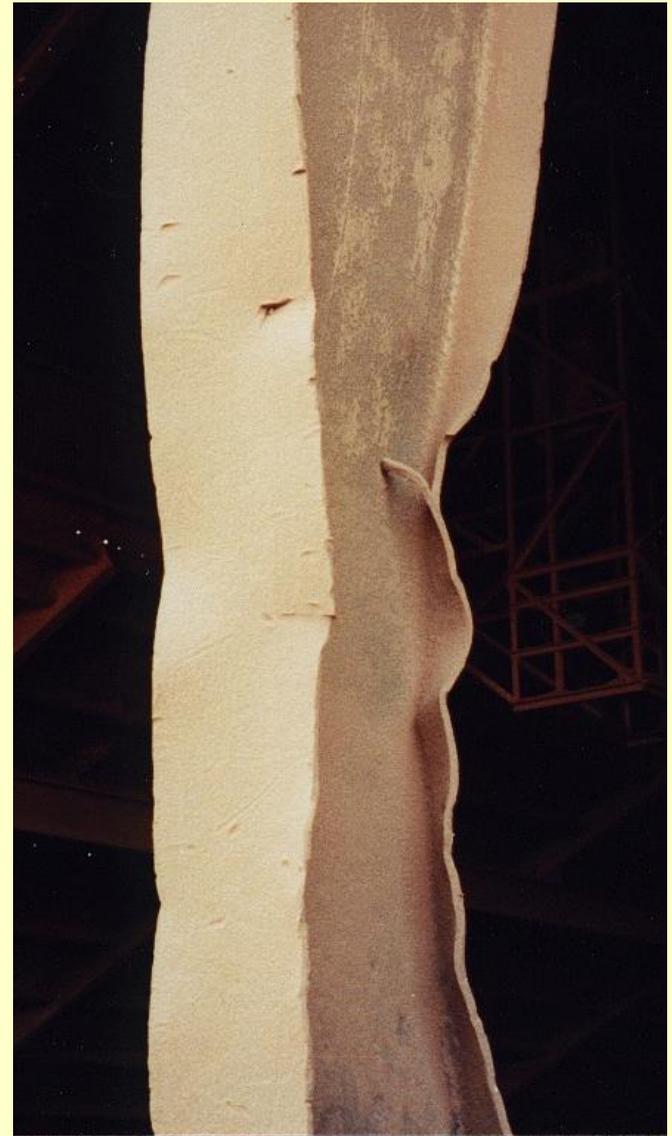
Expose column bases if surrounded by accumulations to assess their condition.

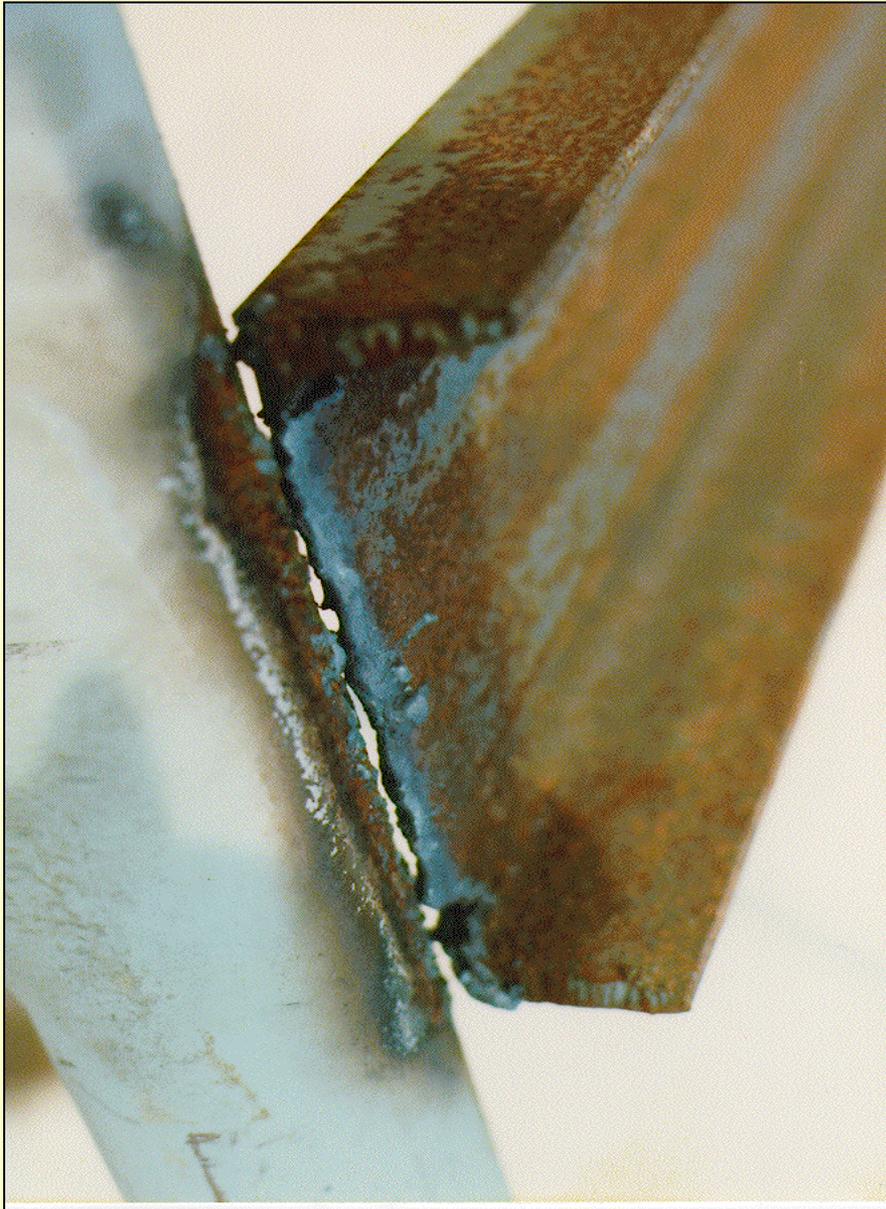
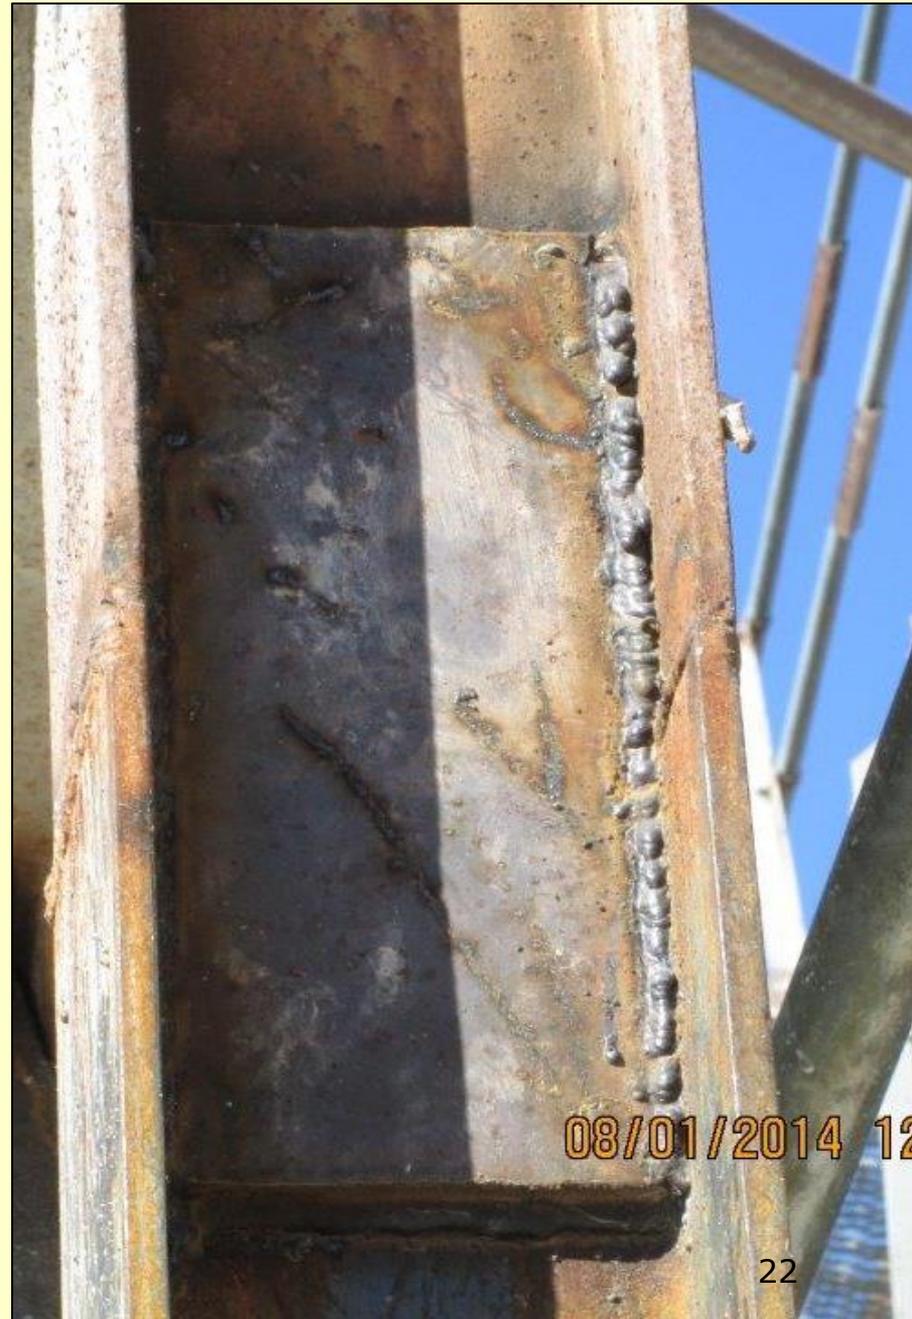
Corroded connections - nuts and bolts
