Mine Surface Structures - Identifying Unsafe Conditions & Avoiding Failures

Plants, Conveyors, & Bins

Terence M. Taylor, P.E.

April 4, 2017

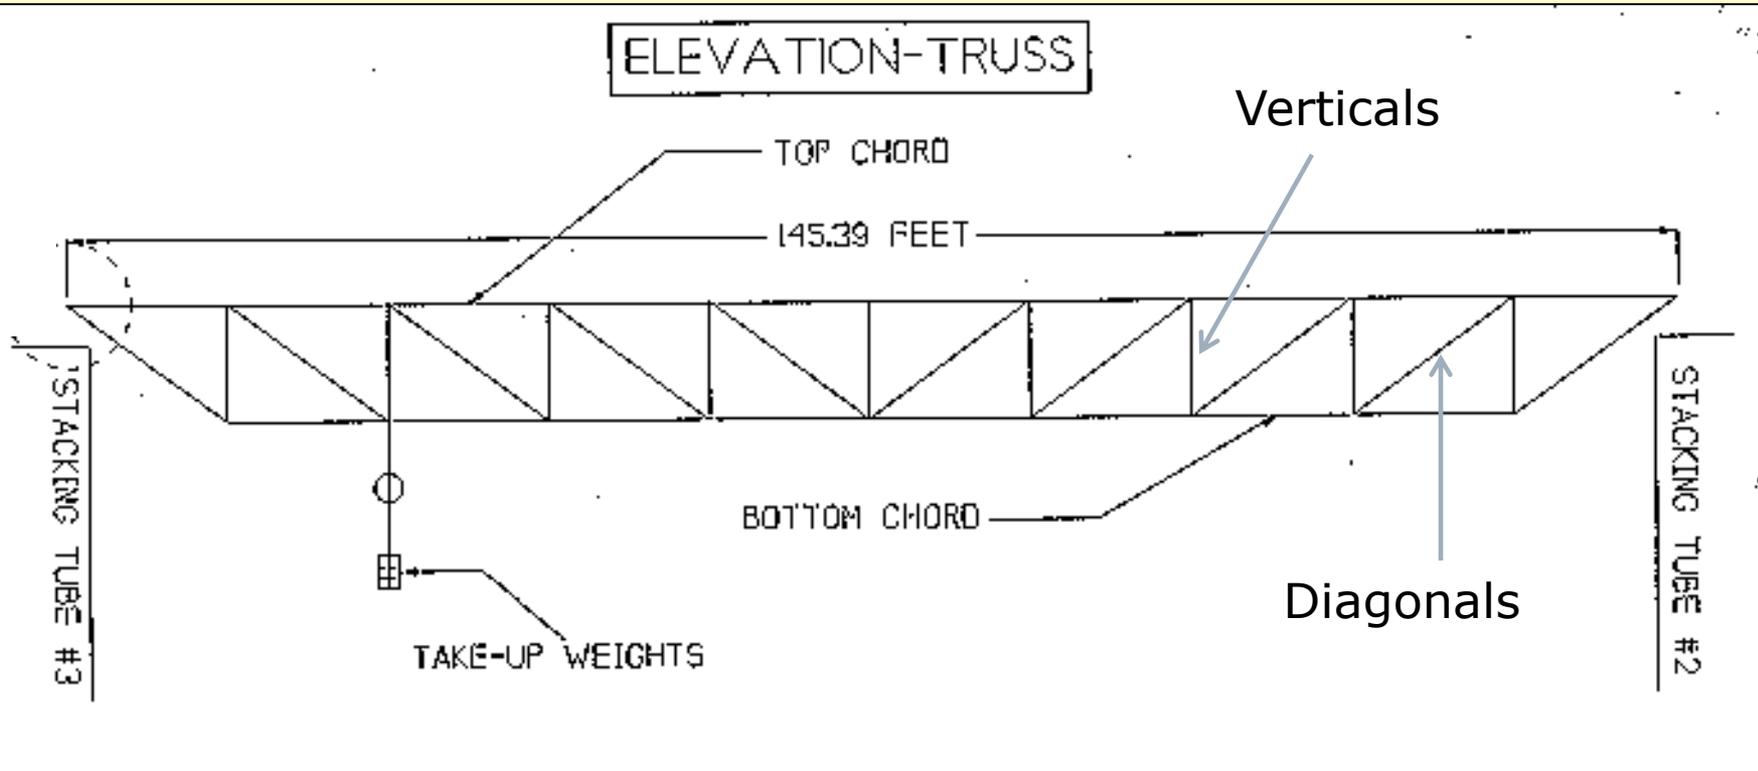
Corrosion holes in truss bottom chords & cross members

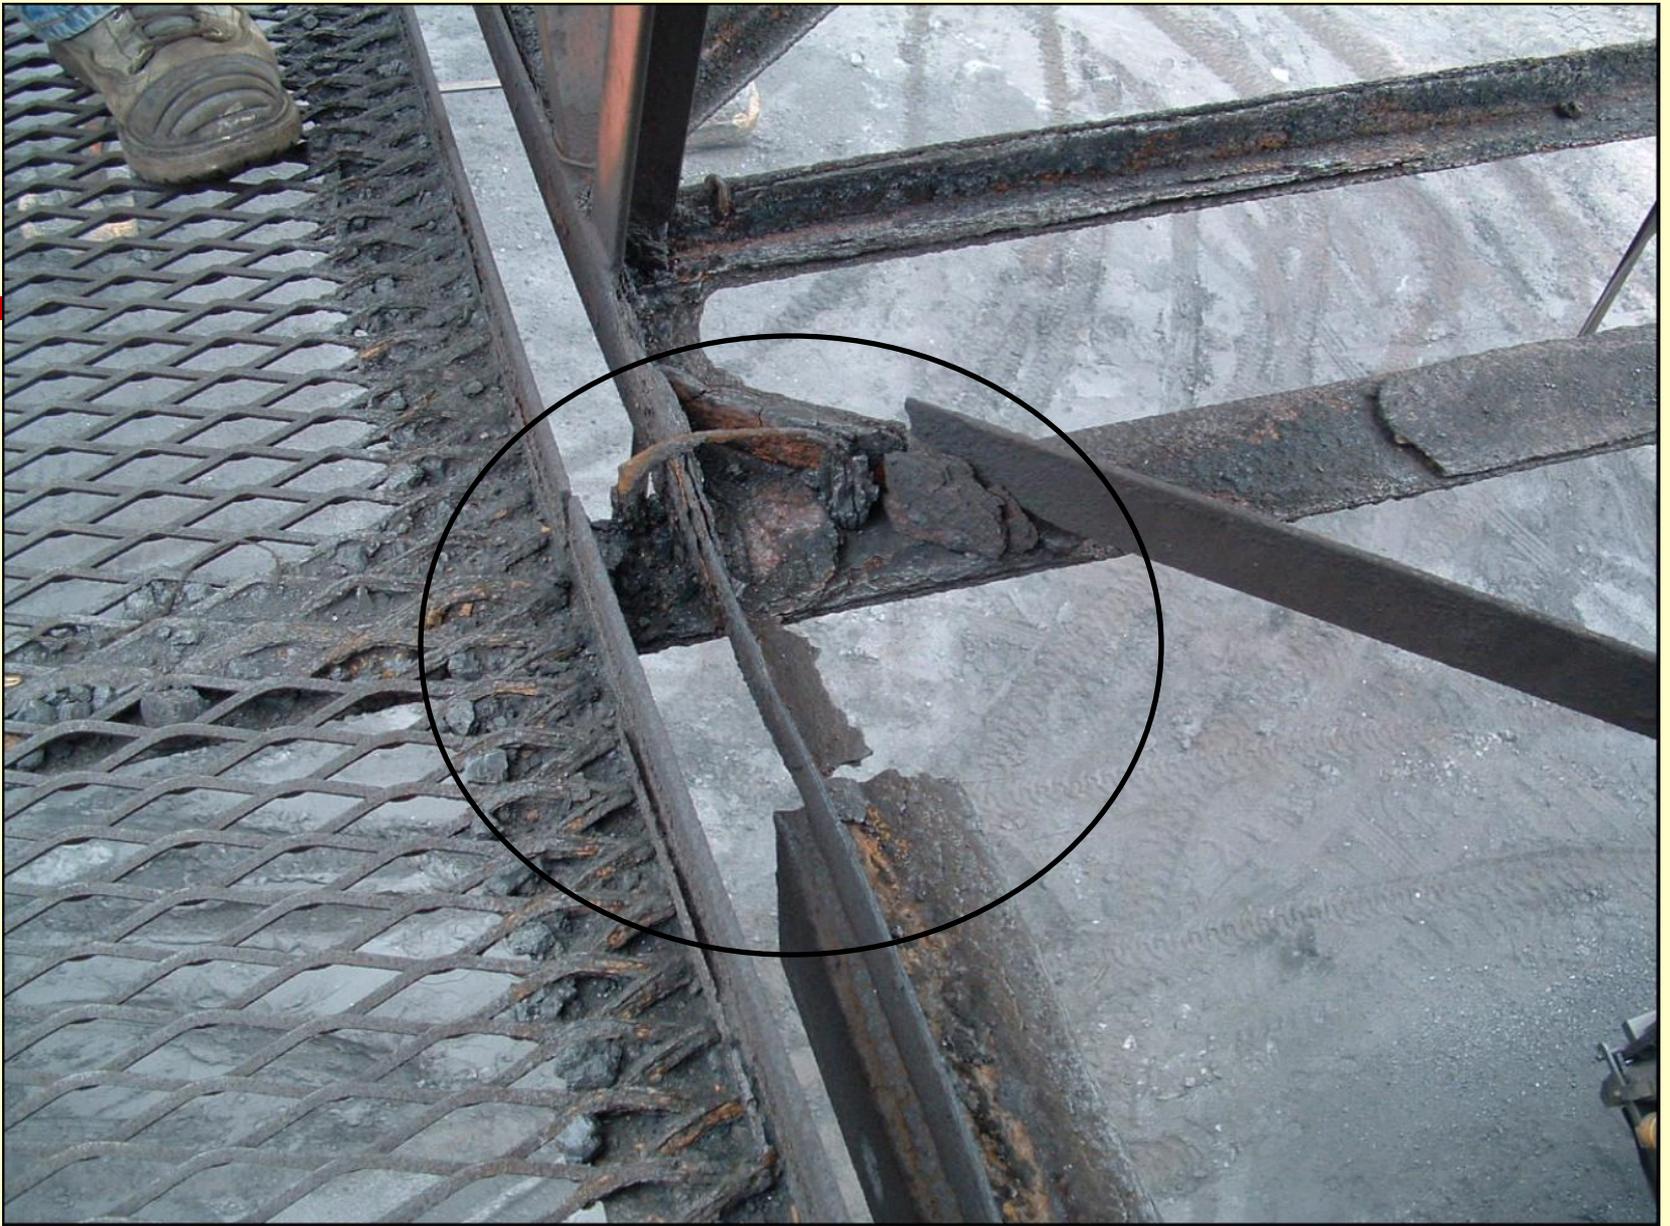
One leg of bottom chord angle corroded through and U-bolt walkway support was also severely corroded

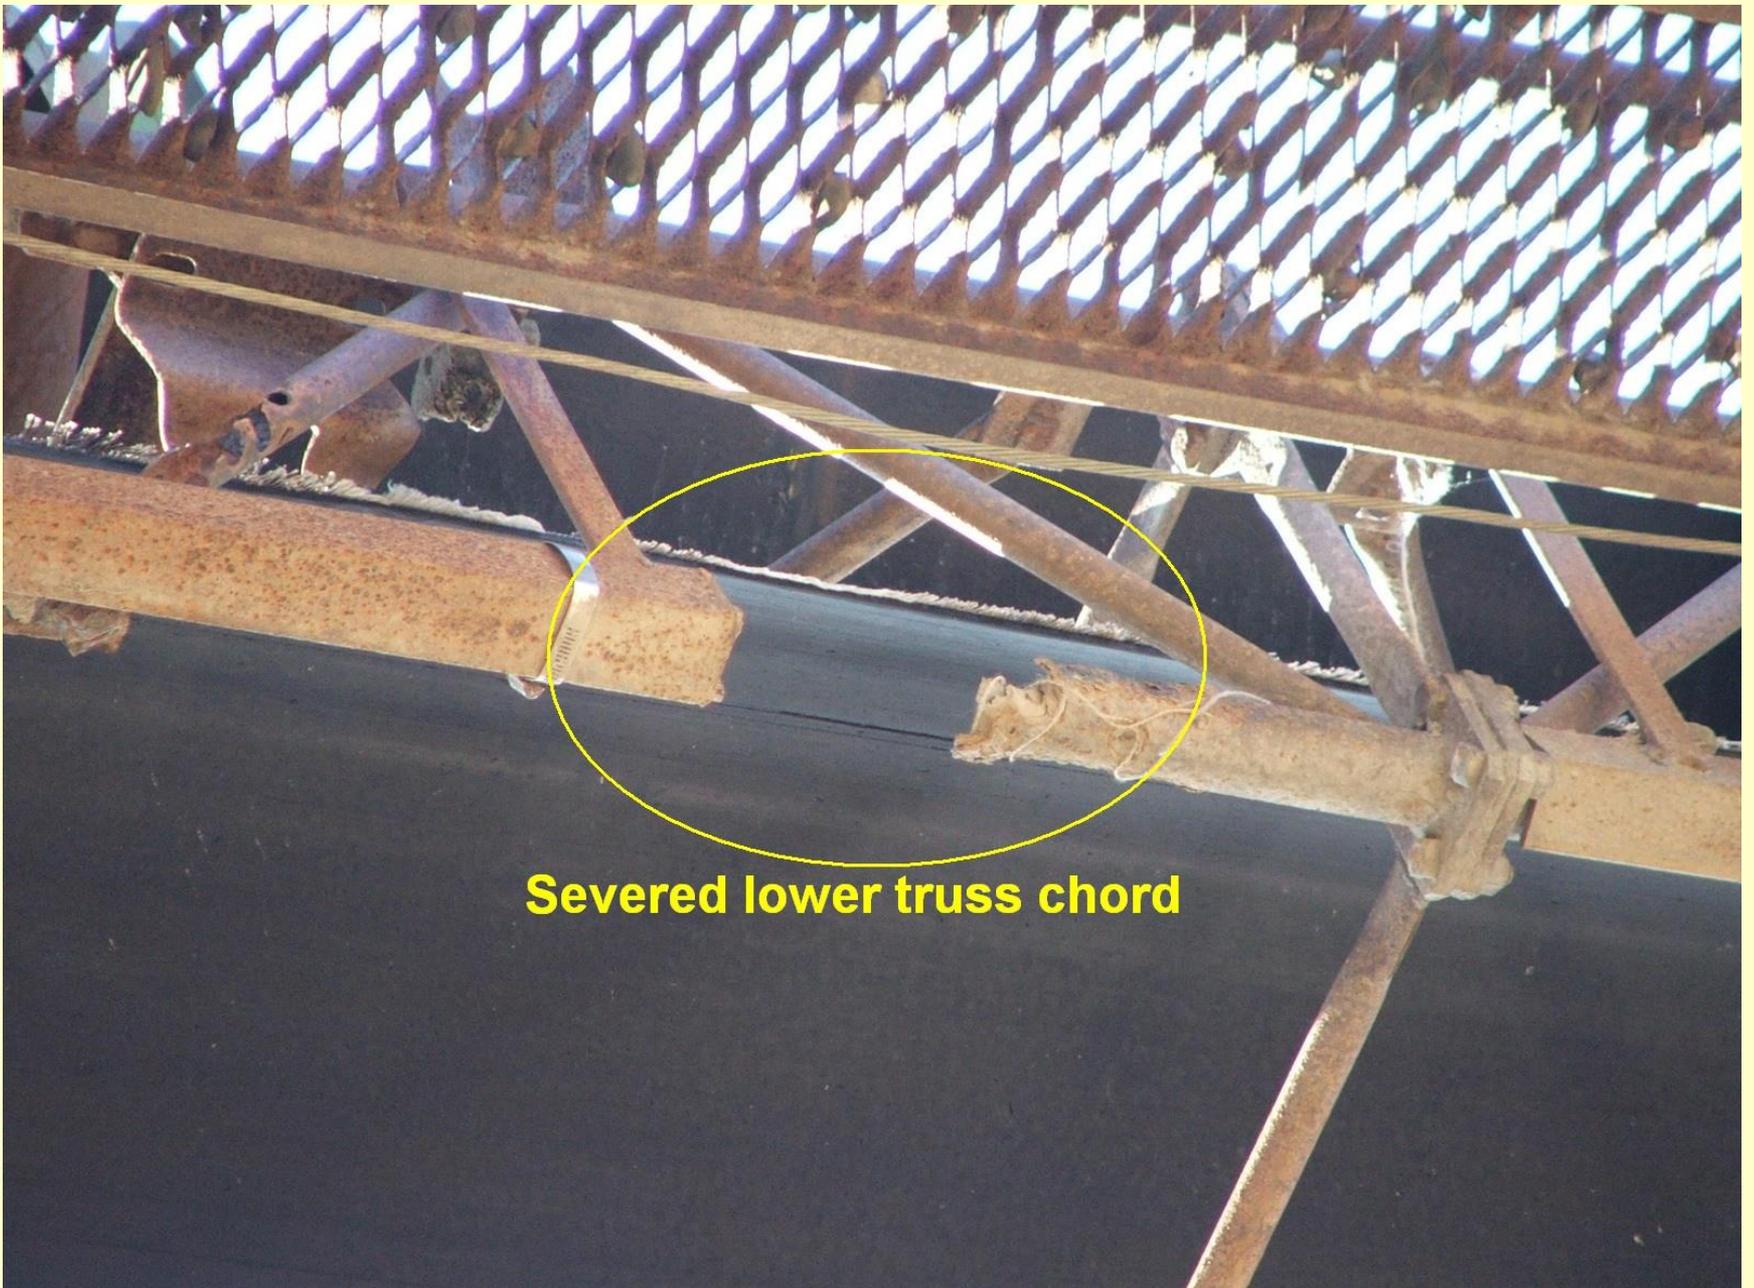
Severed lower truss chord

Fractured bottom truss chord

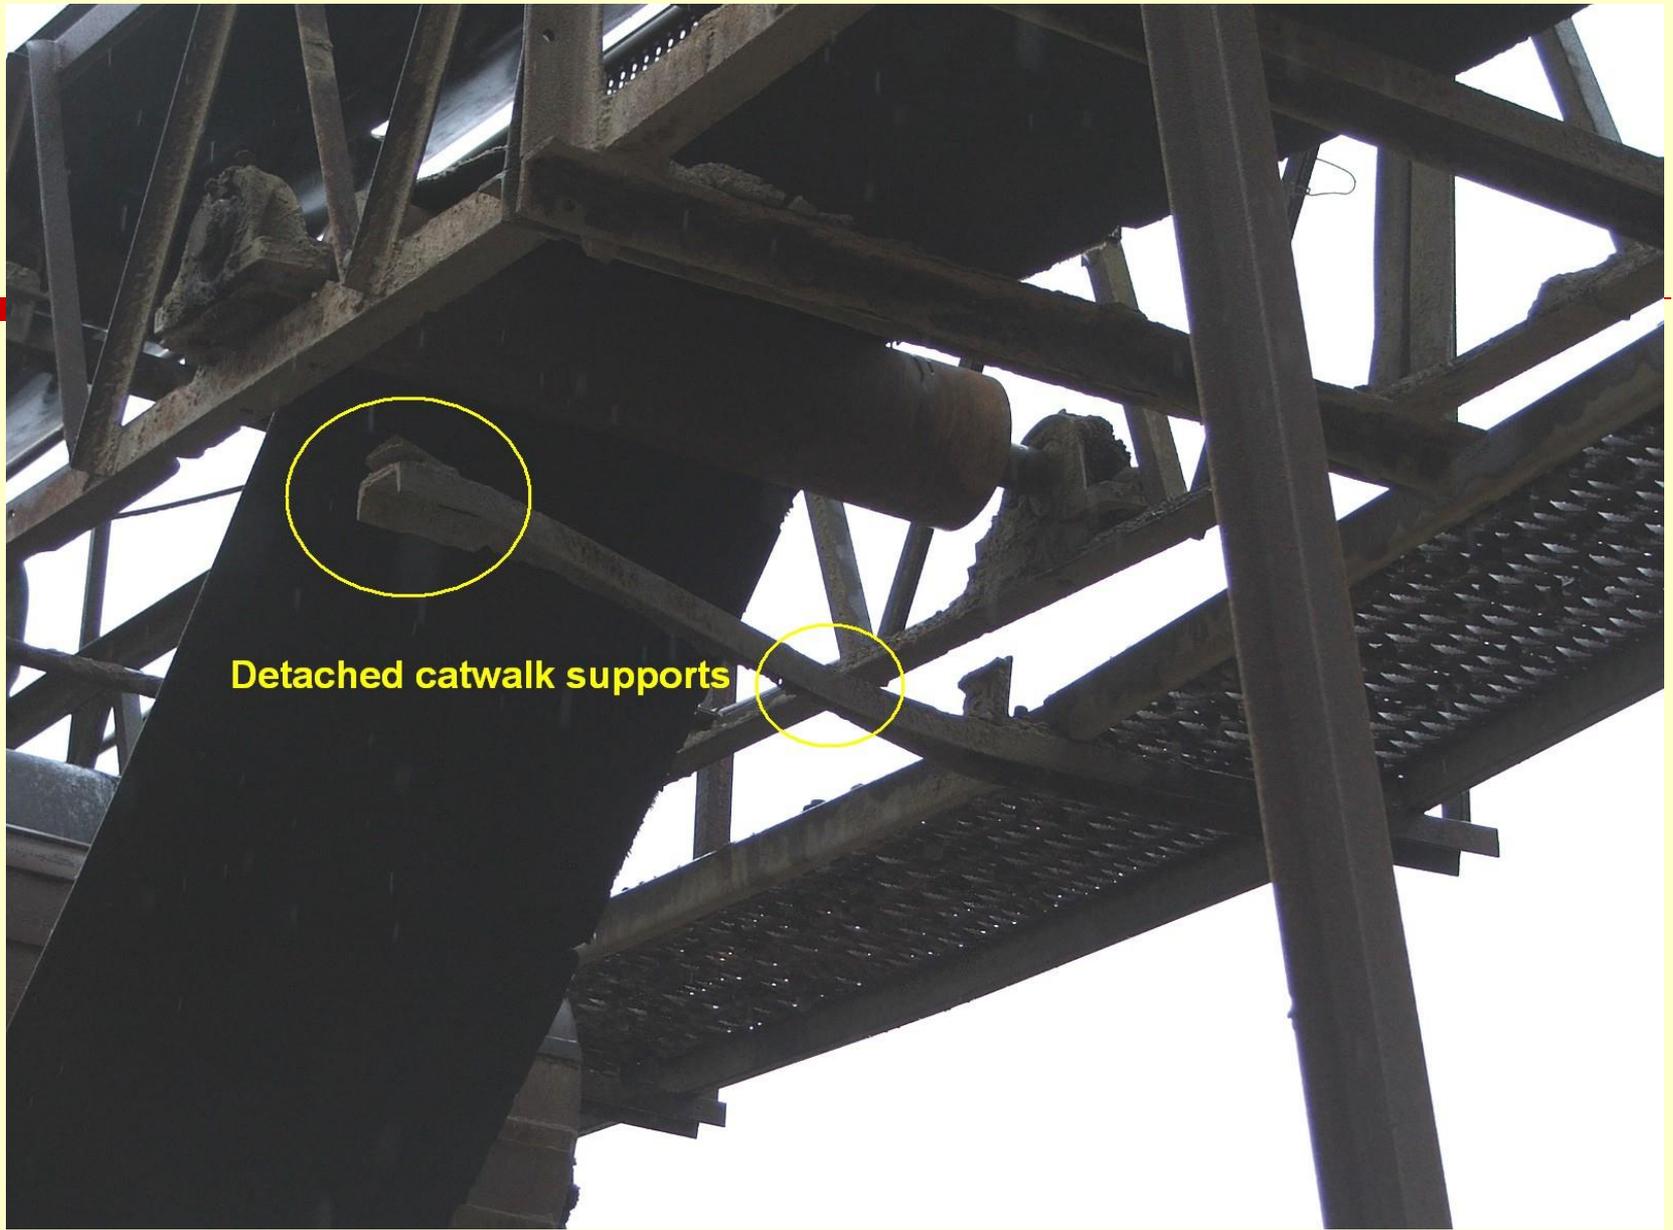
Detached catwalk supports

Belt abrasion notch in truss diagonal angle-shaped member. Section loss resulting in 50% loss of capacity!

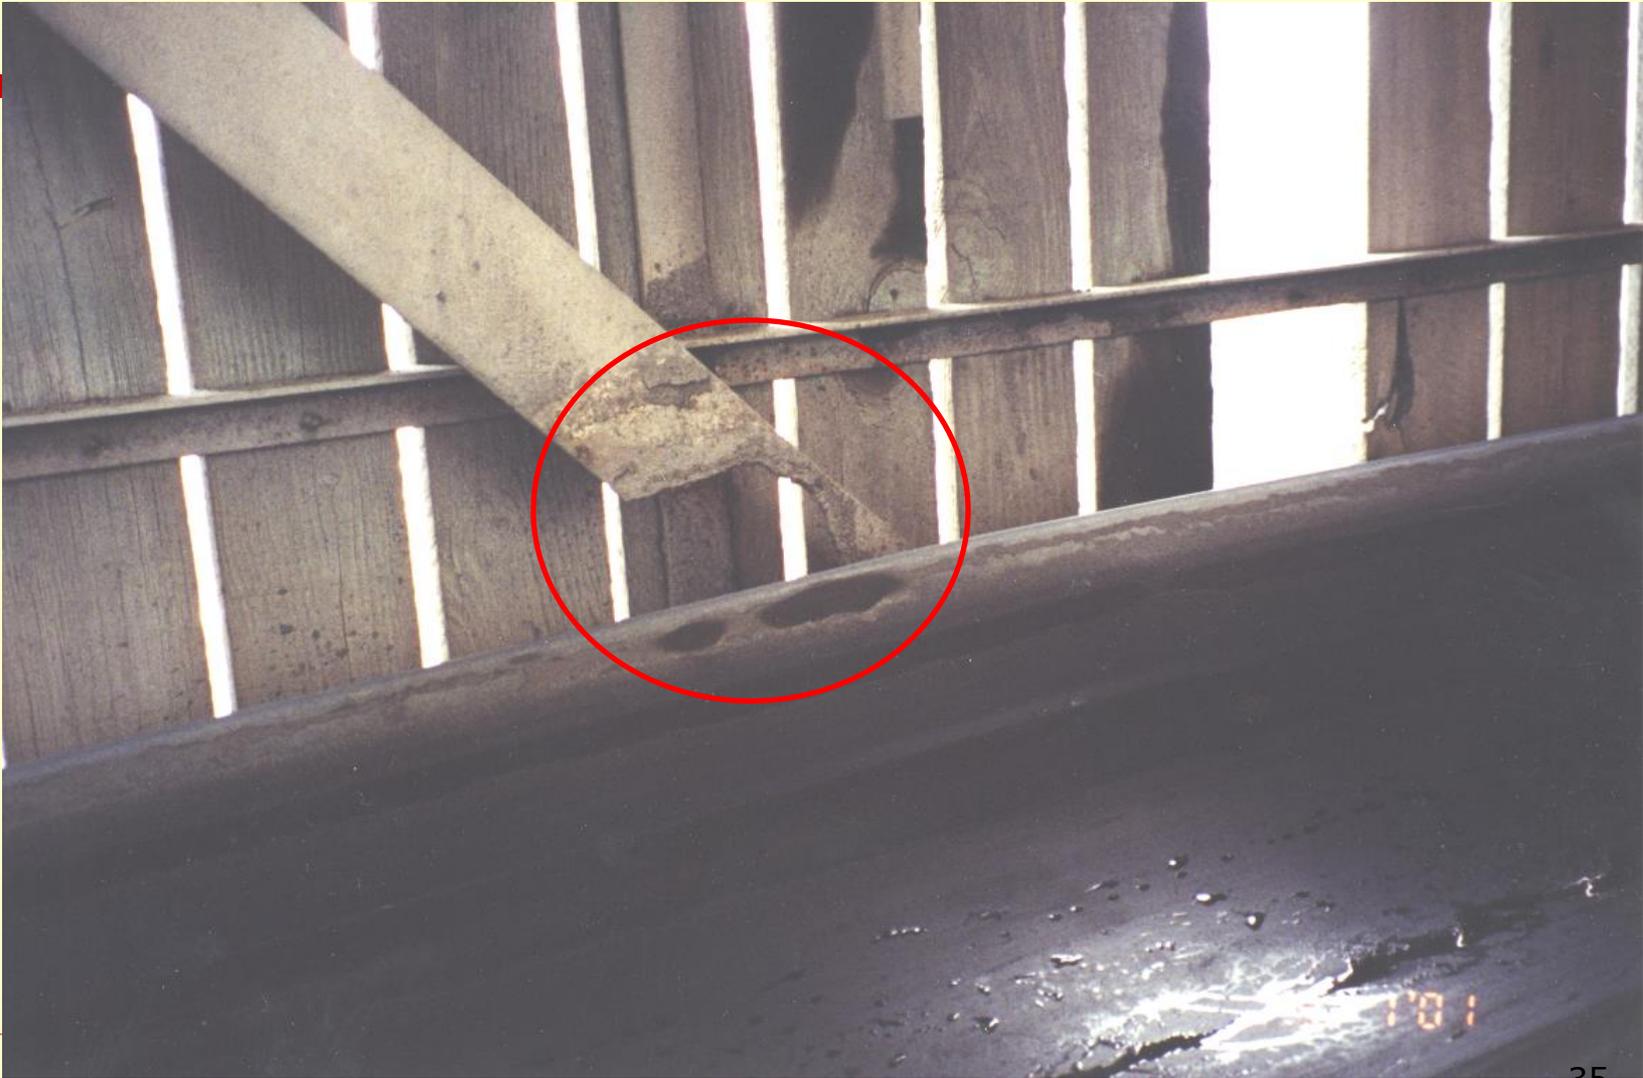
Corroded and severed truss diagonals & chords

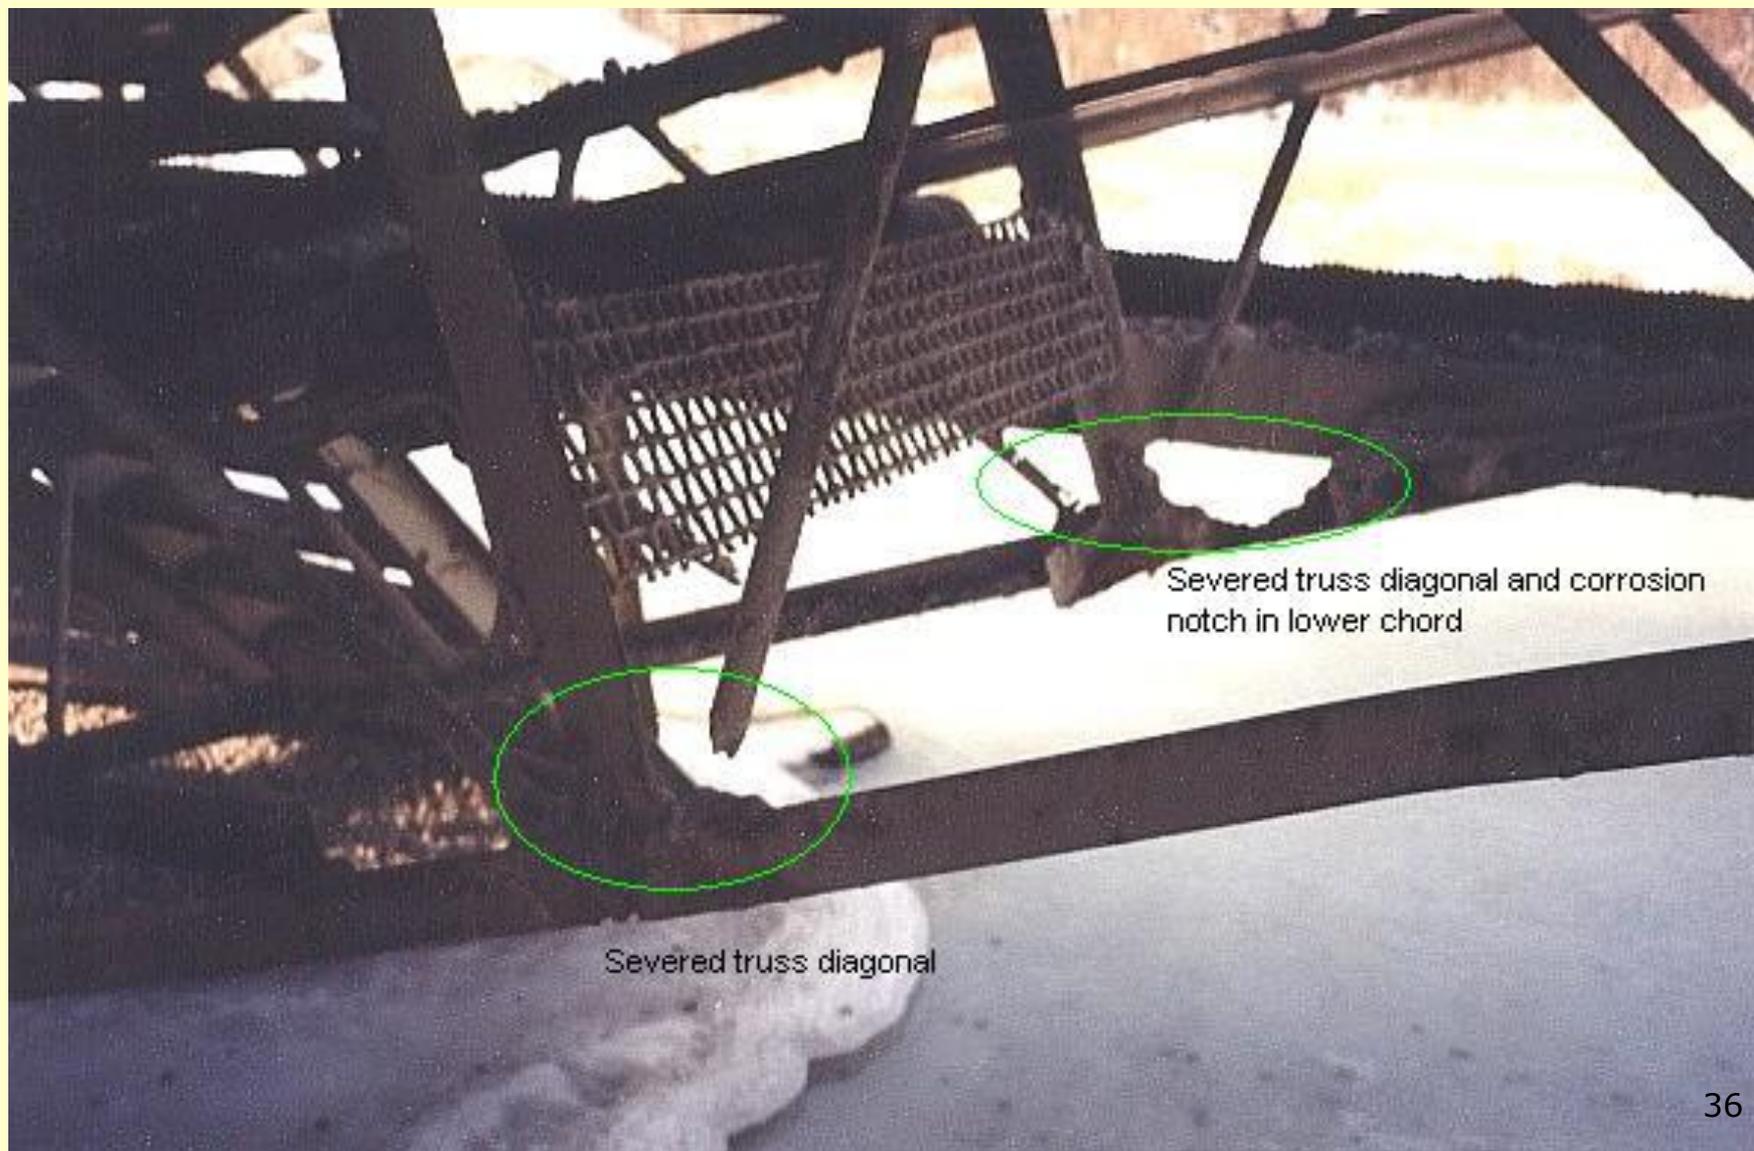
Fractured bottom chord angle section

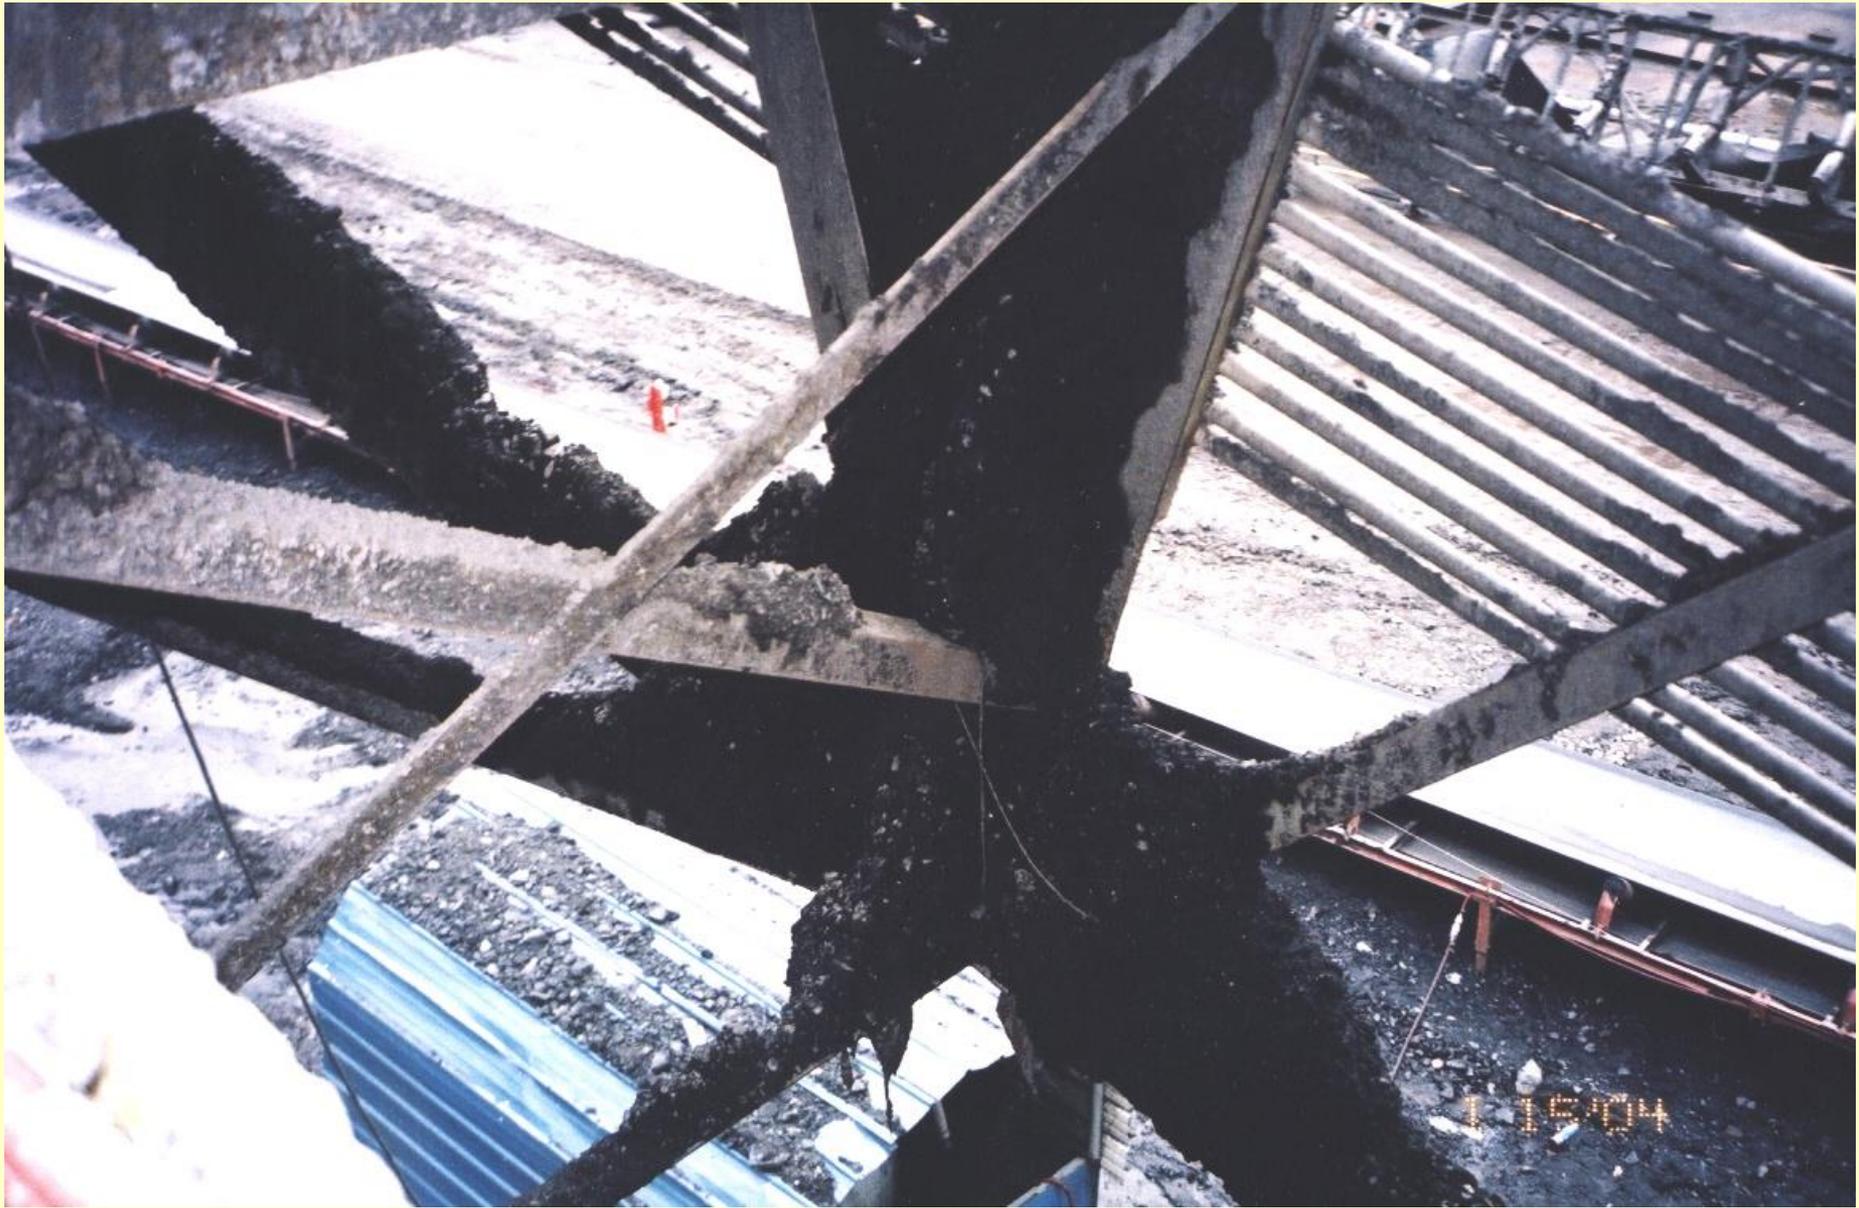
Accumulations on bottom chords and verticals add weight and may³⁸ facilitate corrosion

Overall sag of a conveyor belt truss of approximately 2 feet.

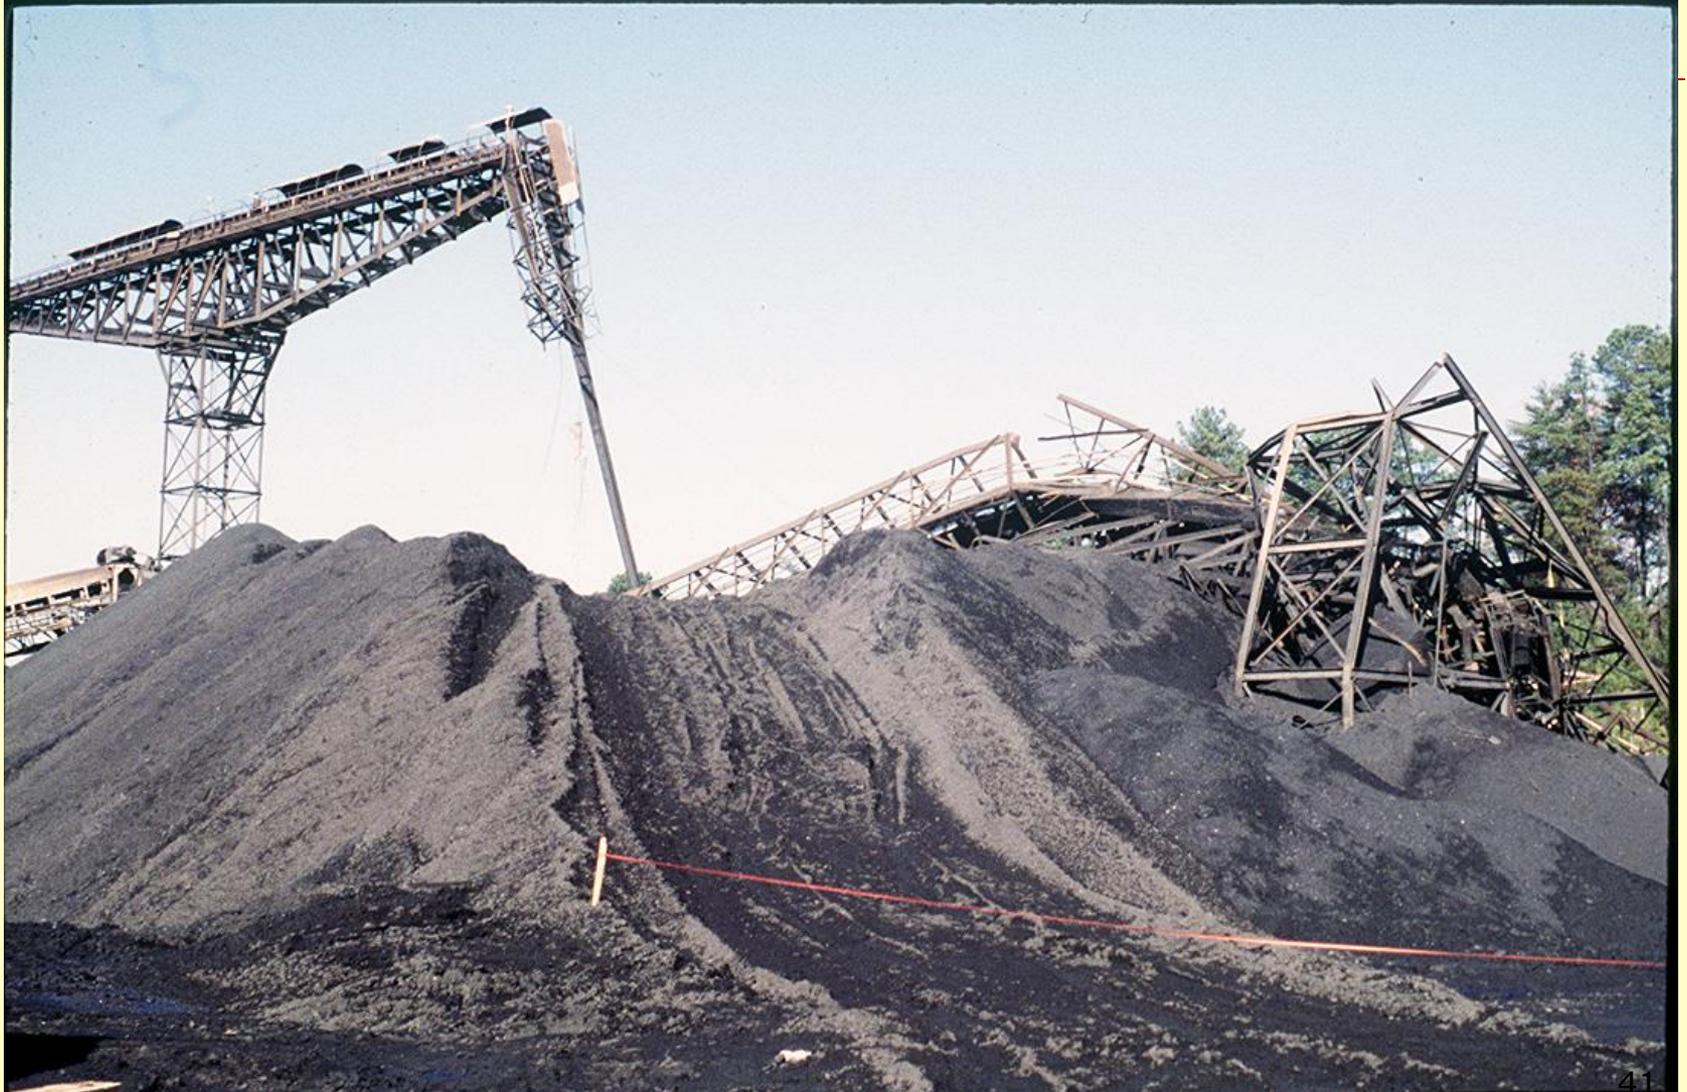
Corrosion caused fatal @ Drummond, AL - 1995

Fractured bottom chord angle section on the truss had 70% loss of cross-sectional area from corrosion.

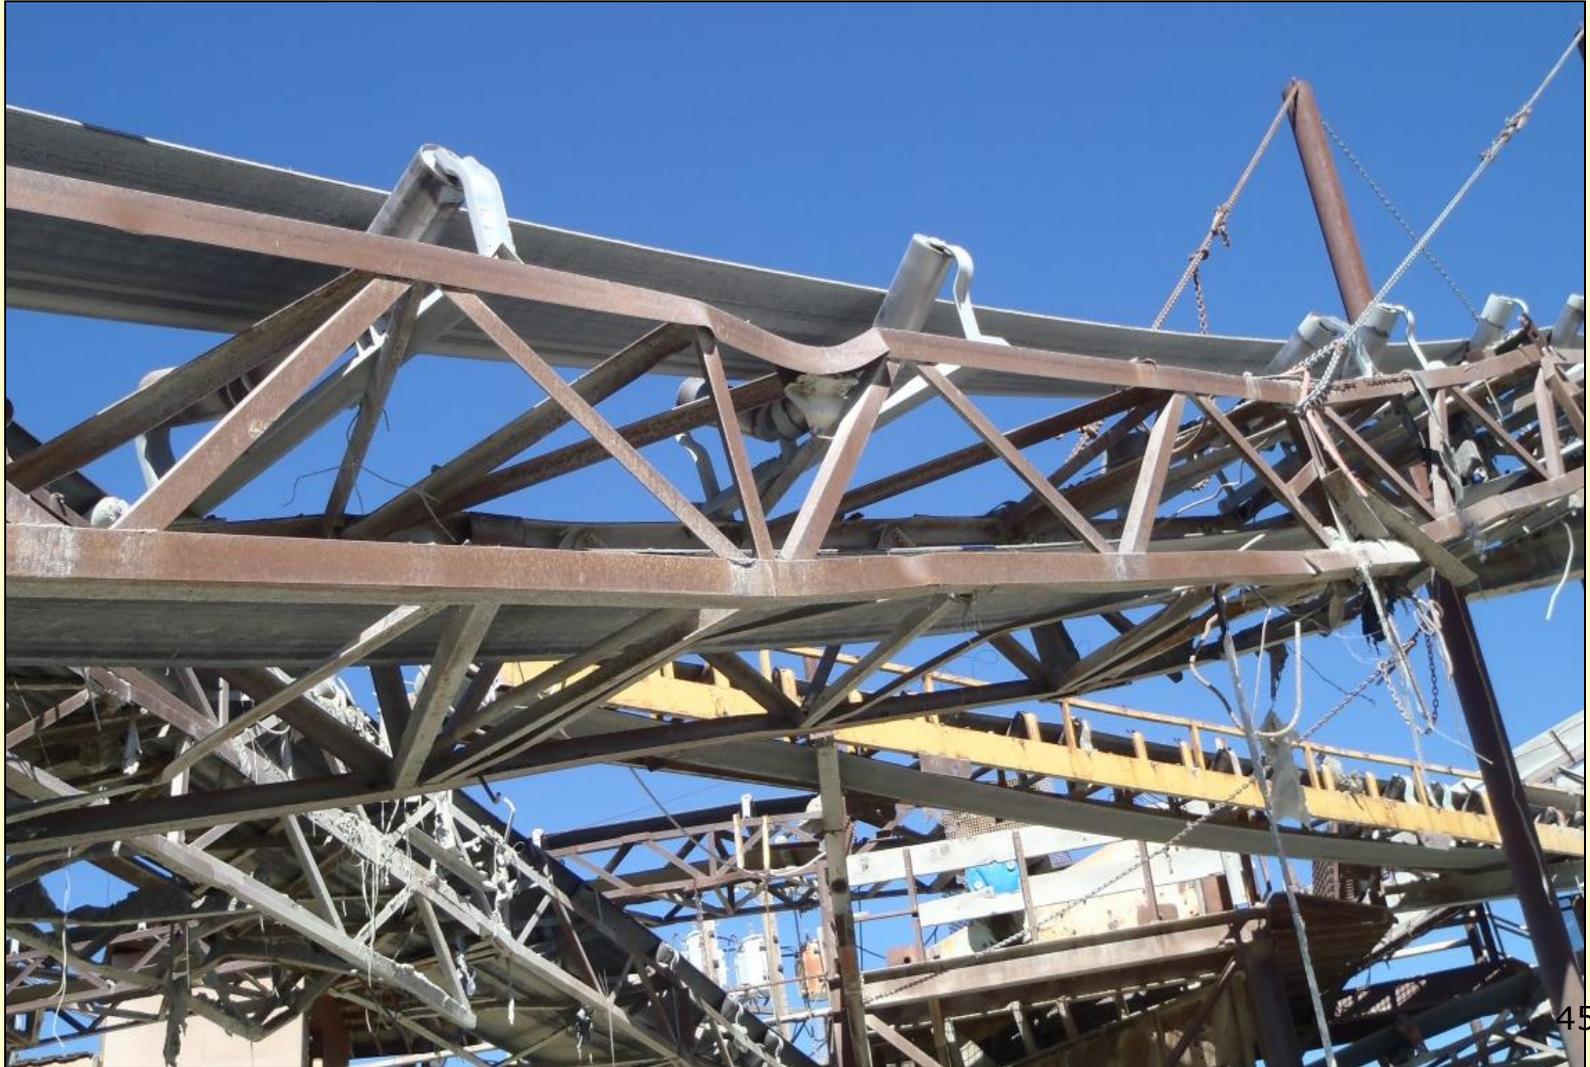
Impact damaged bent w/ inadequate repair

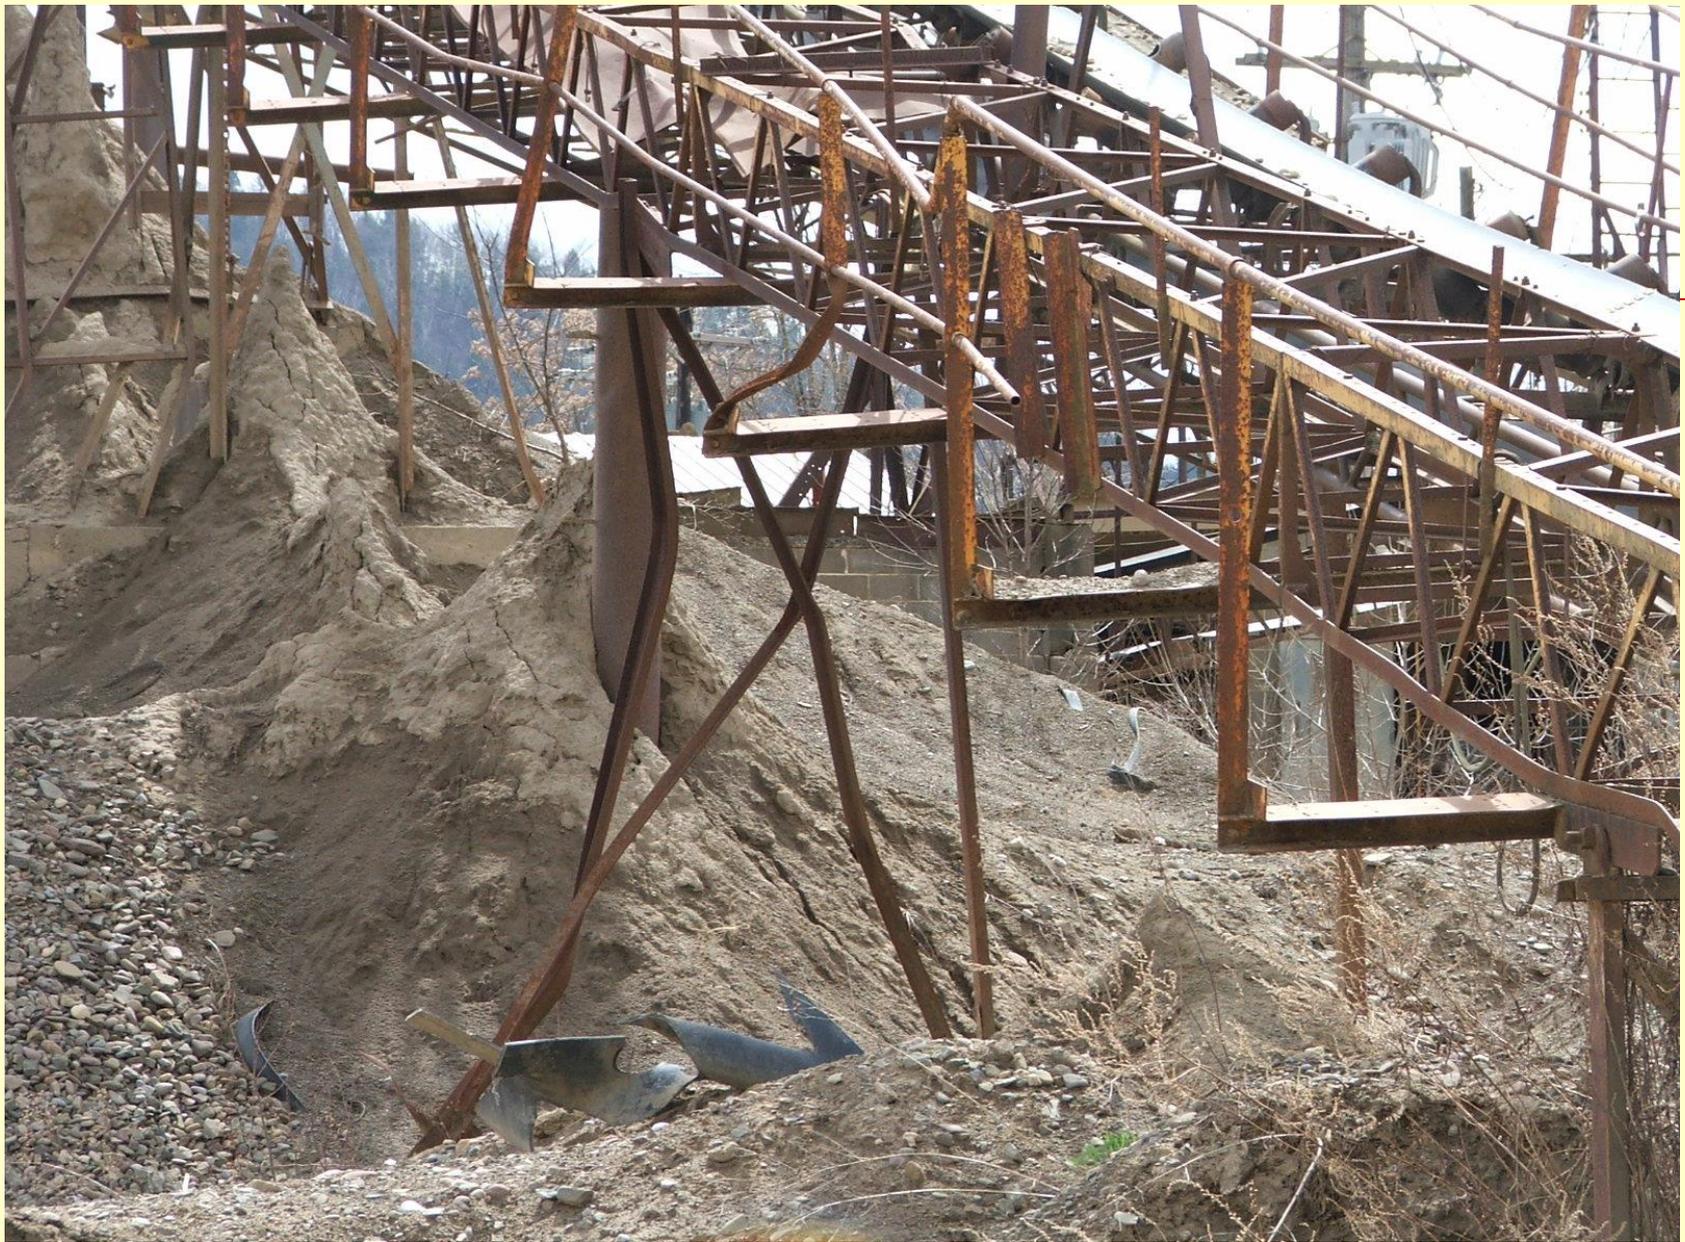
Impact damage to a conveyor bent and excessive material build₄₇up

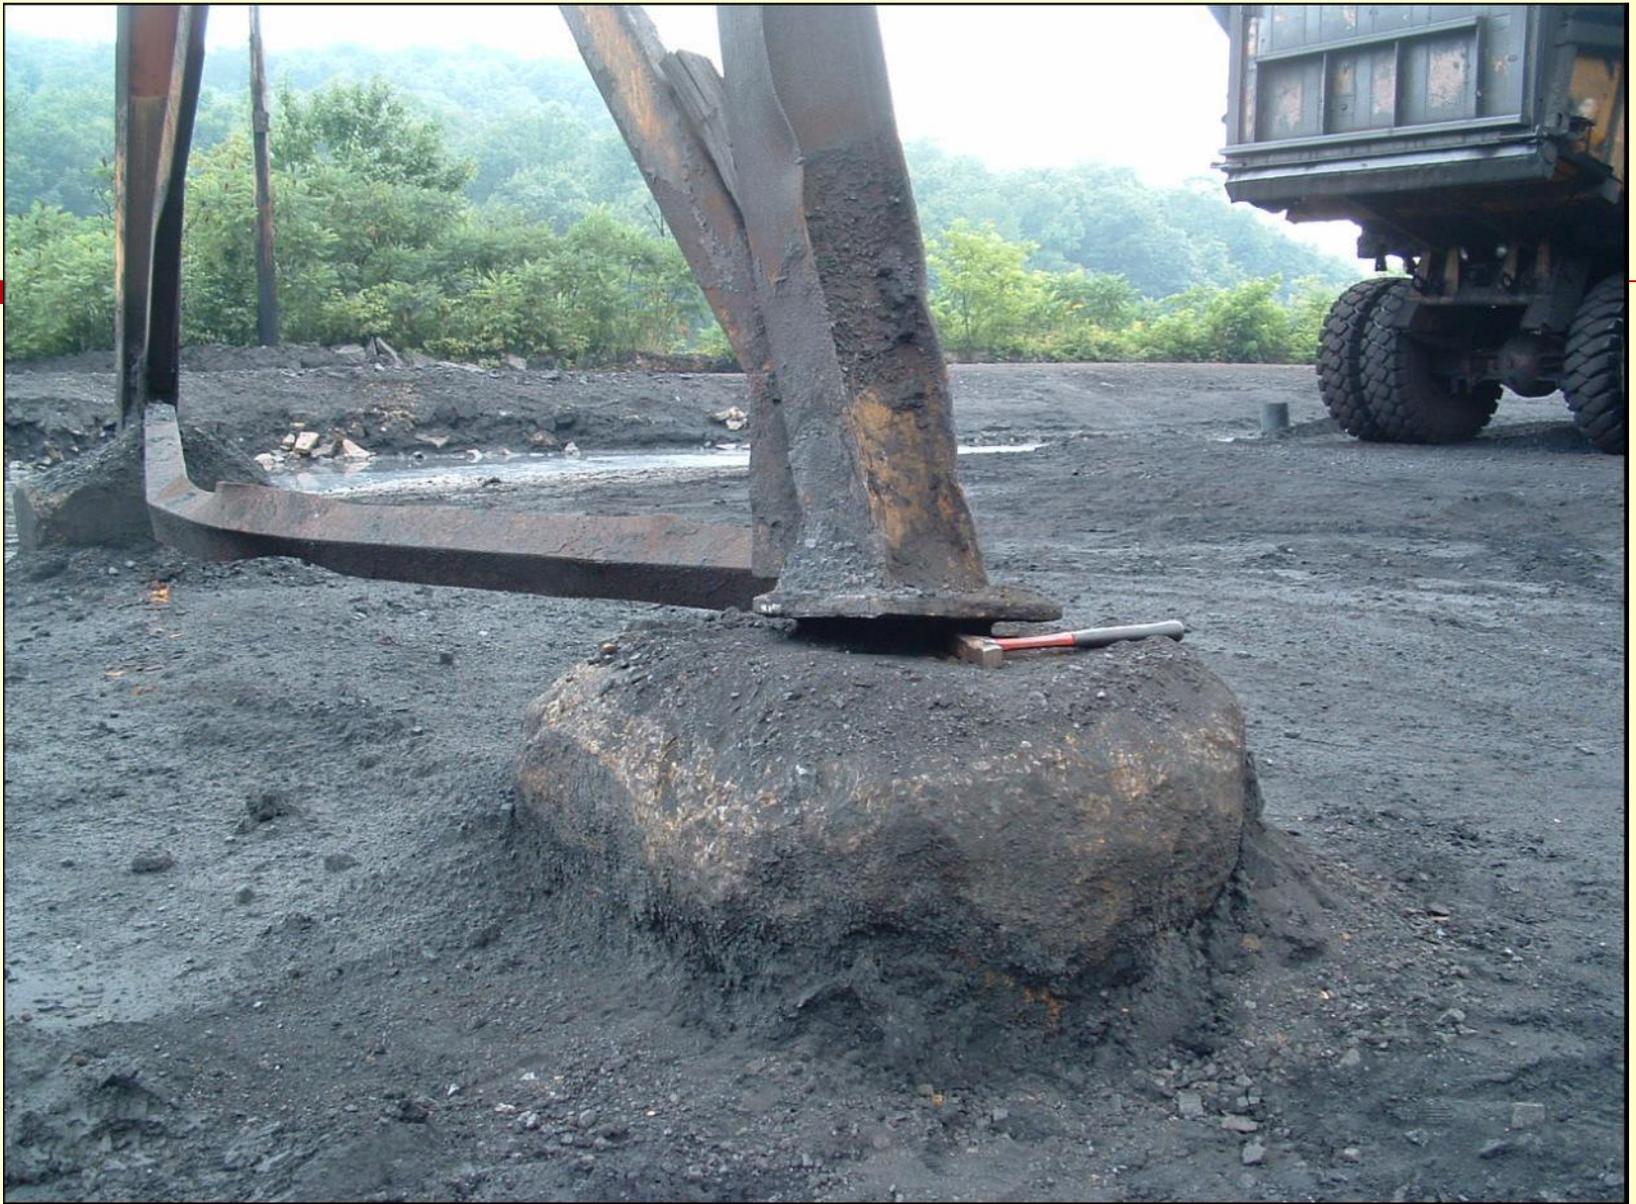
Impact damage - conveyor bent separated from the concrete foundation

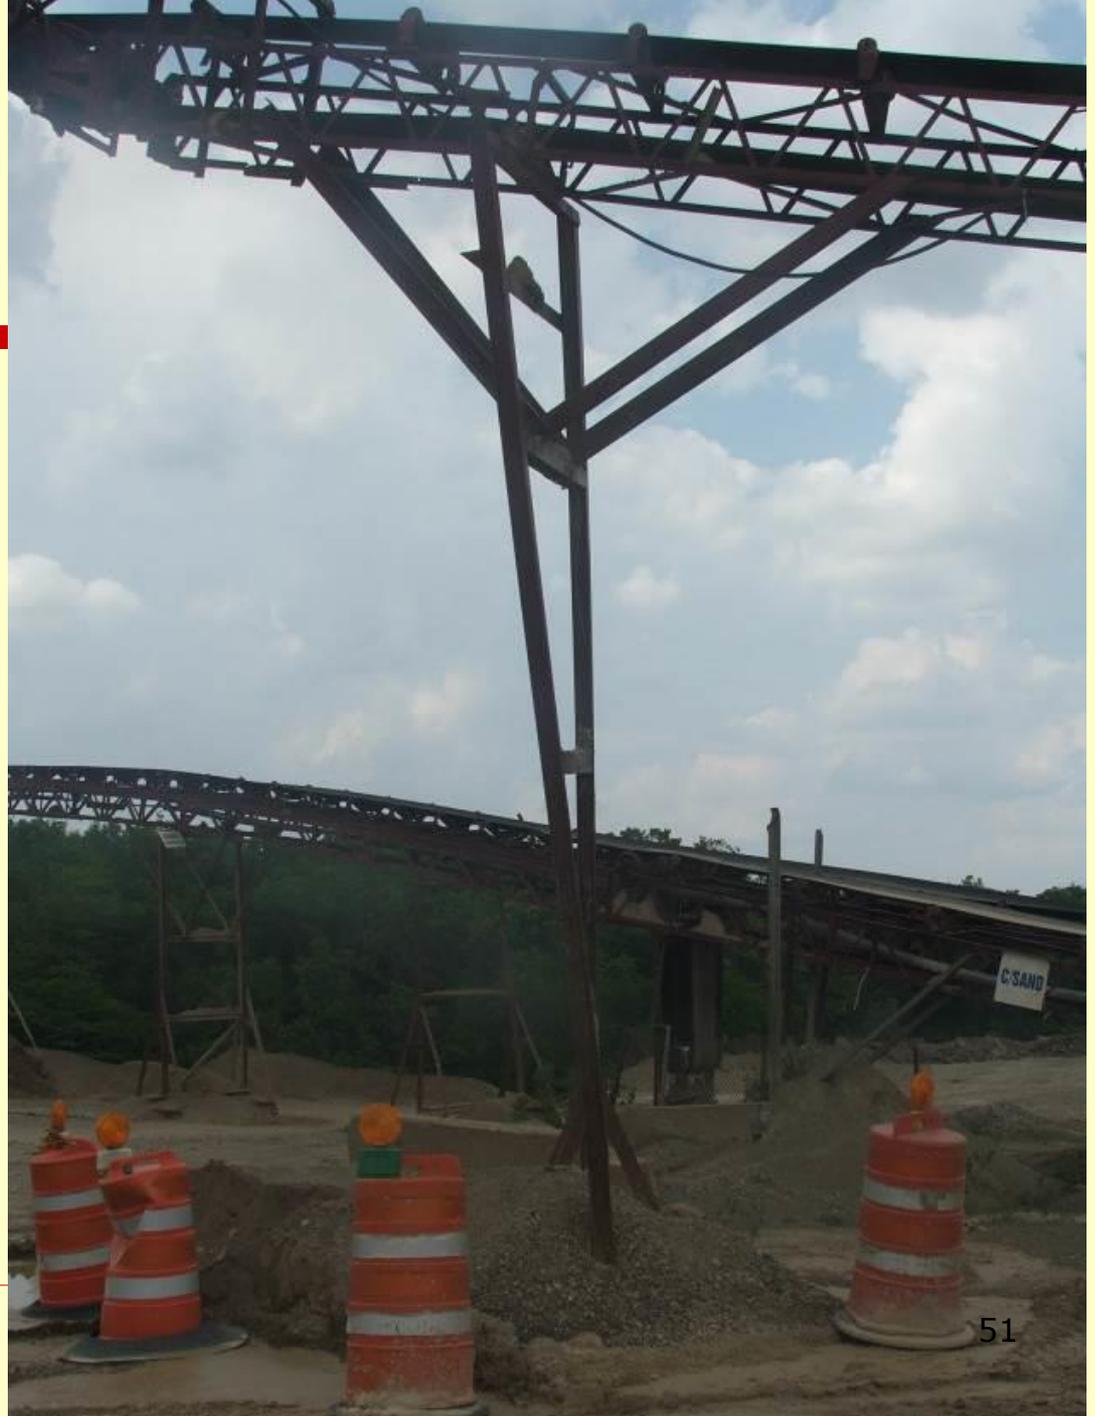
Corroded column at the base of a conveyor support bent.
