Mine Surface Structures - Identifying Unsafe Conditions & Avoiding Failures

Plants, Conveyors, & Bins

Terence M. Taylor, P.E.

April 4, 2017

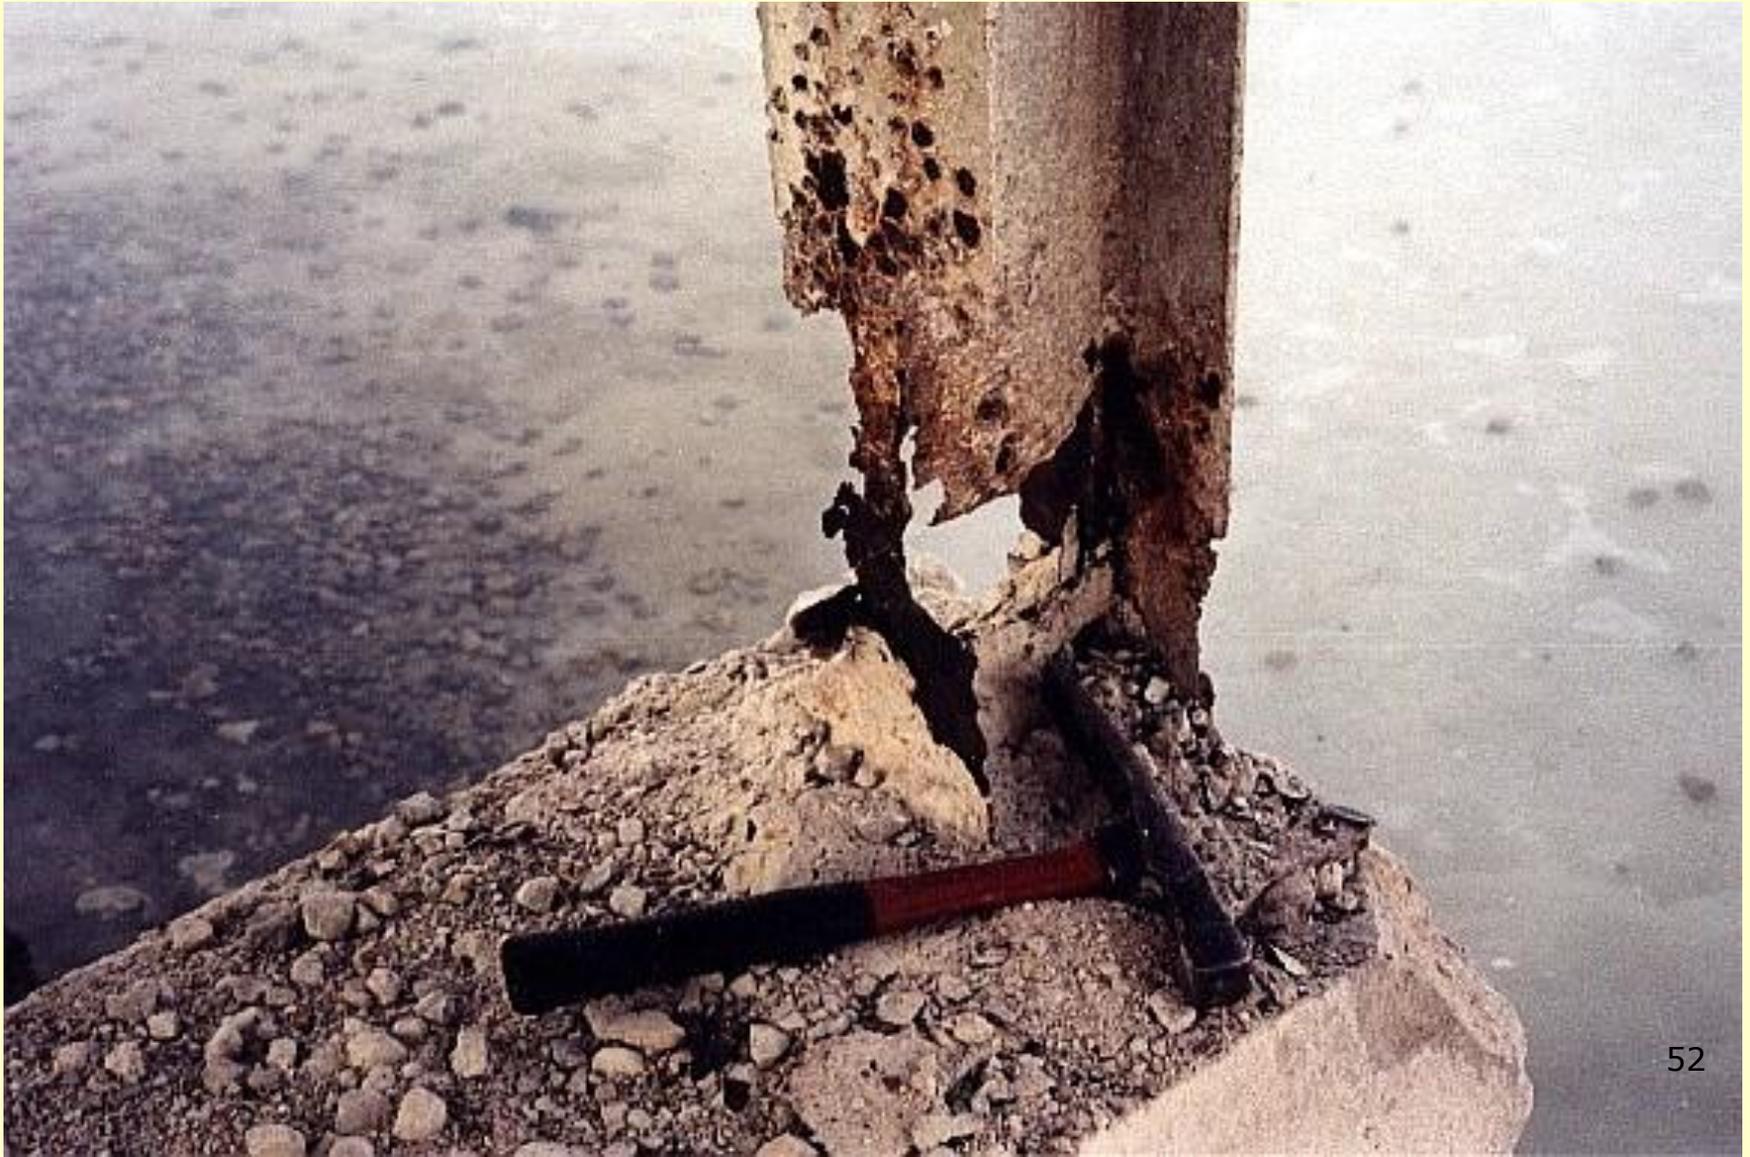
Corroded conveyor belt supports

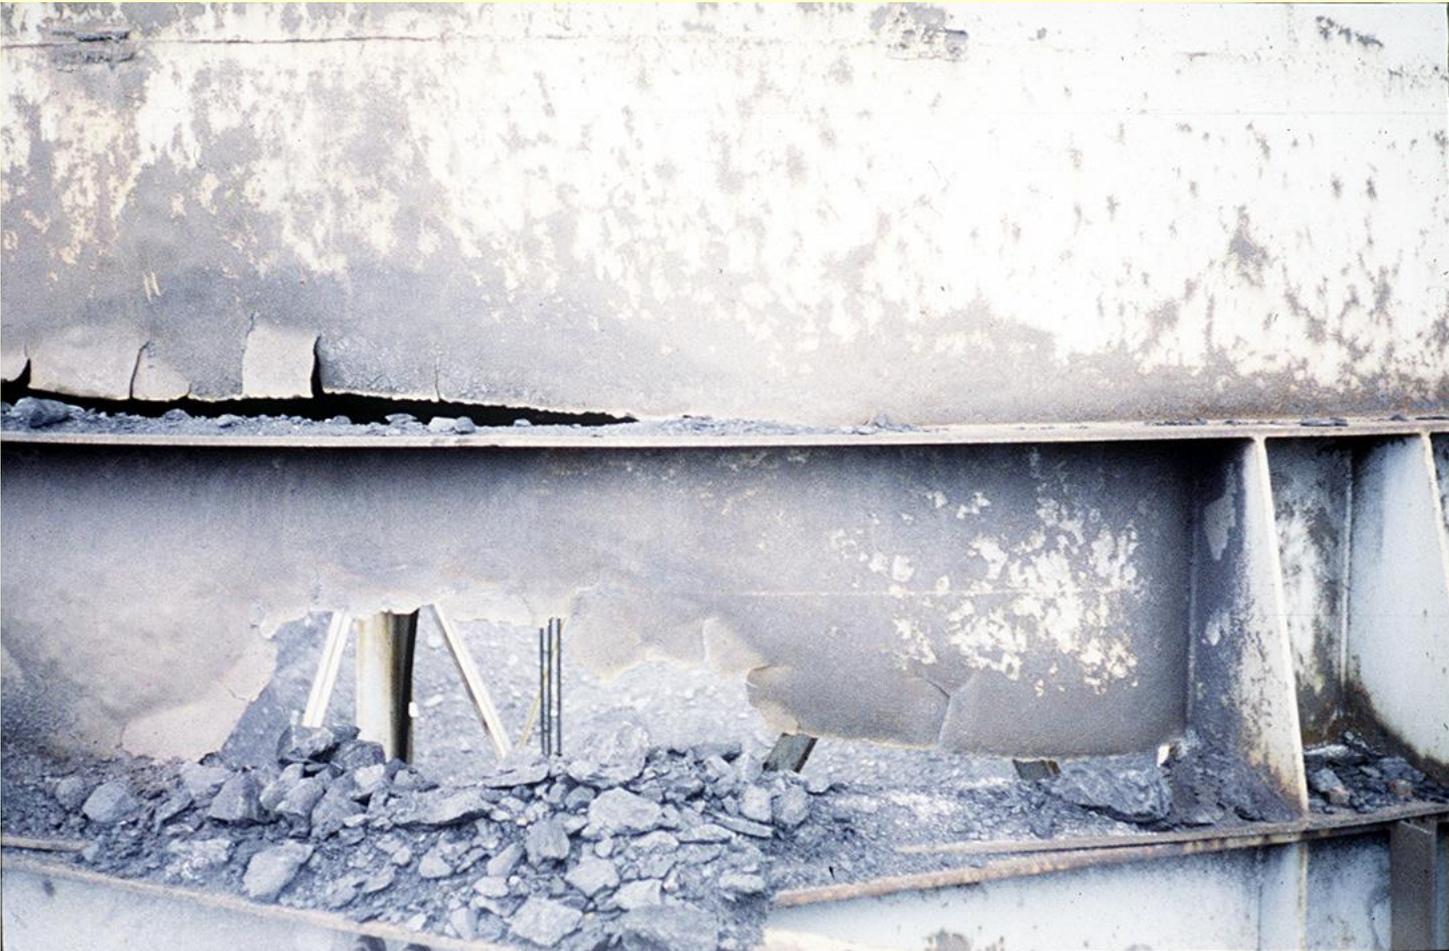
Corrosion holes in the cone at the junction with the cylinder. Aggregate was peaking through.

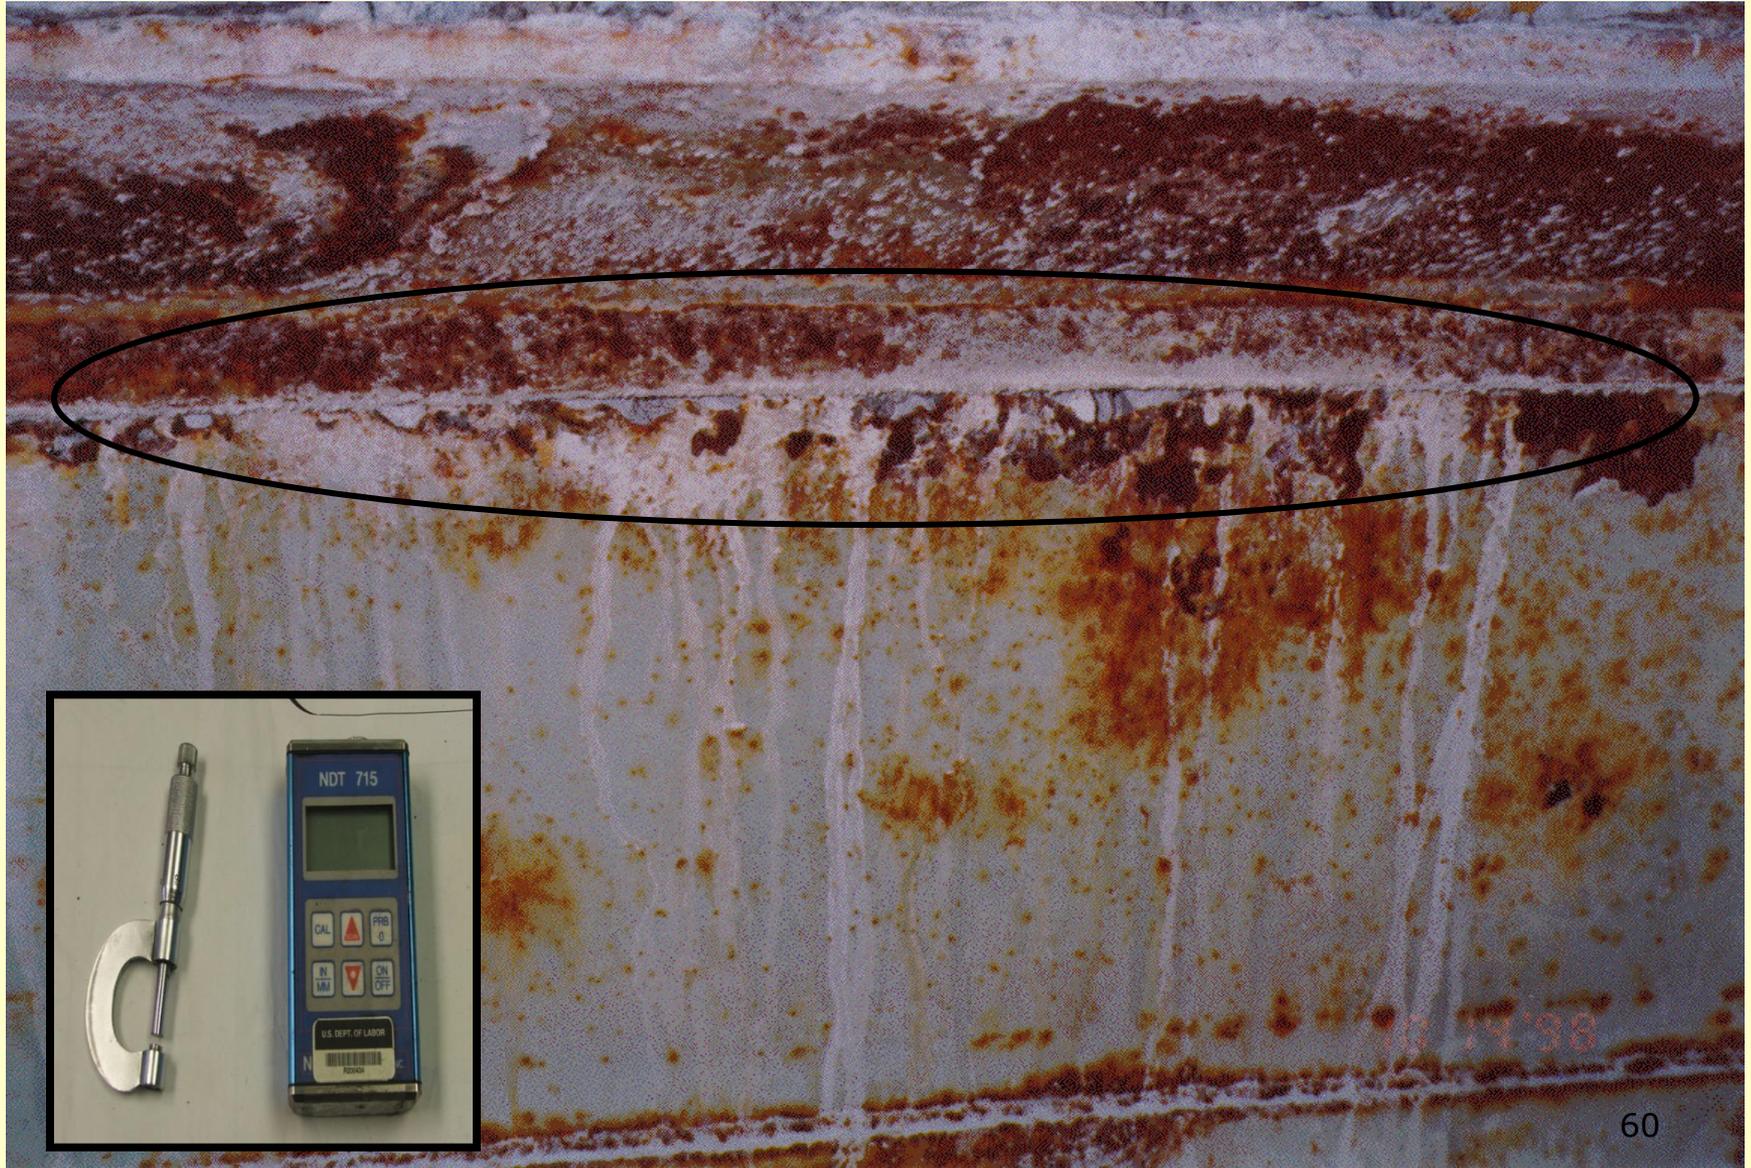
Corrosion-related partial failure of the cone to cylinder connection

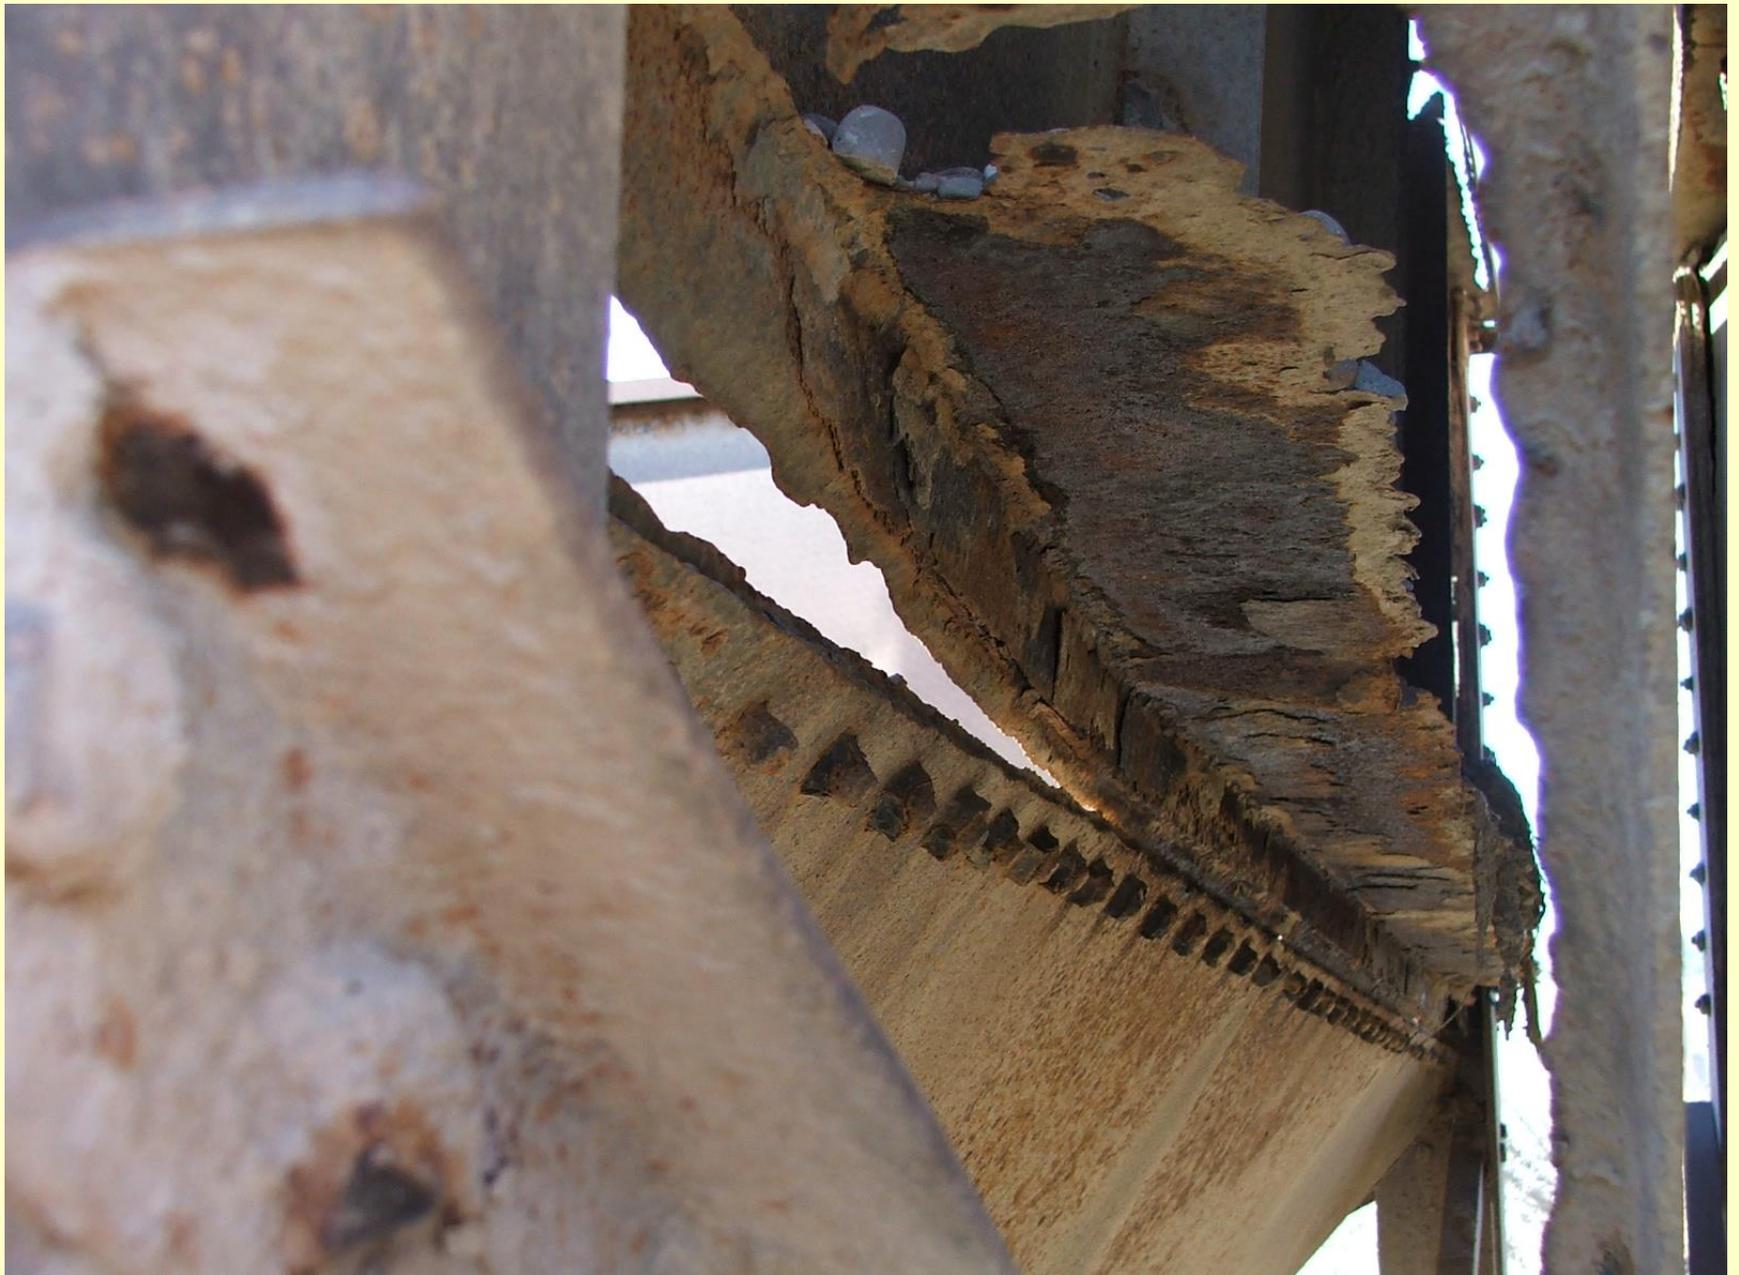
Hopper separation from the bin wall. ⁶²

Light shining through detached bin wall at the hopper connection

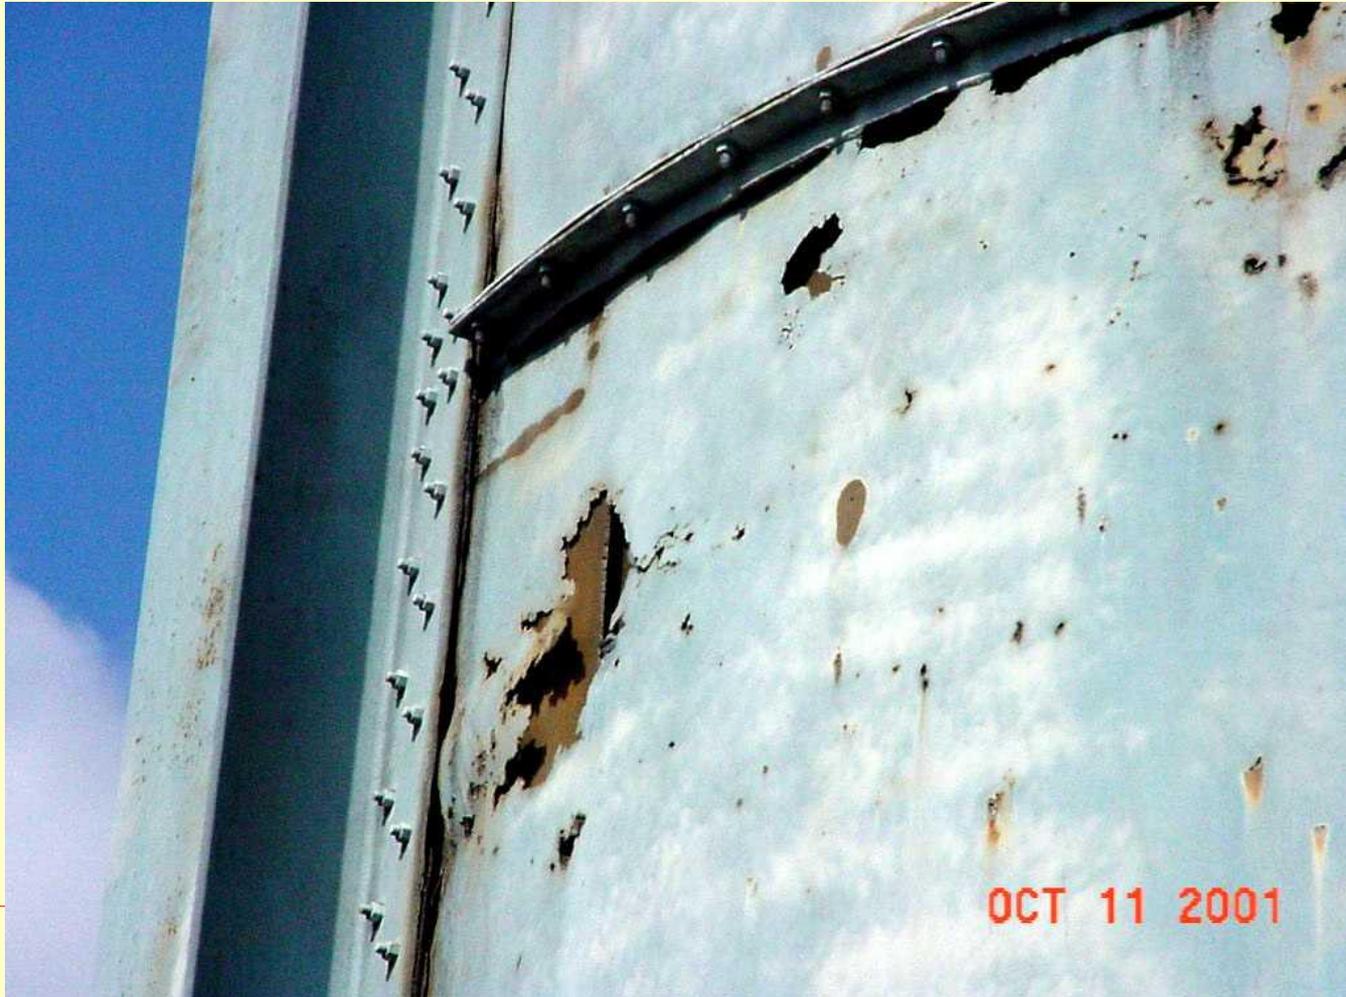
Cracks in vertical bin walls

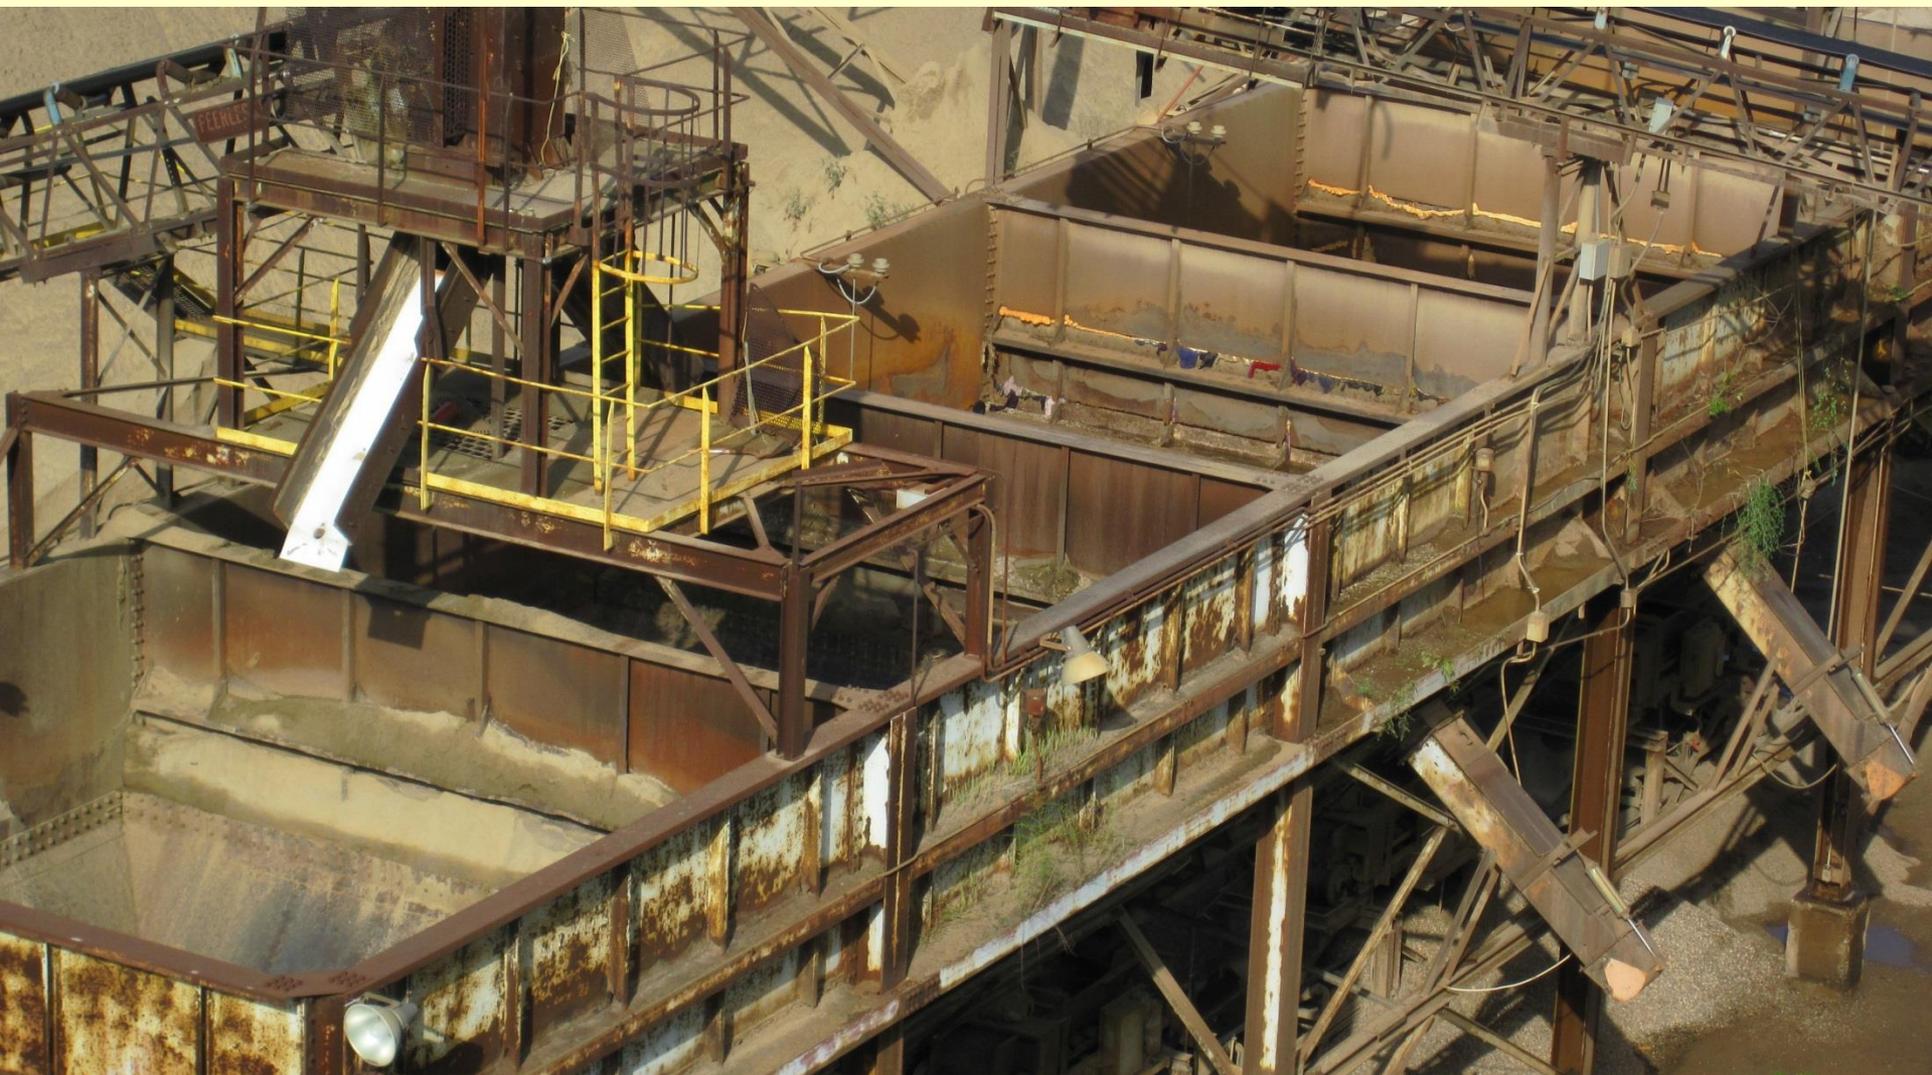
Lines of corrosion in the bin walls that were stuffed with rags and a weak polyurethane foam to prevent aggregate escape and contamination. However, the loss of structural integrity was not re-established.

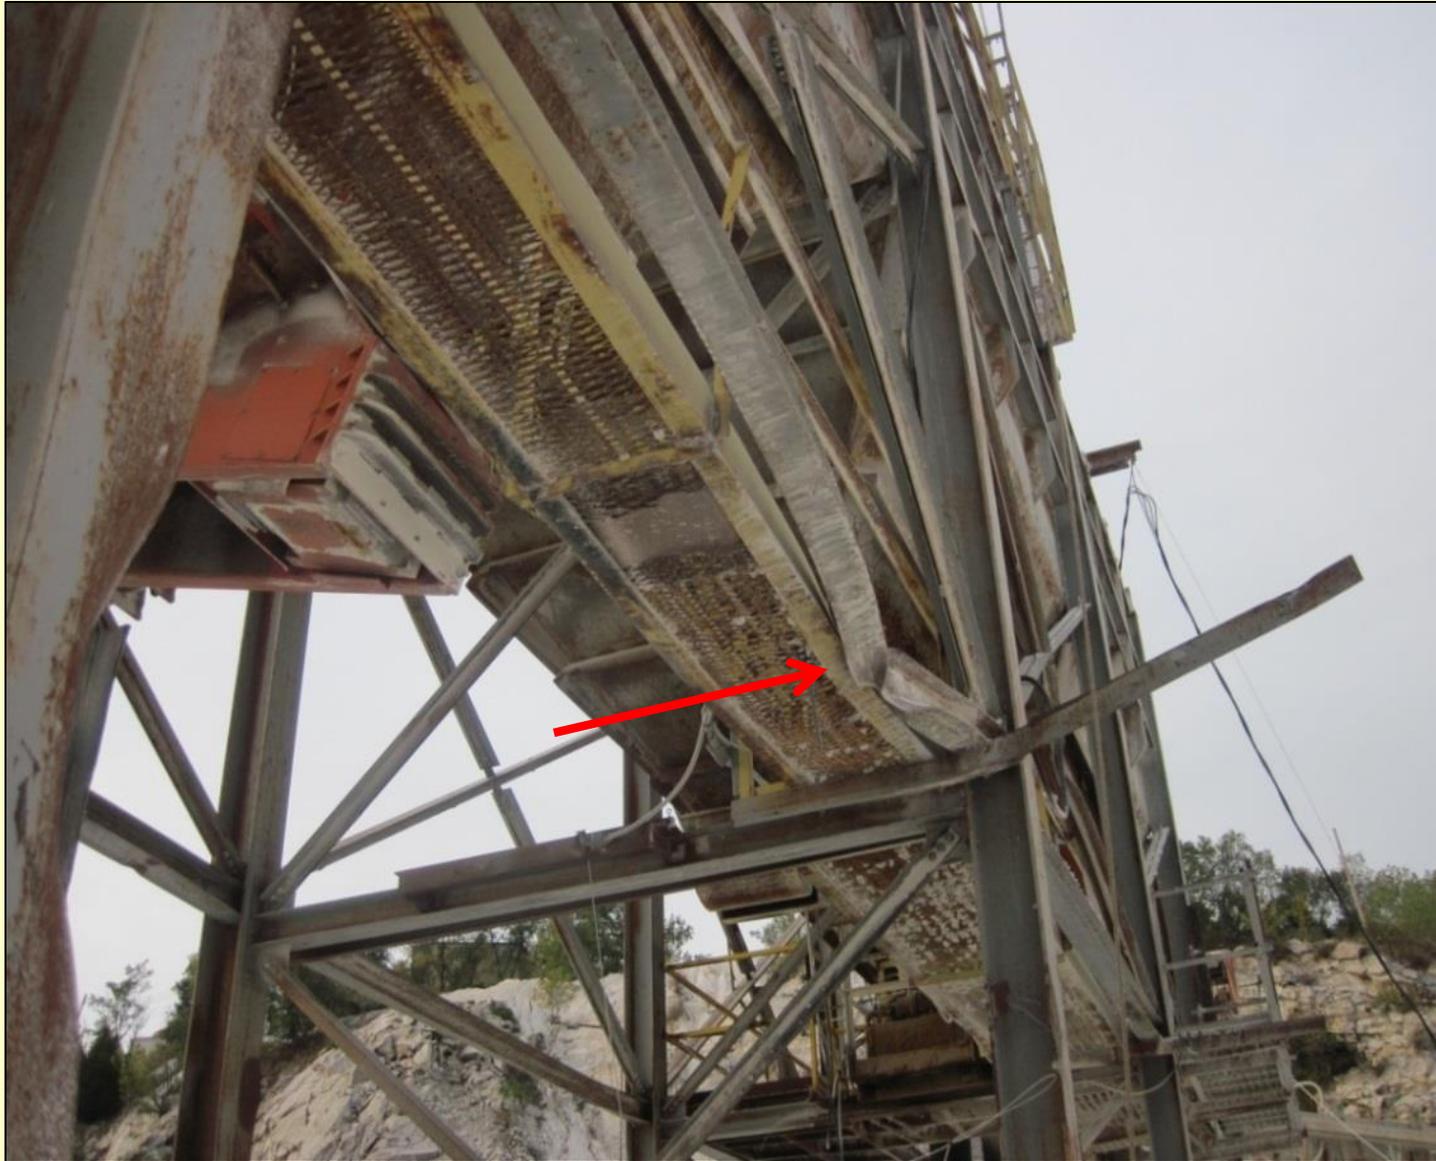
Damaged lateral beam supporting a bin column.

Replace lateral bracing on bin columns if it has been removed or damaged as a result of equipment impact, or severely corroded - otherwise the column may buckle.

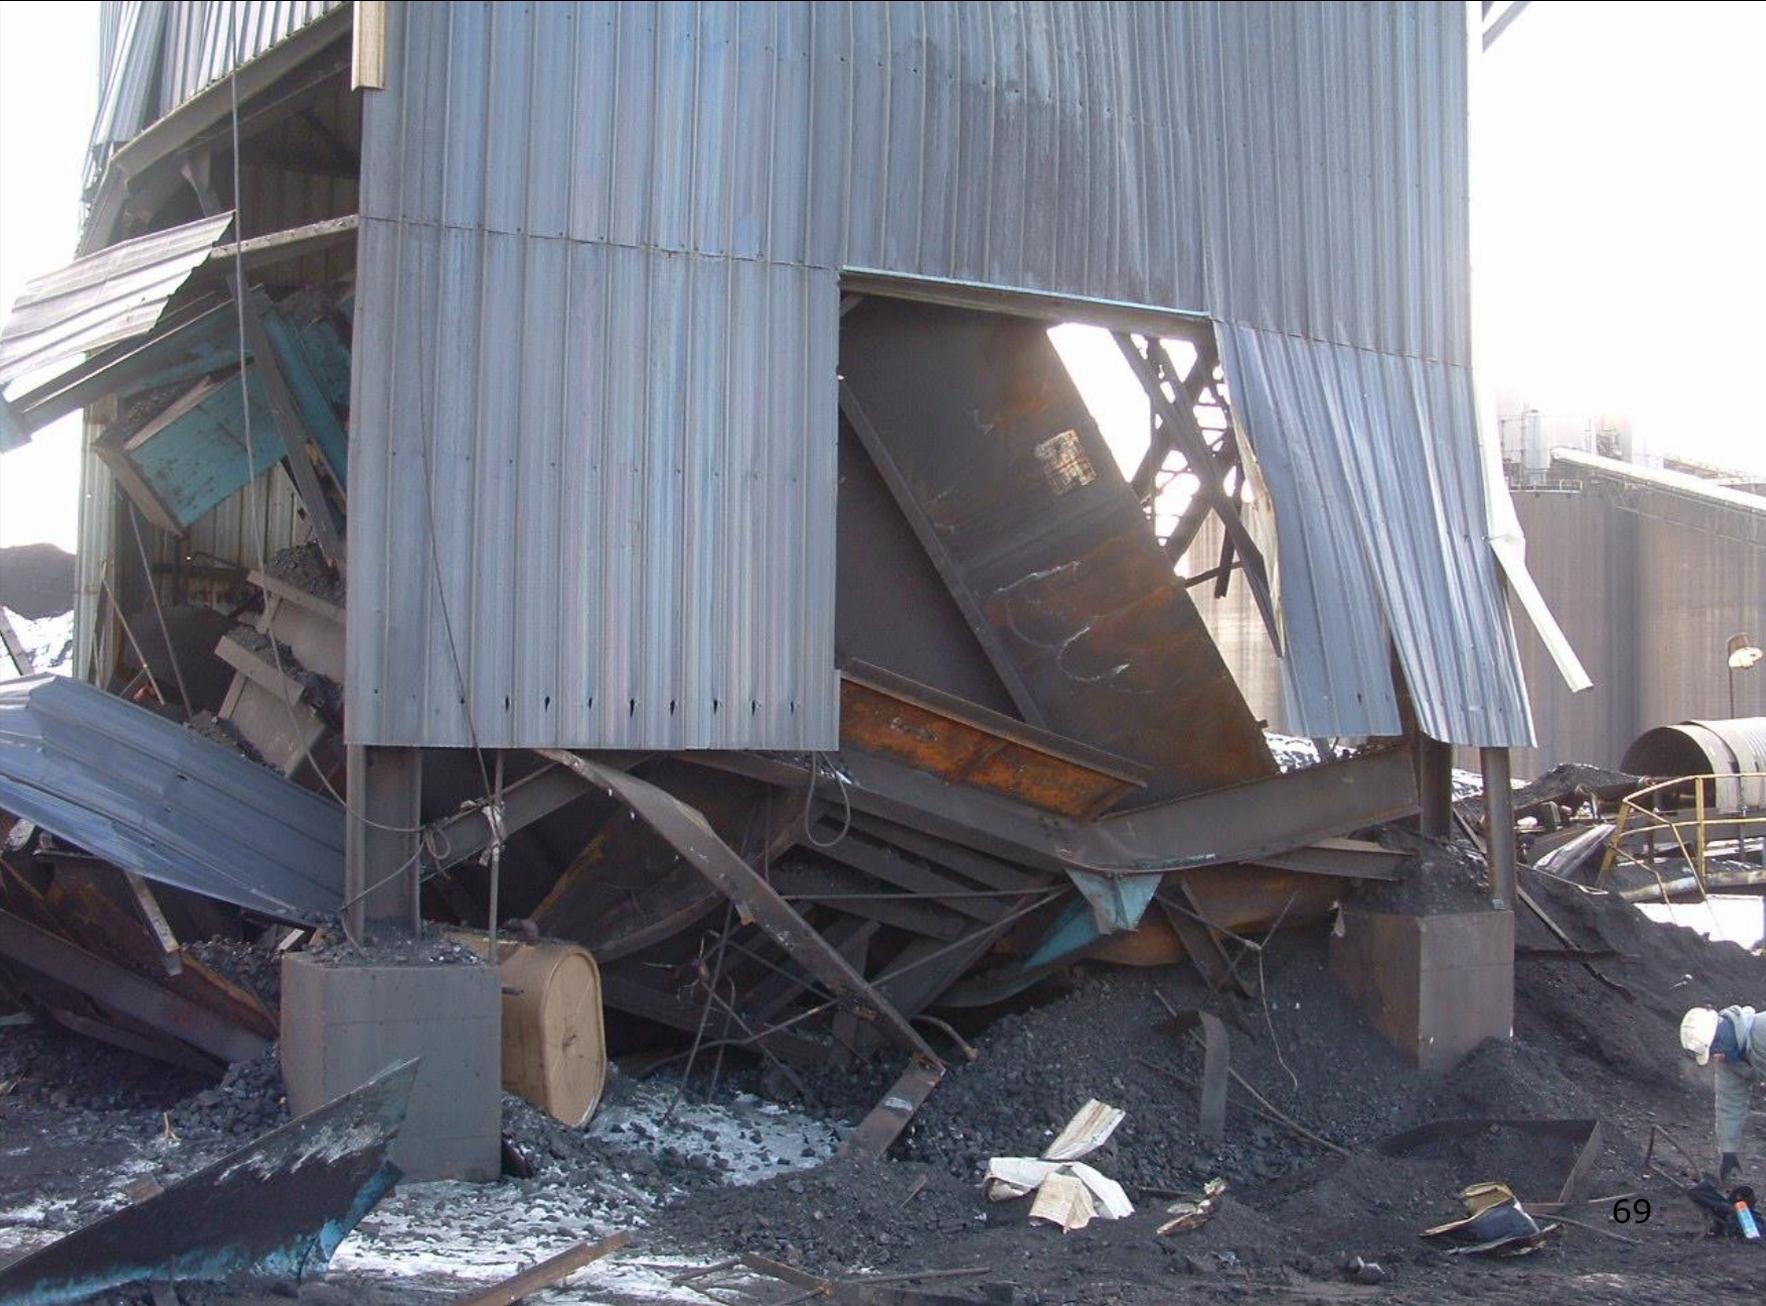
Pyramid-shaped hopper fell off a coal bin

Corrosion caused a 70% loss of cross-sectional area of the hopper plate resulting in the fracture.

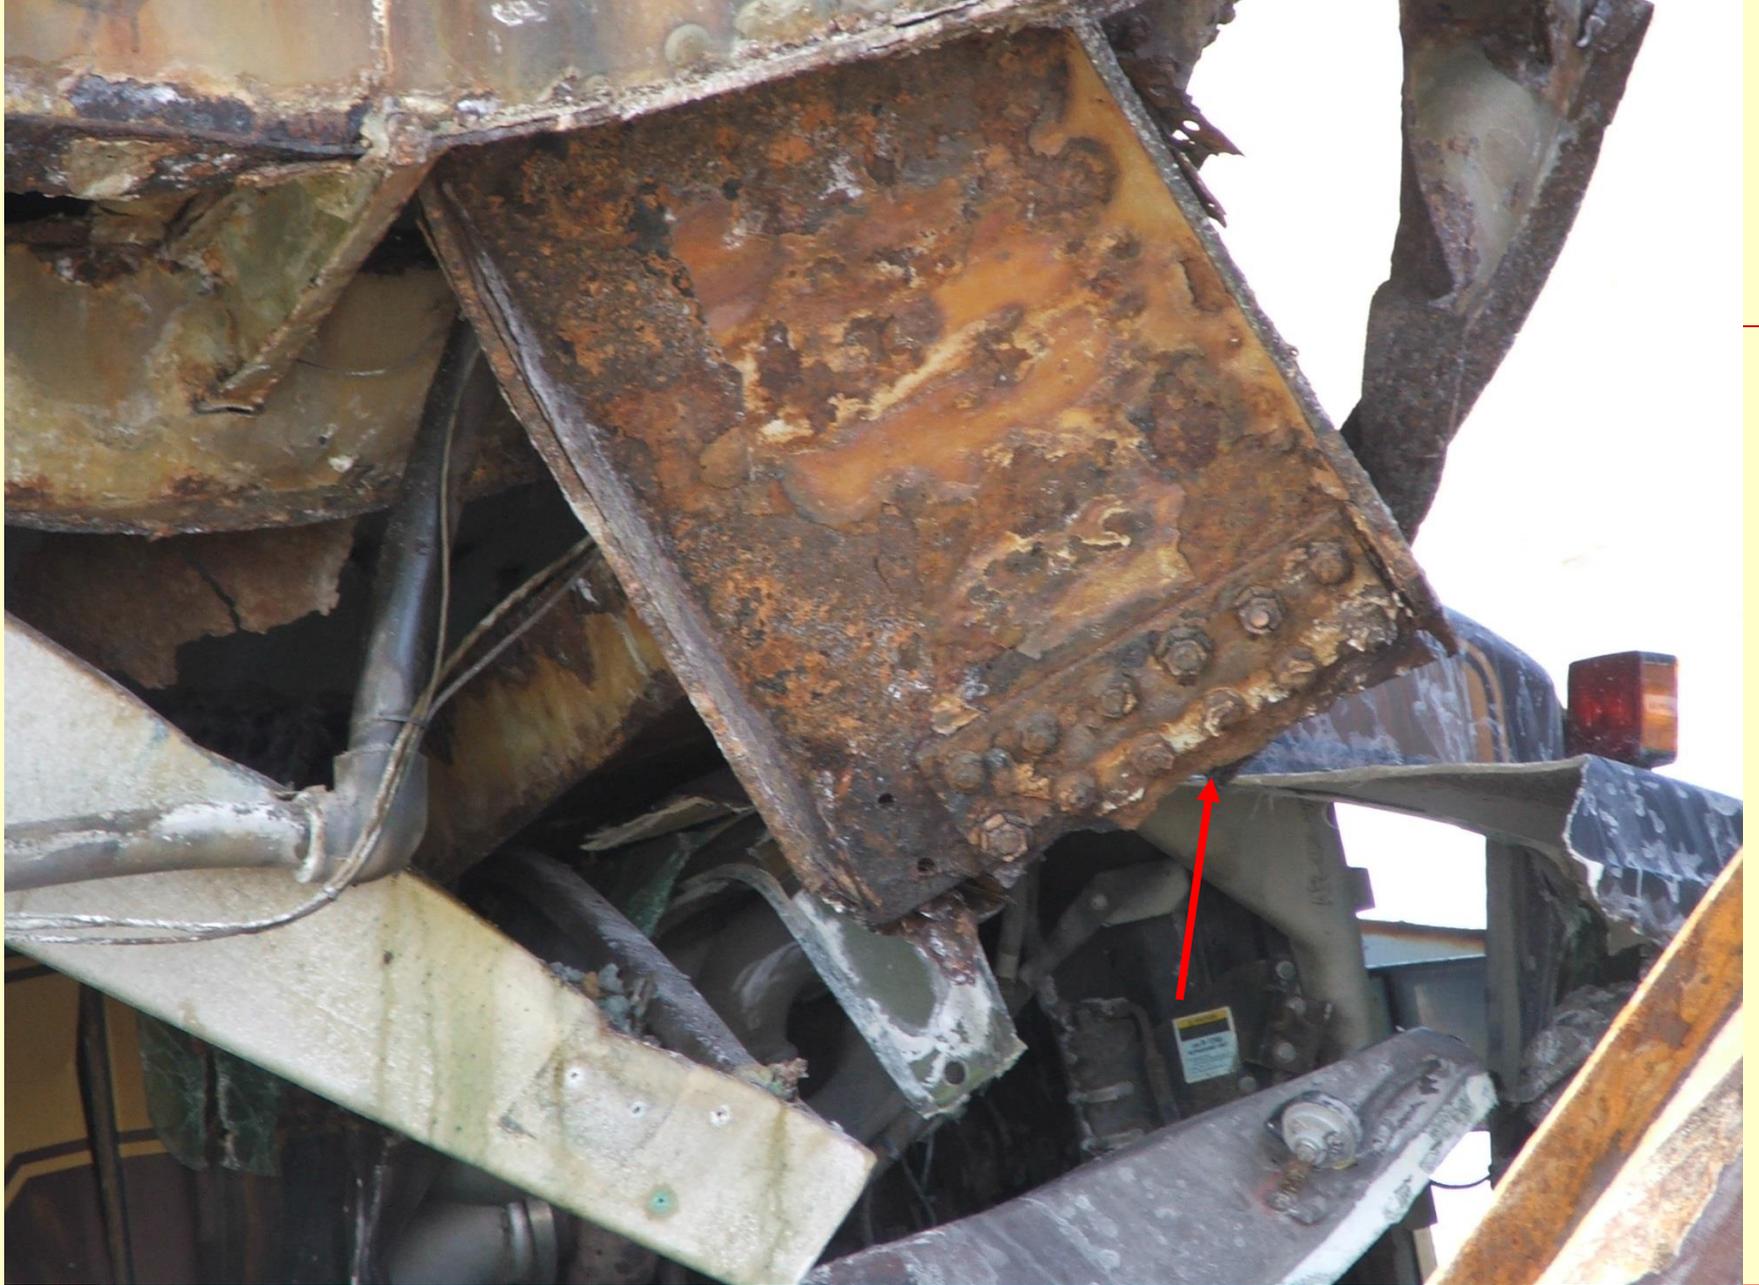
Failed shear tab "A" only 10% effective area remaining

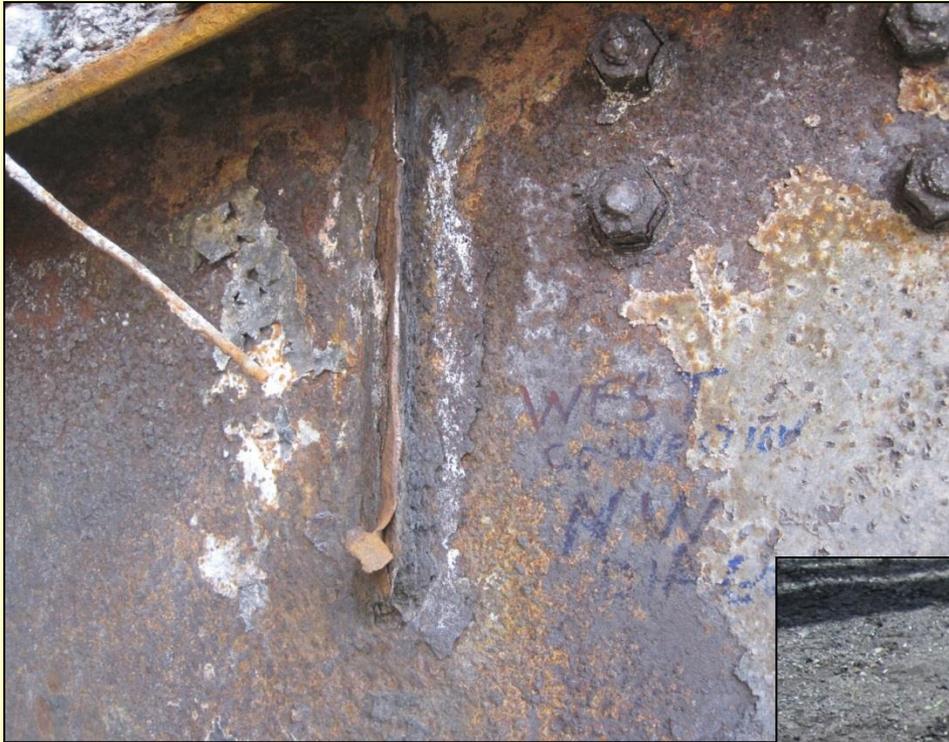
Remnant of northwest shear tab/plate failure. Avg. thickness = 0.1" compared to the original of 0.375"

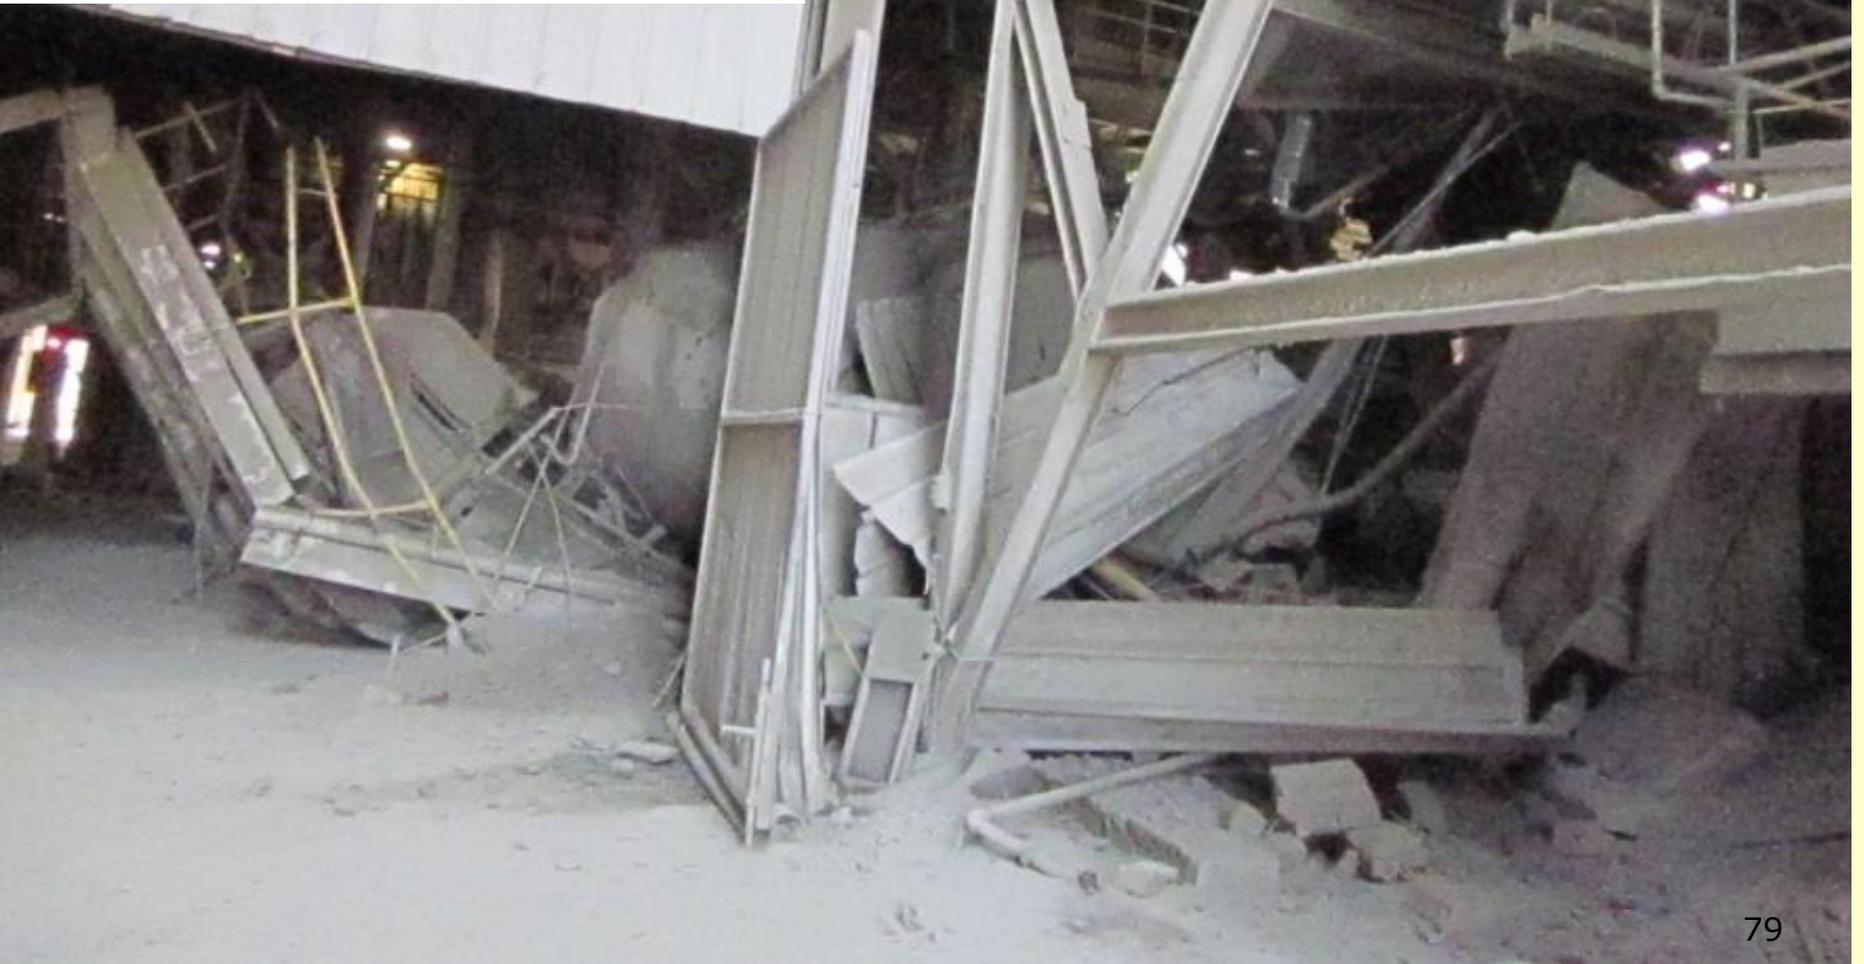
The bin fell through the floor. Just 10 minutes prior, there had been 5 miners under the bin on the bottom level.

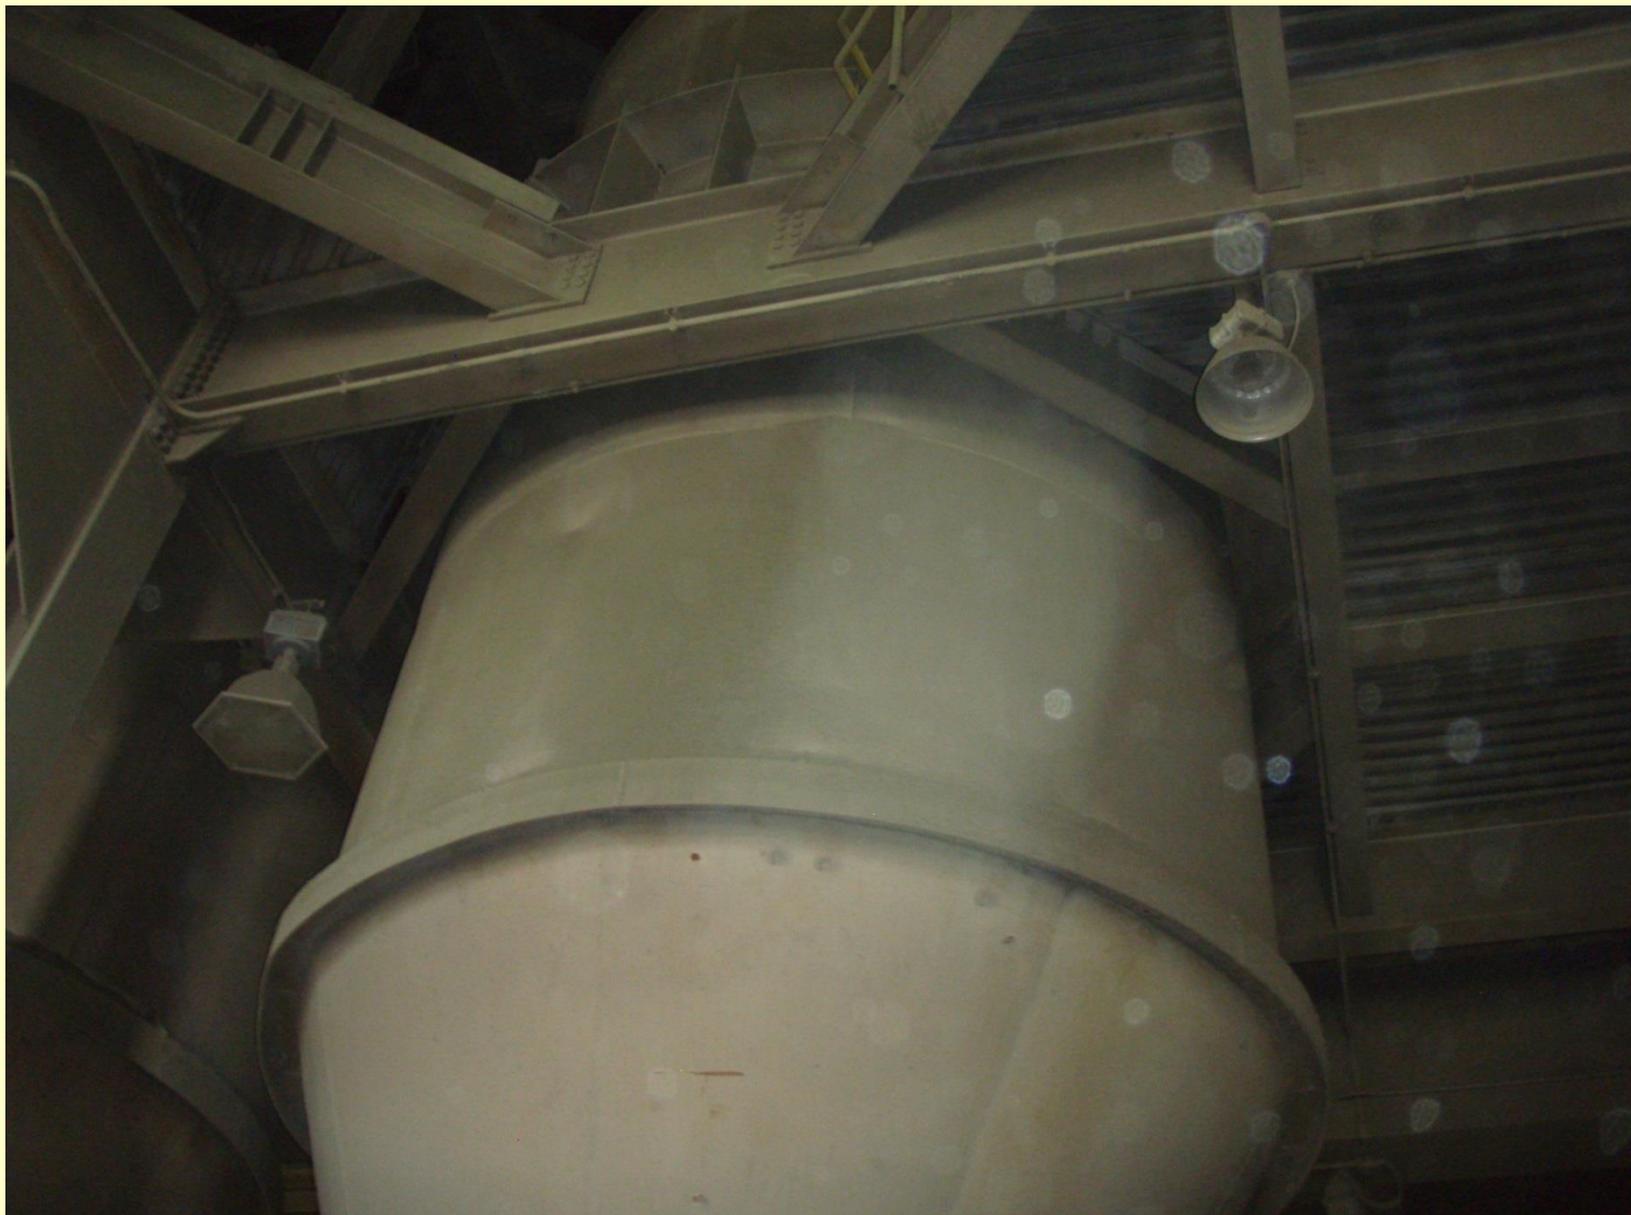
Similar bin that did not fail. The failed bin had a 200 ton capacity and contained mill scale. The bin was 14' in diameter and 34 feet tall.

Original bin plates were 1/4" thick – 40 years later they were paper thin.
