Mine Surface Structures - Identifying Unsafe Conditions & Avoiding Failures

Plants, Conveyors, & Bins

Terence M. Taylor, P.E.

April 4, 2017

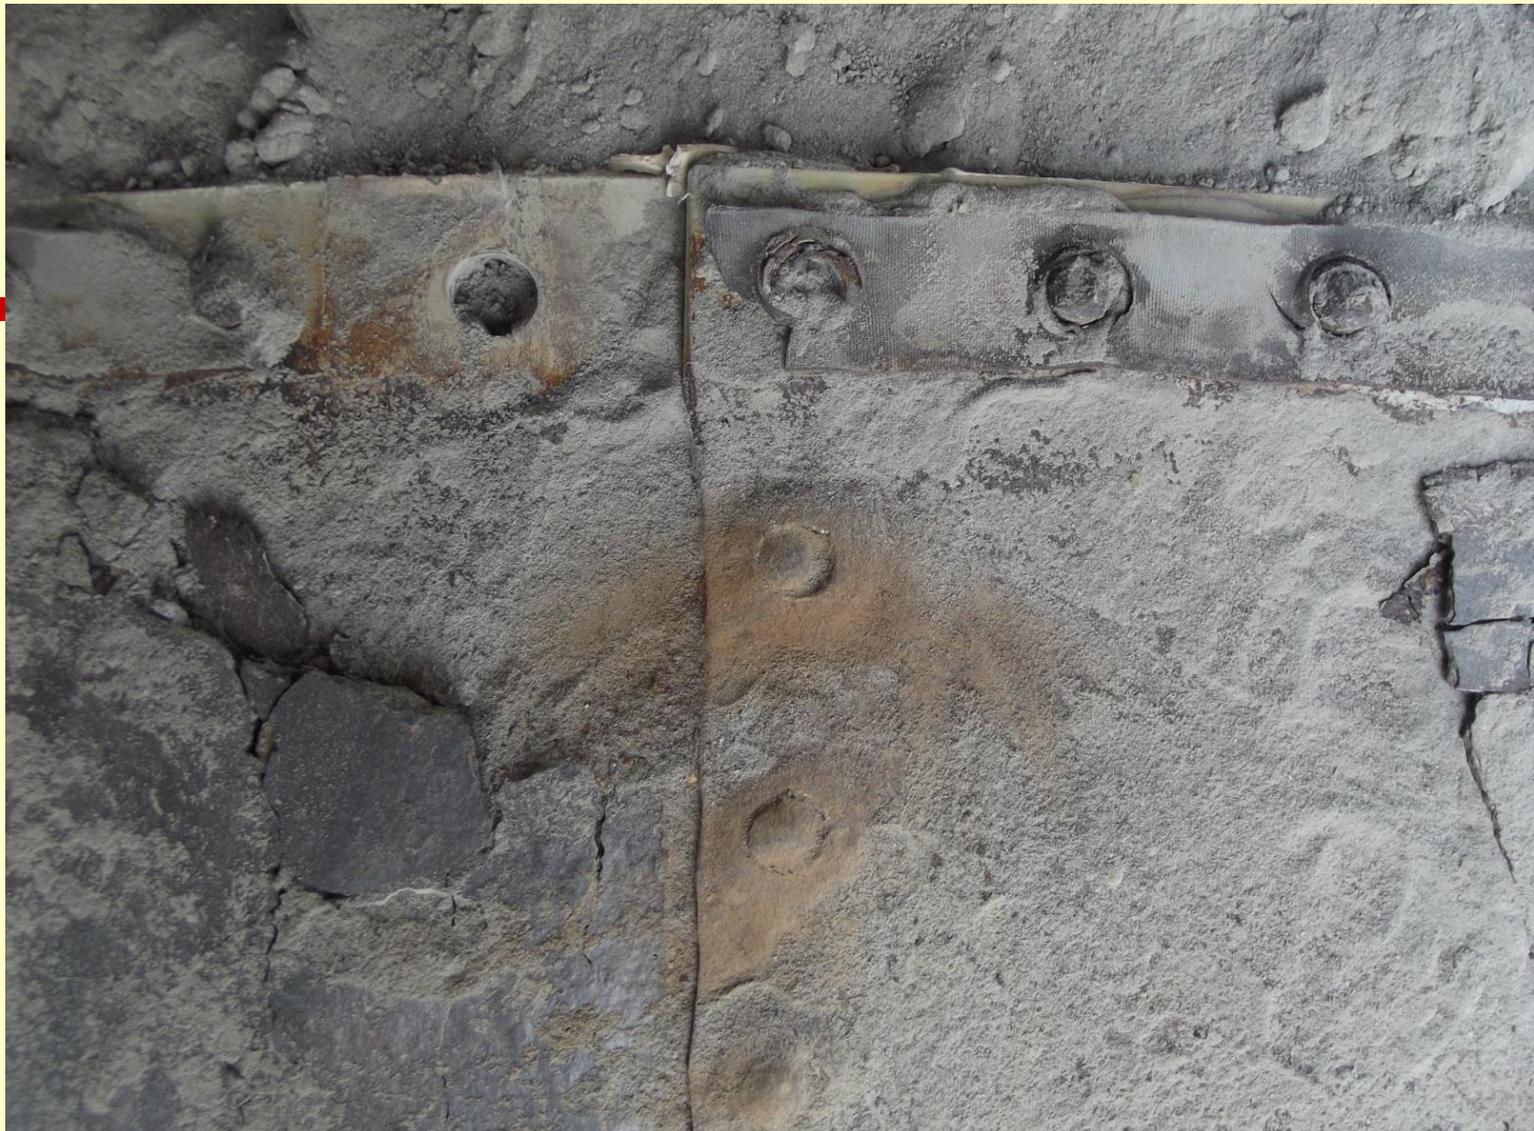
Bolt heads were abraded and corroded off on the inside. They were completely worn off on the south side, but not on the north. Material was static on the north side and flowing on the south side where the abrasion occurred.
