Mine Surface Structures - Identifying Unsafe Conditions & Avoiding Failures

Plants & Conveyors

Terence M. Taylor, P.E.

November 9, 2017

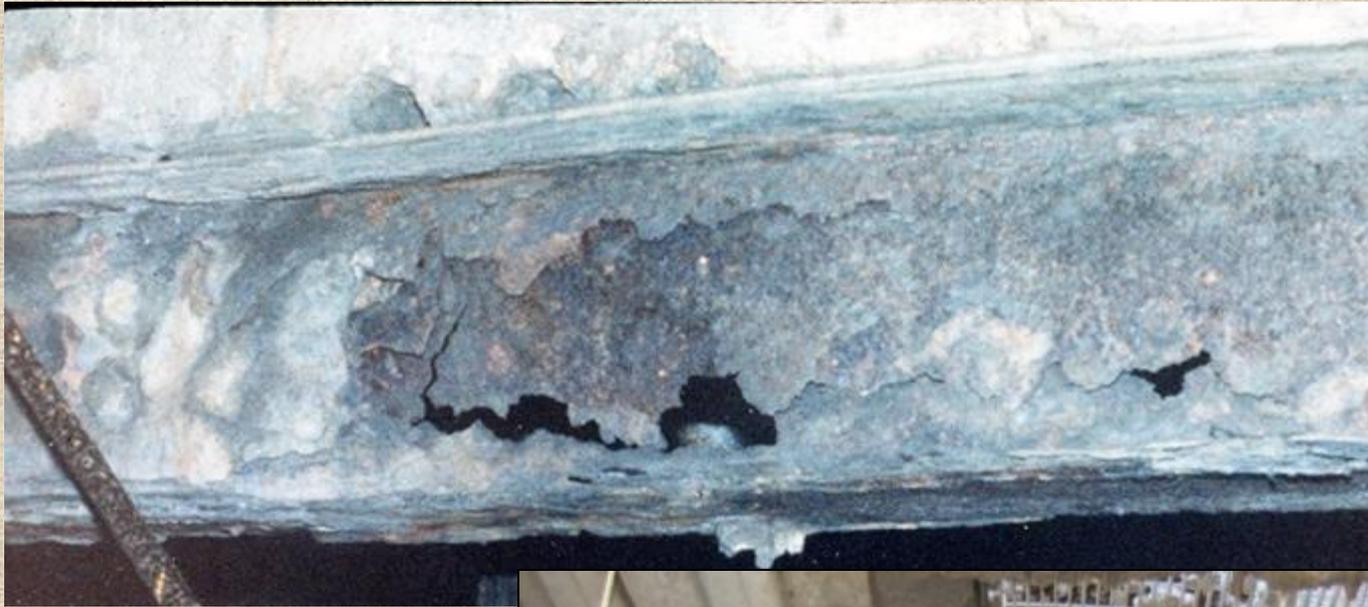
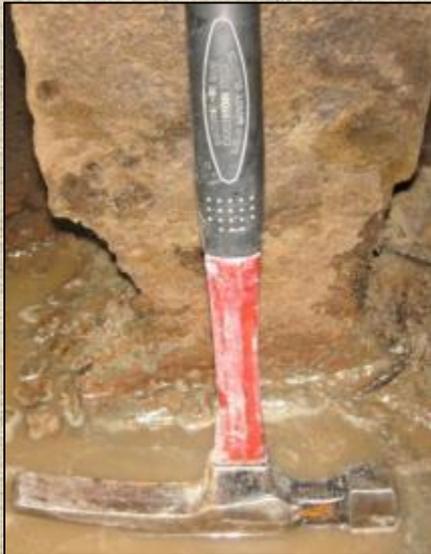
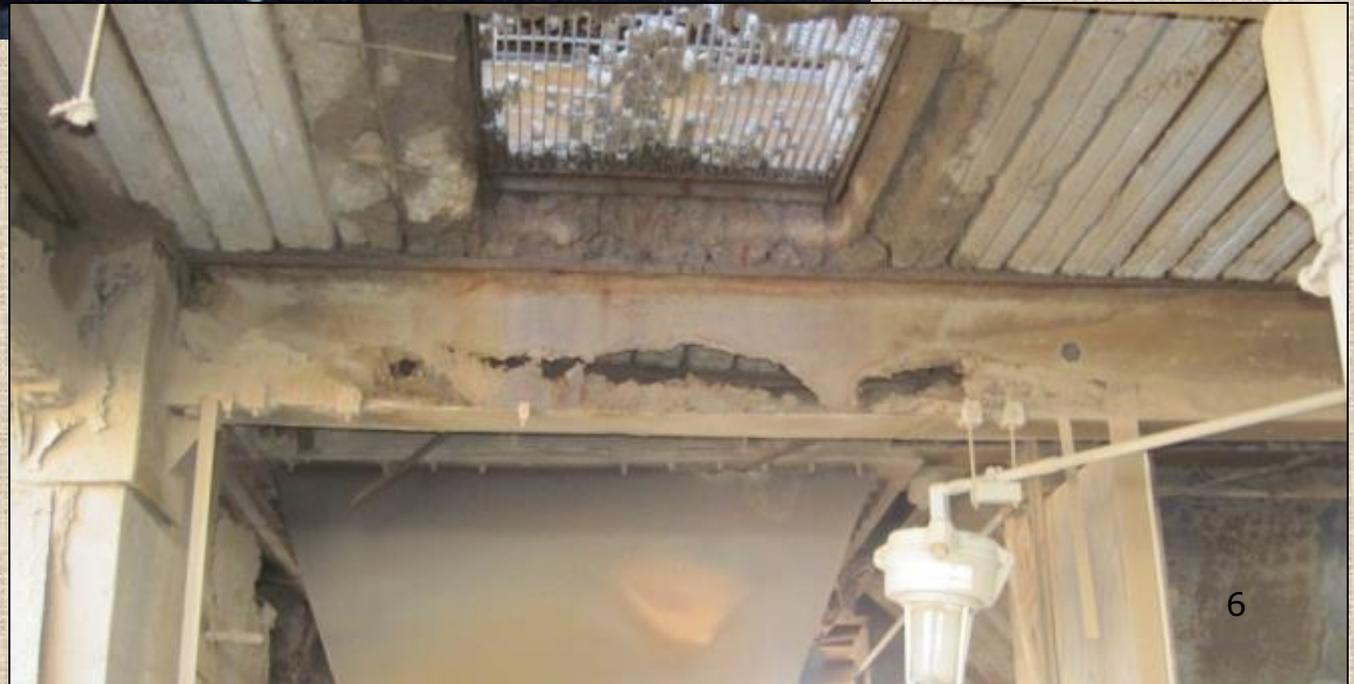
Corrosion hole/notch near the beam end connection

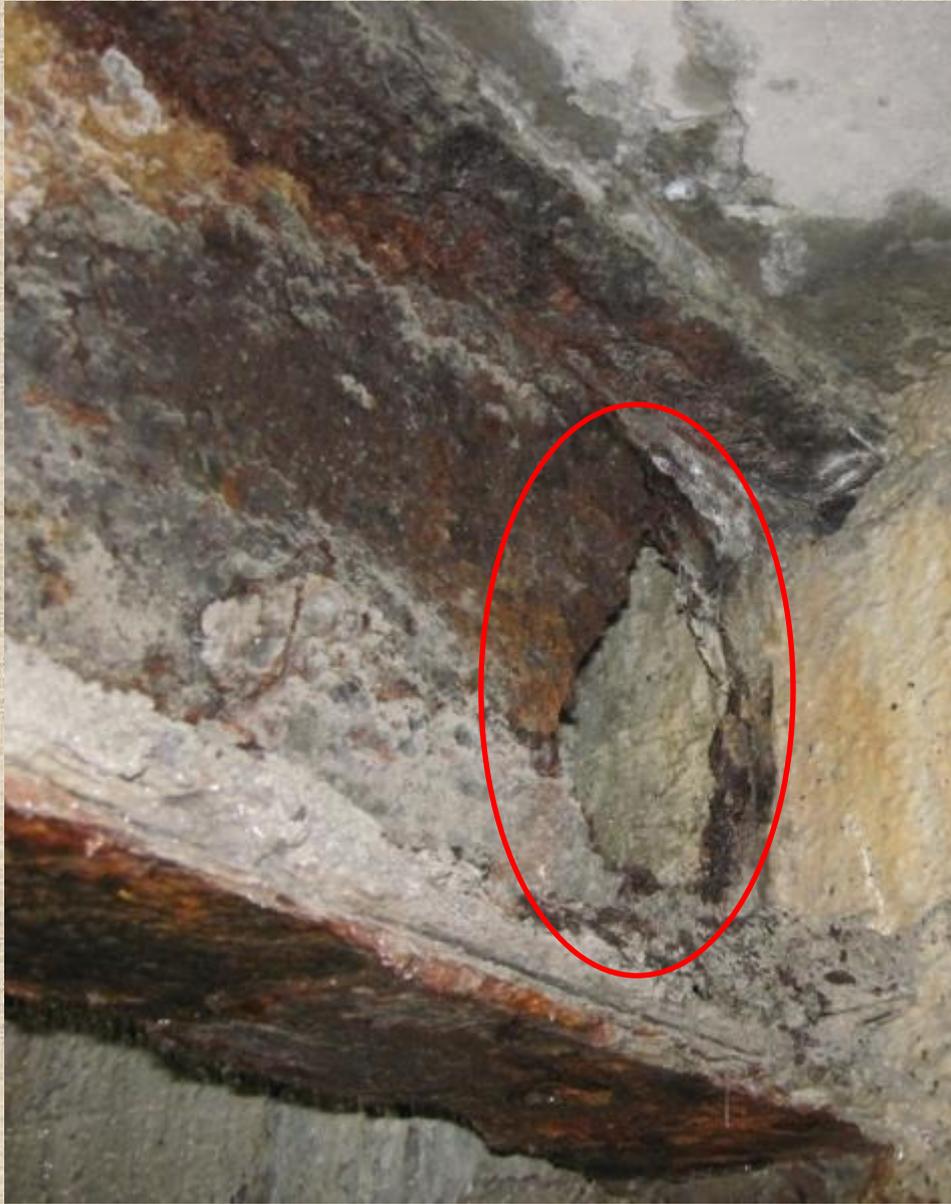
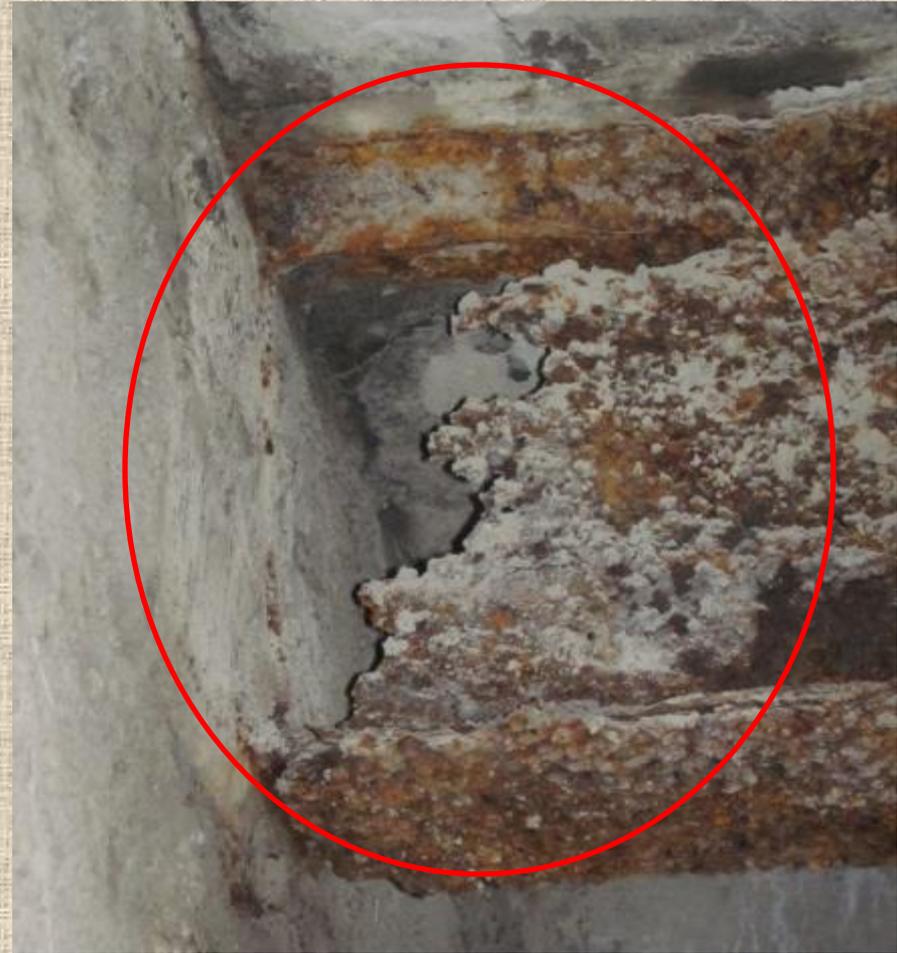
Corrosion holes resulted in web collapse of the back beam.

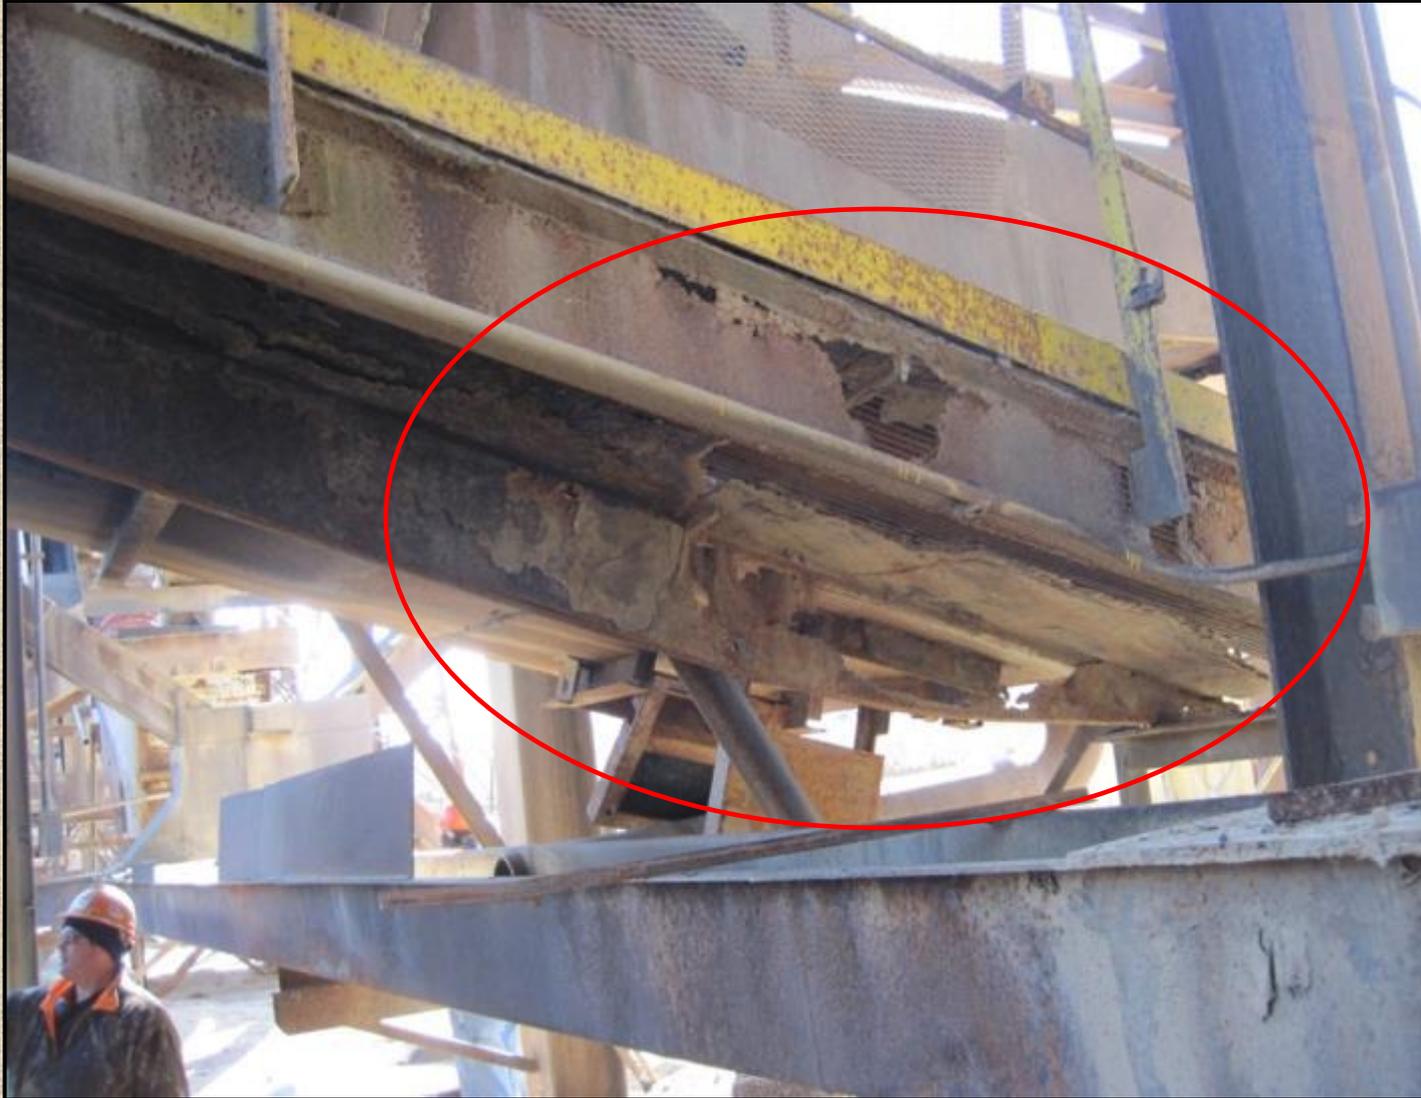
Overloading!
Beam w/ a buckled web

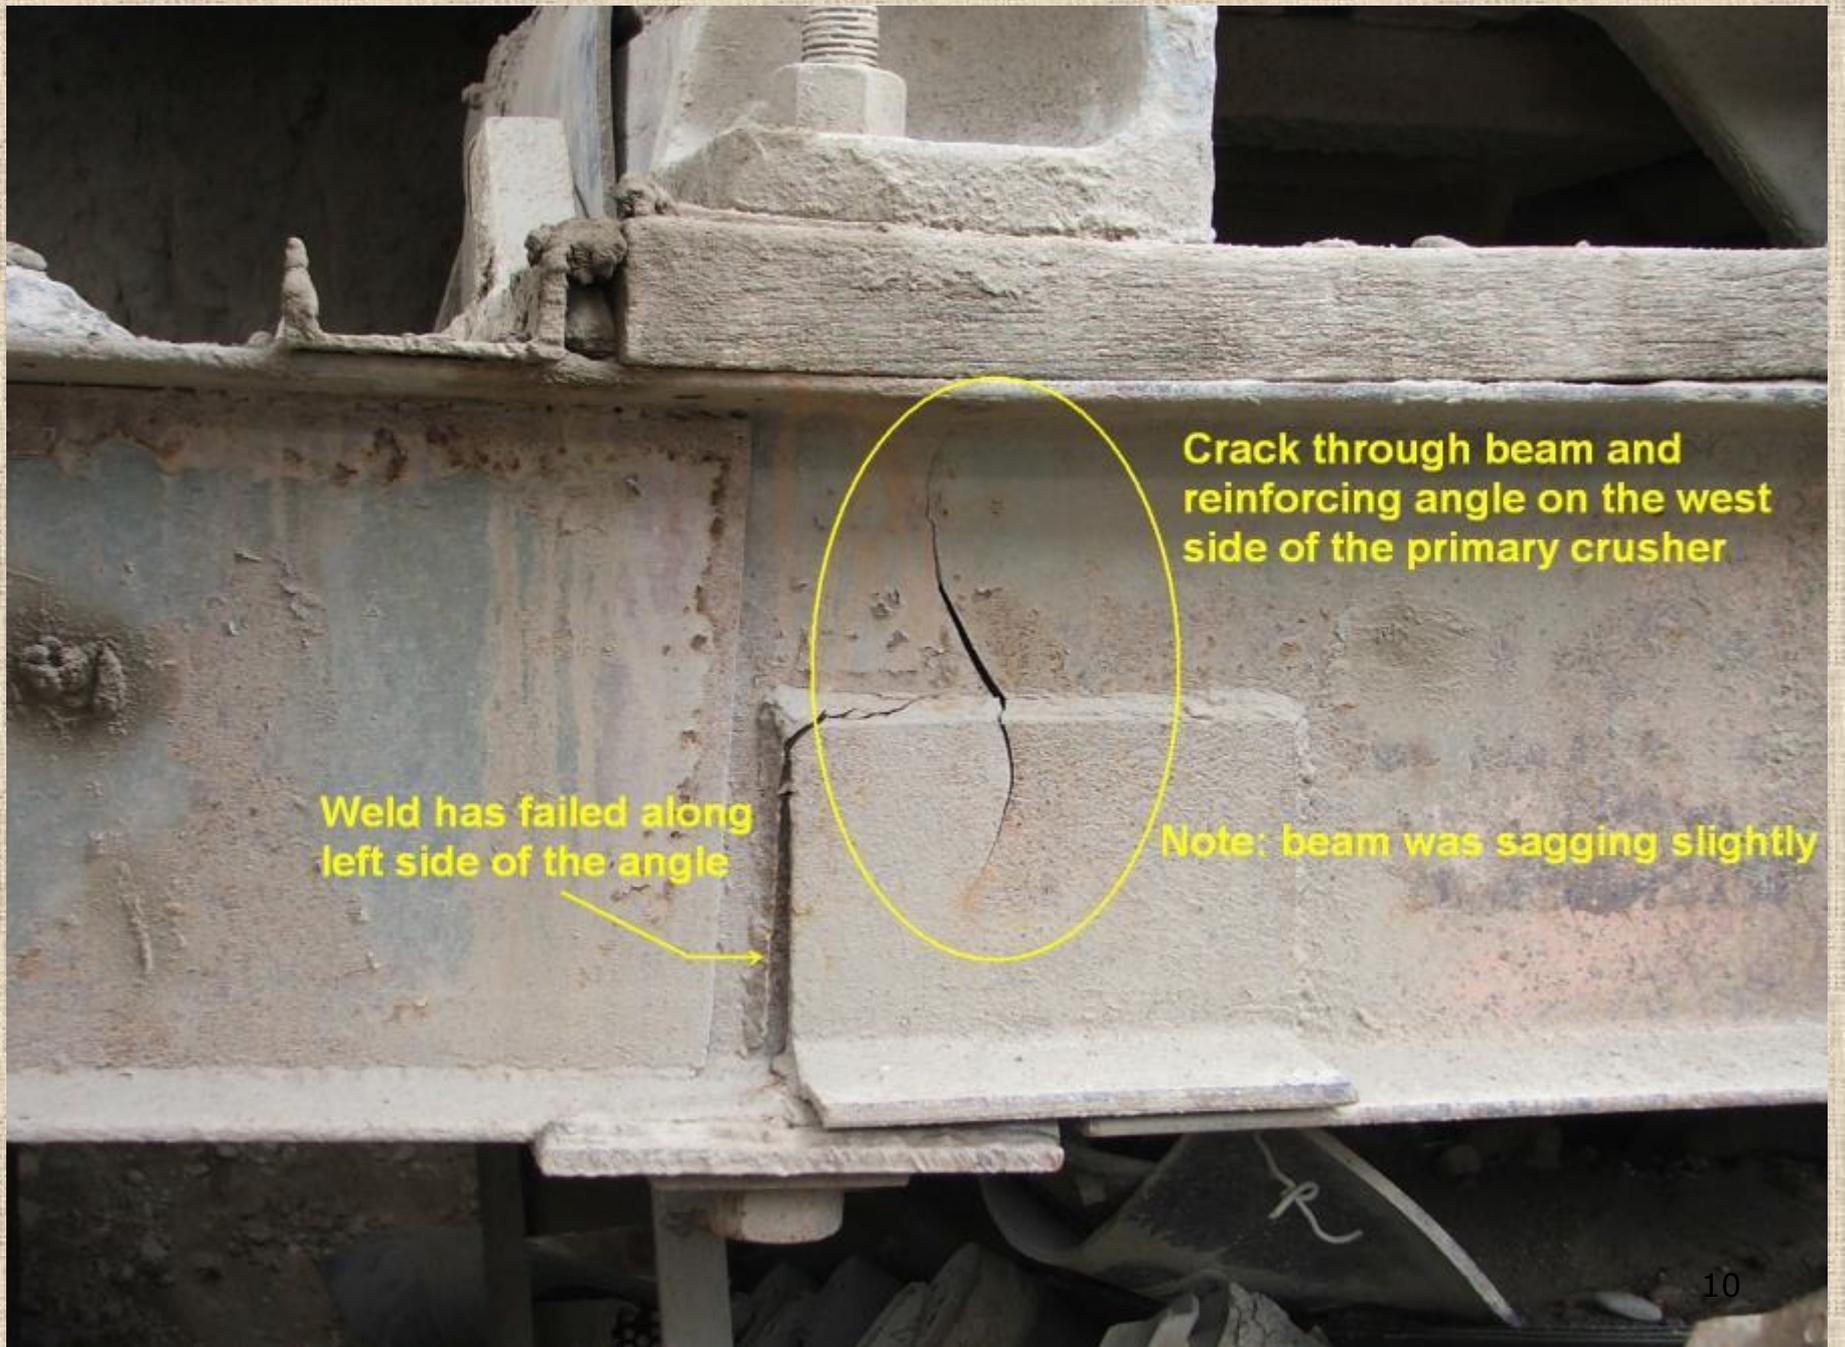
Crack through beam and reinforcing angle on the west side of the primary crusher

Weld has failed along left side of the angle

Note: beam was sagging slightly

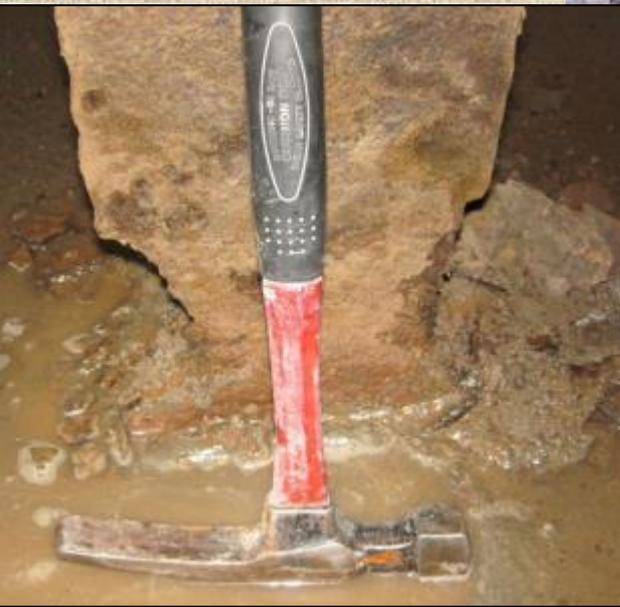
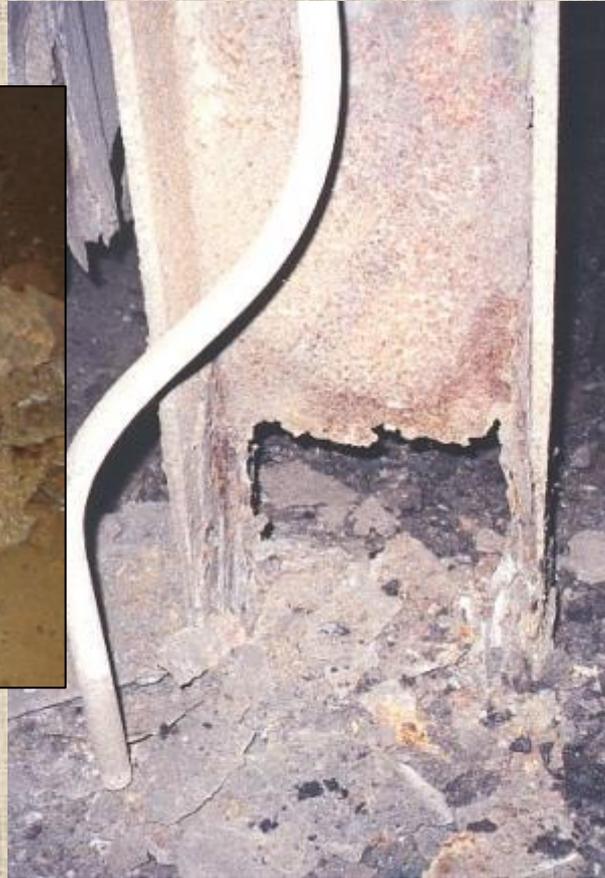
Corrosion notches in flanges and holes in column webs – particularly right above the floor.

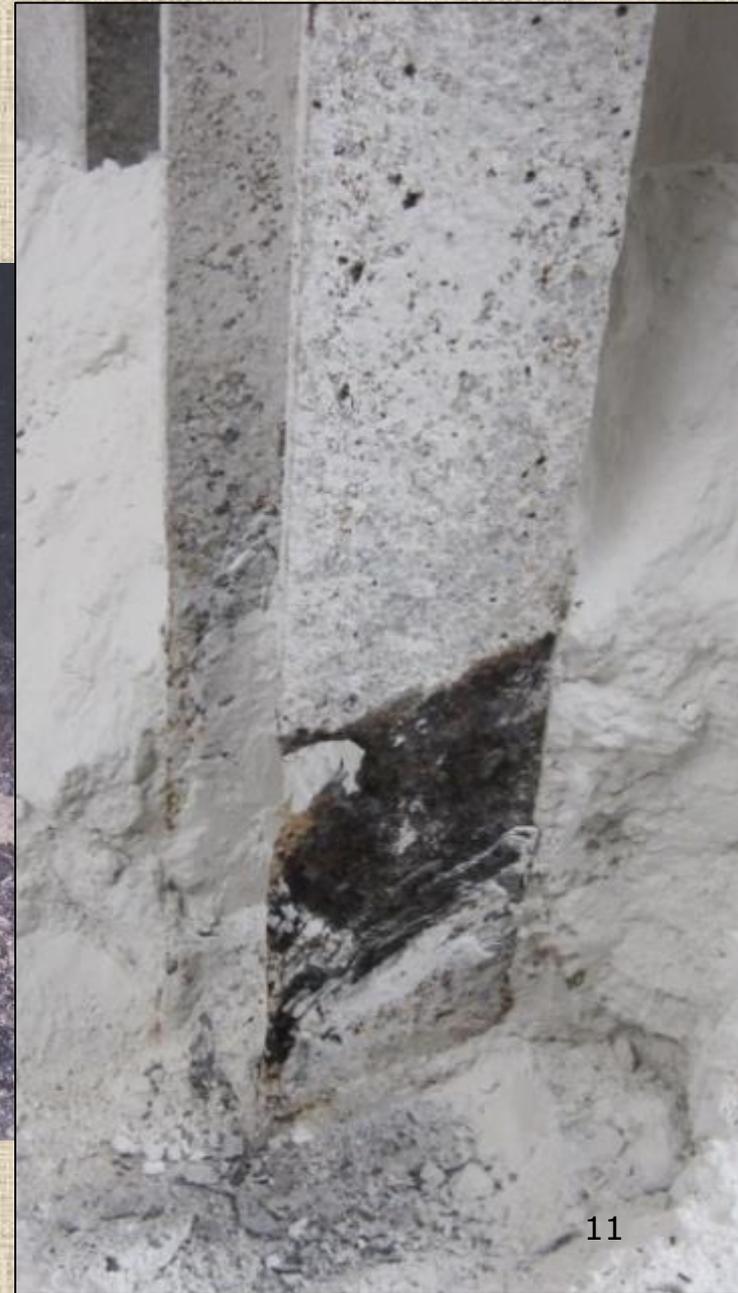
Hole in a column web – well above floor level

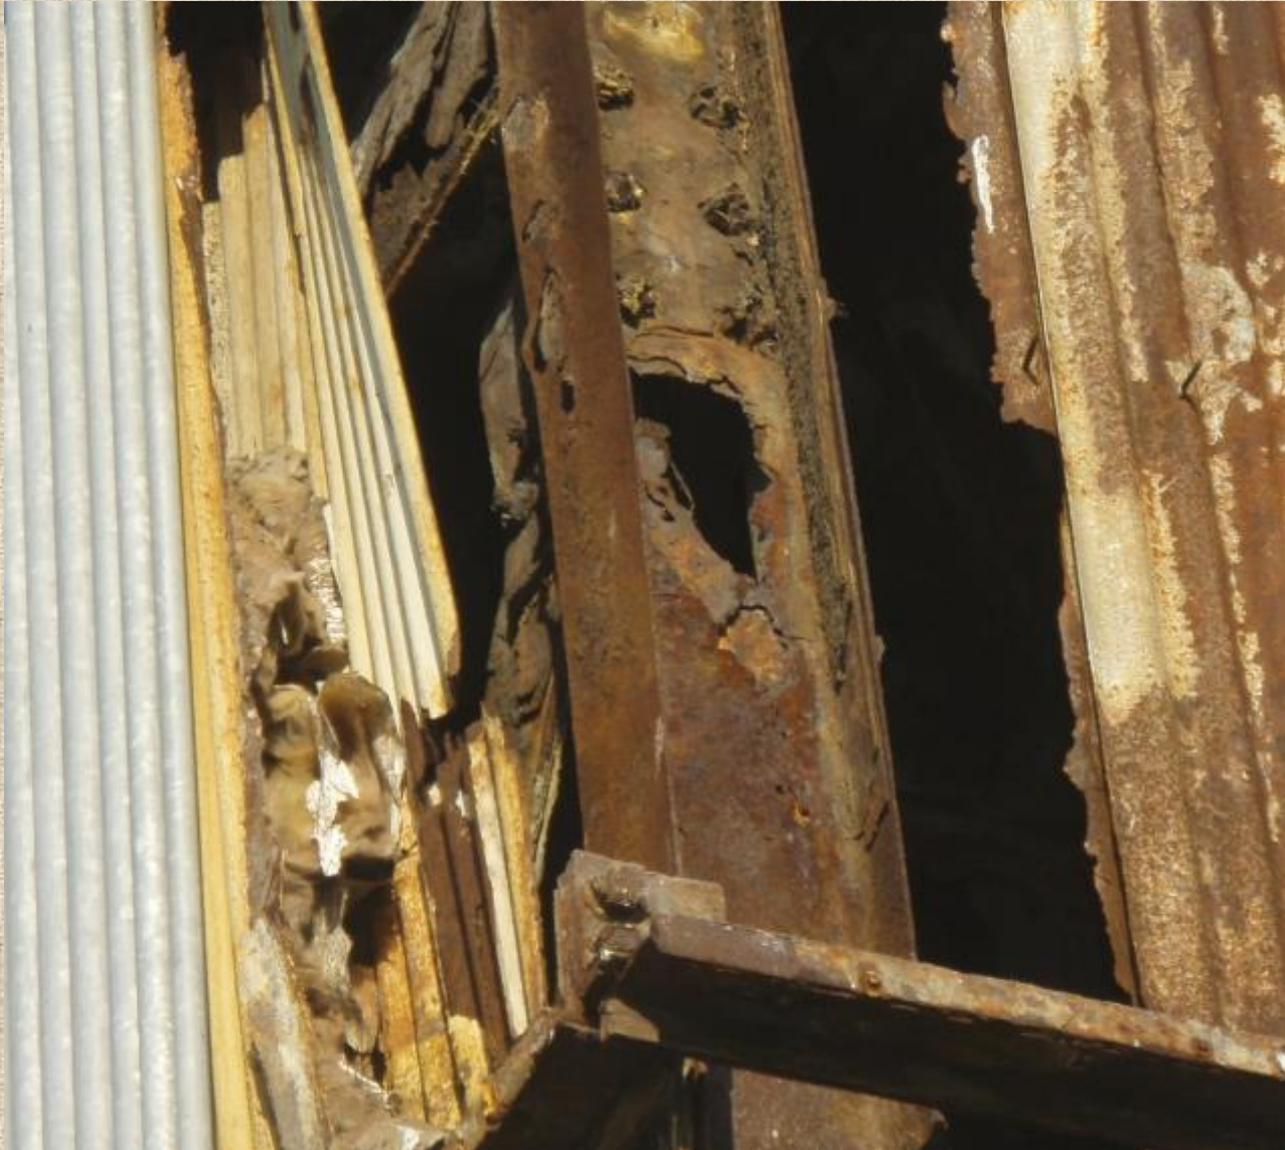
Corroded diagonal braces (and sometimes intentionally removed braces to accommodate equipment changes or access) should be repaired or replaced. Braces are necessary to resist lateral loads such as wind, earthquake, and vibration.

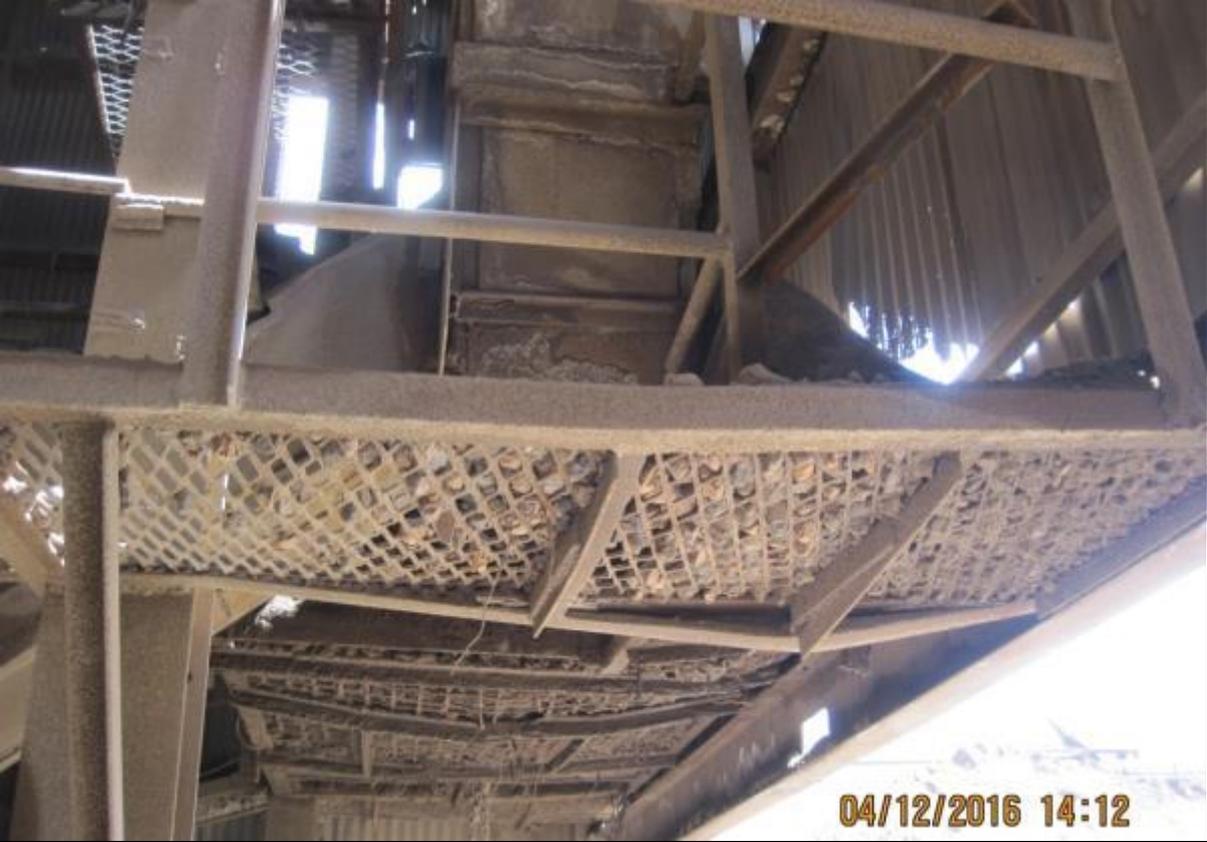
Material build up
and sagging
flooring

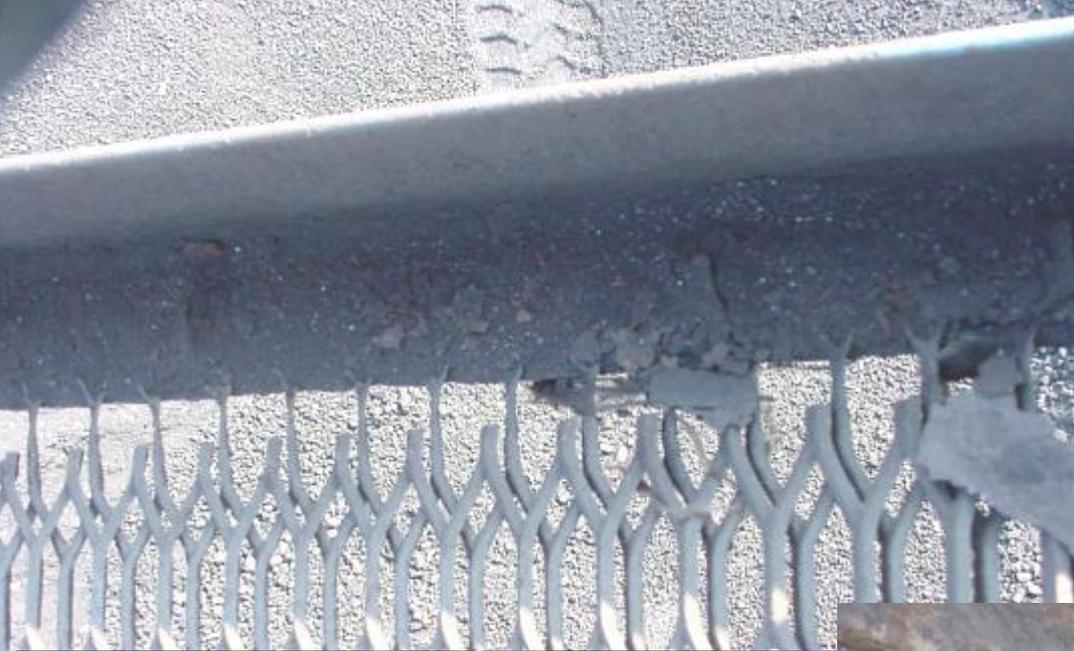
Corrosion at support edge of walkway grating, corrosion holes in a stairway channel stringer, and holes in an angle supporting a tread.

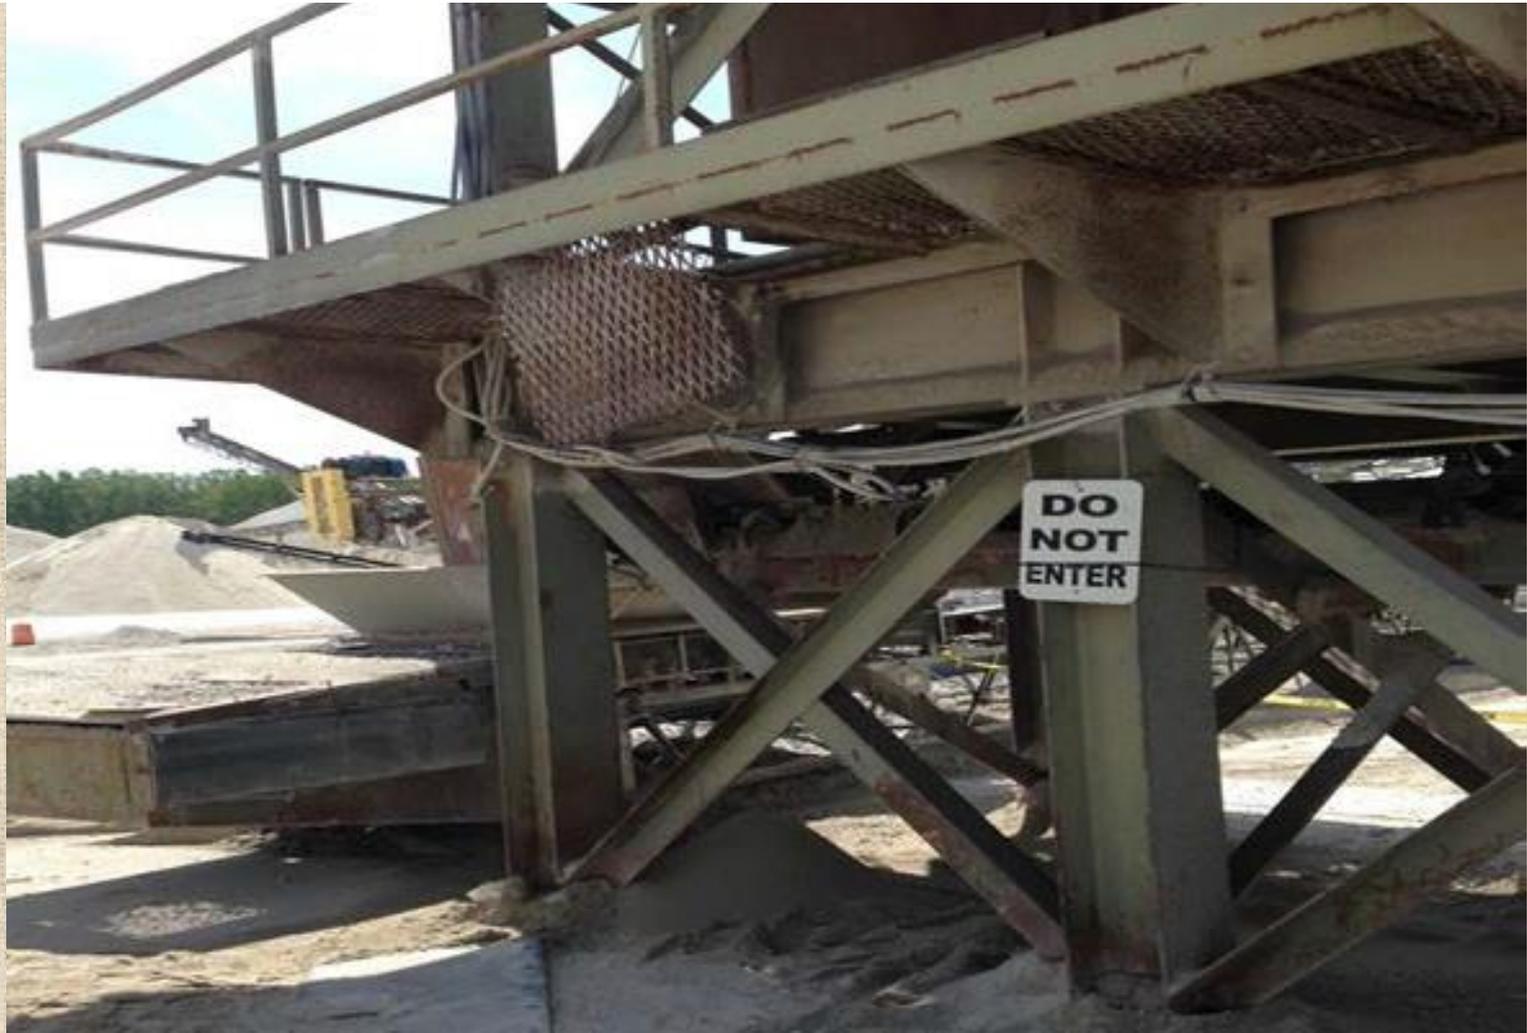
Buckled column

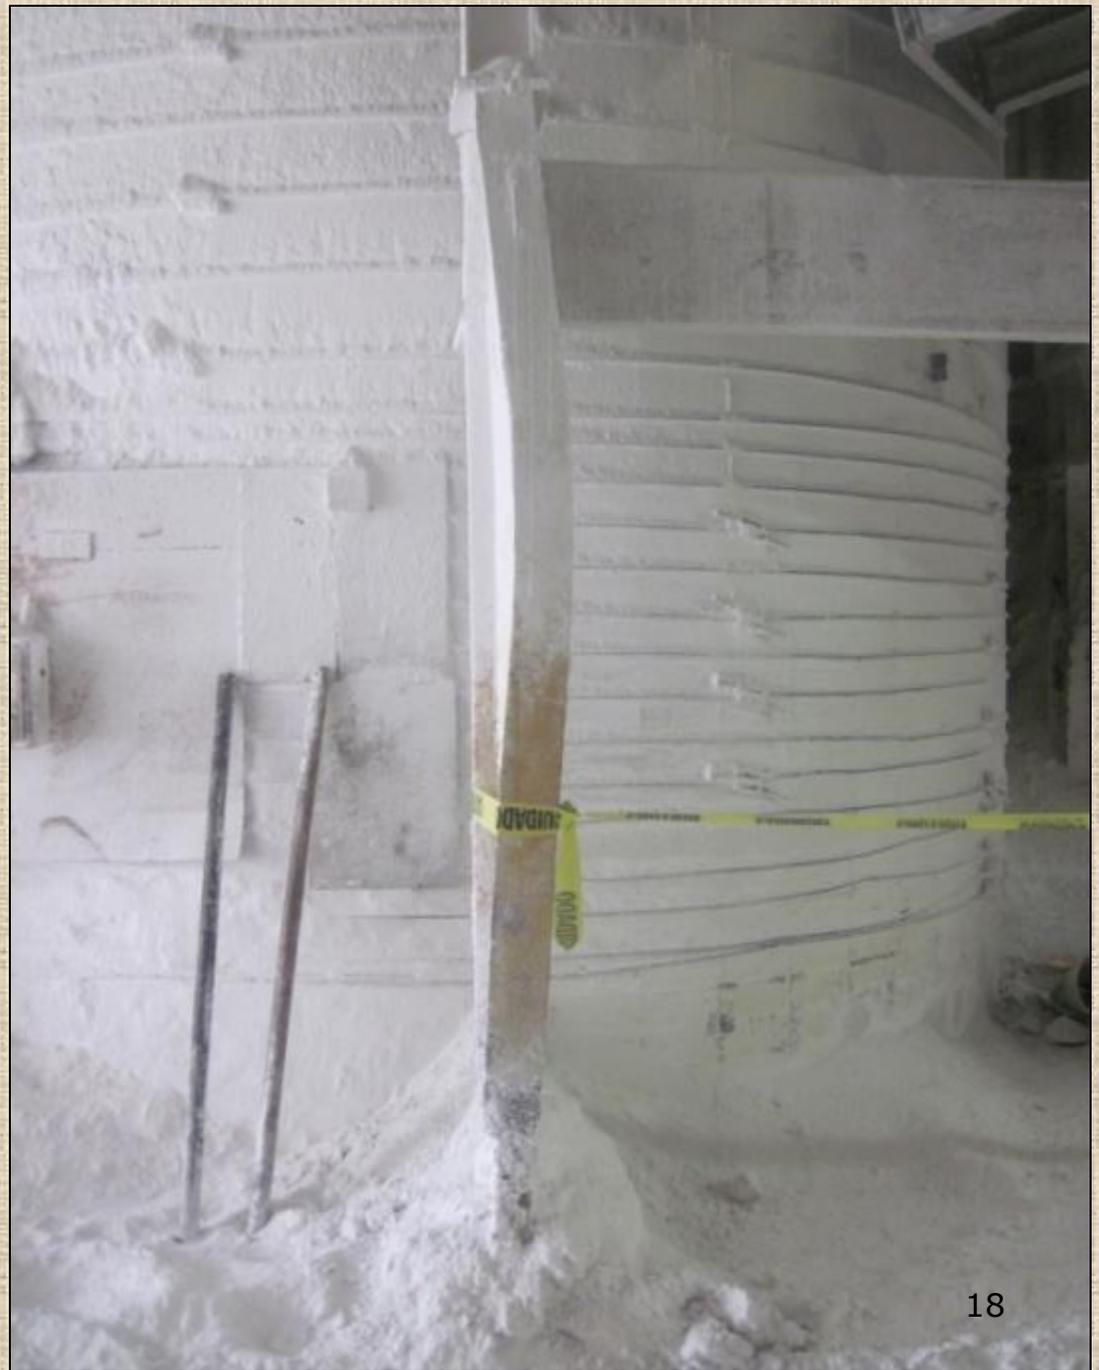
Equipment impact damage to columns

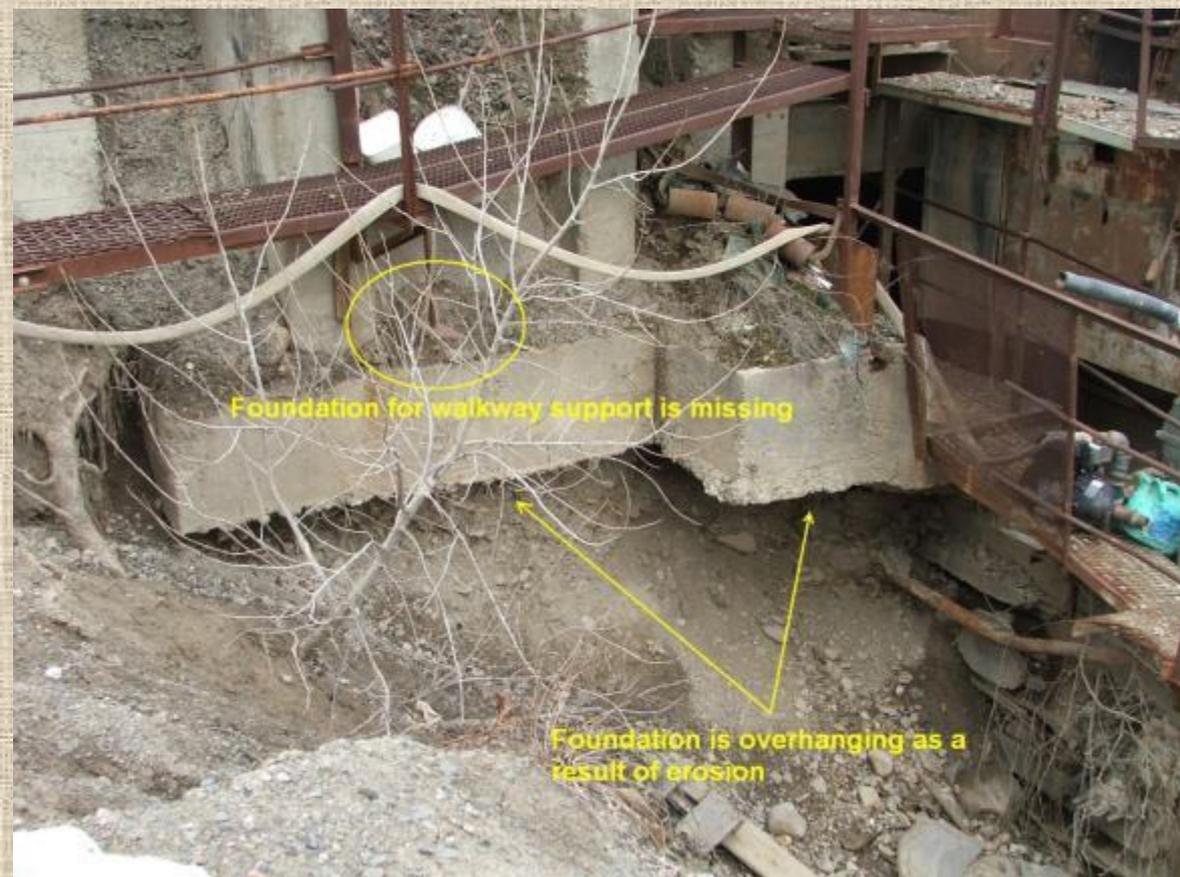
Foundation for walkway support is missing

Foundation is overhanging as a result of erosion

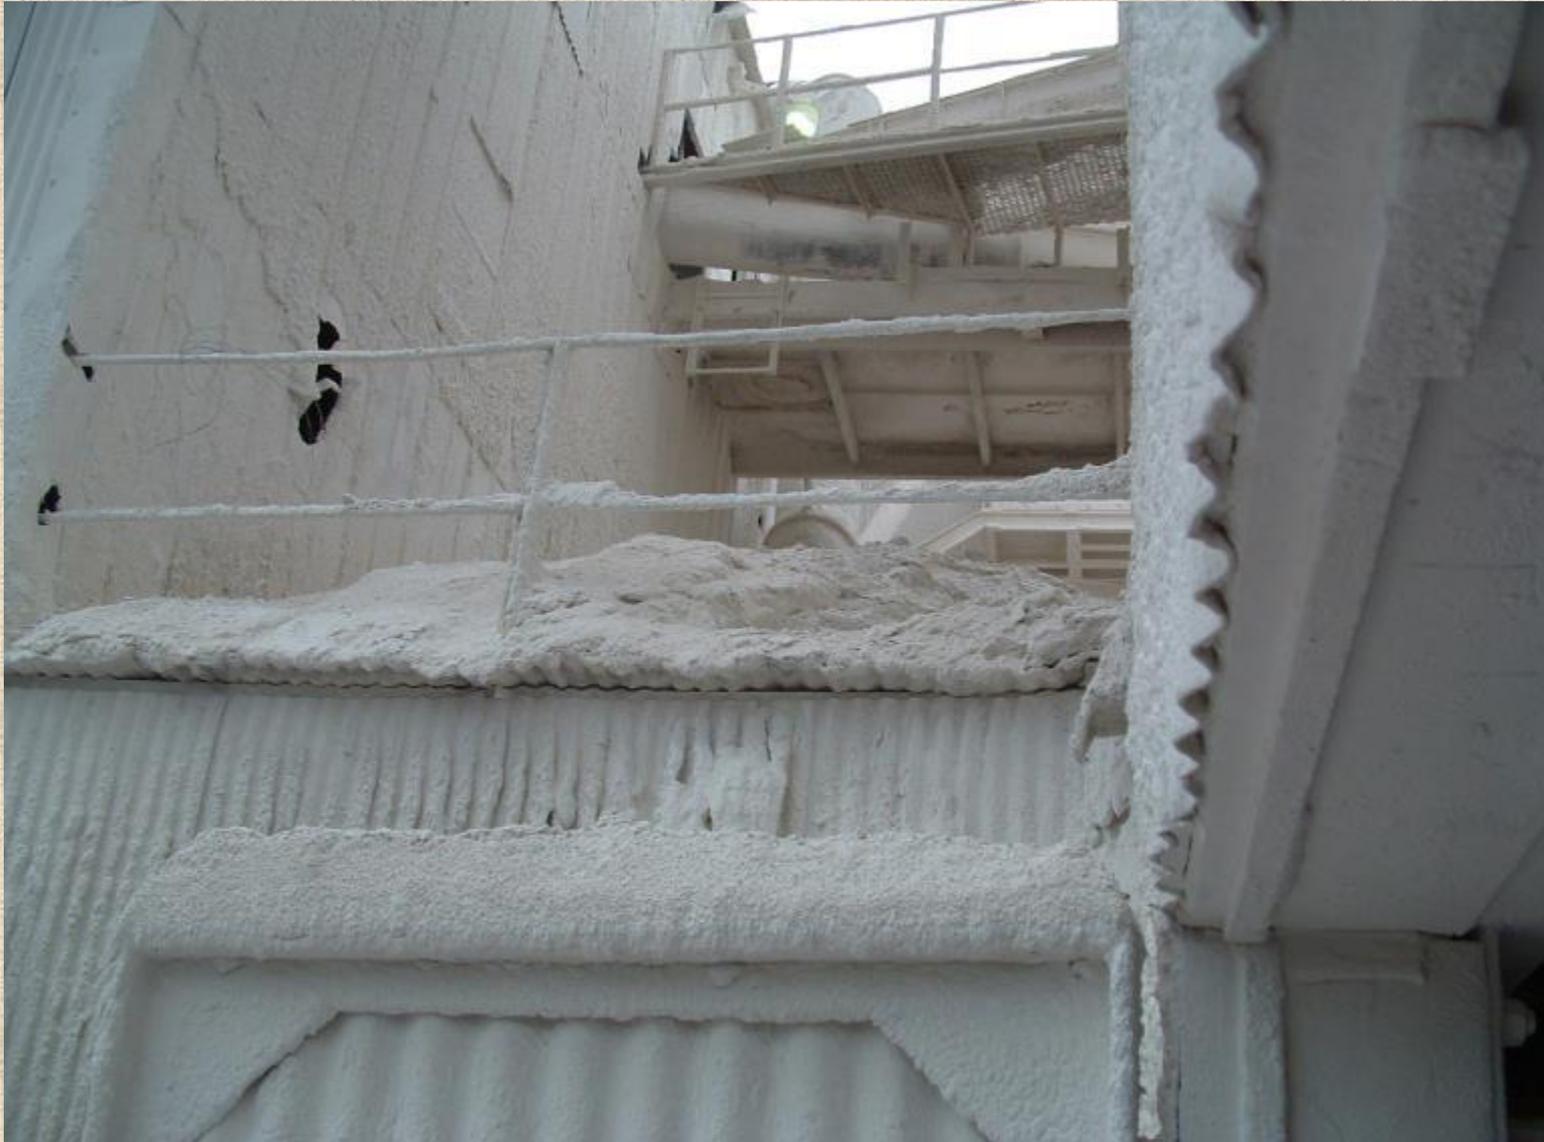
Overloaded sagging roof purlin as a result of material accumulations

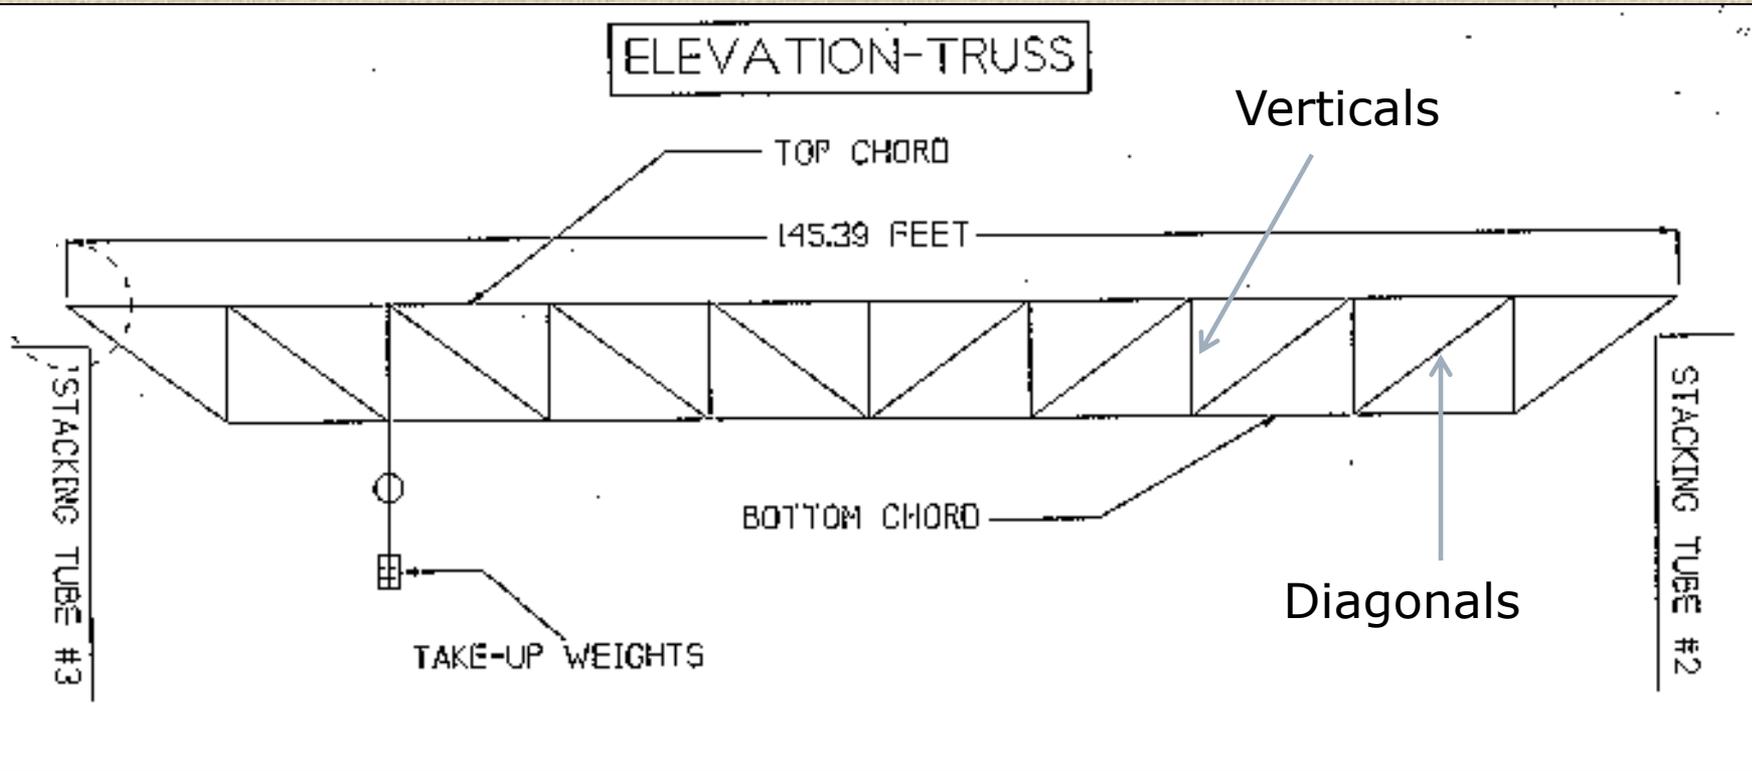
Corrosion holes in truss bottom chords & cross members

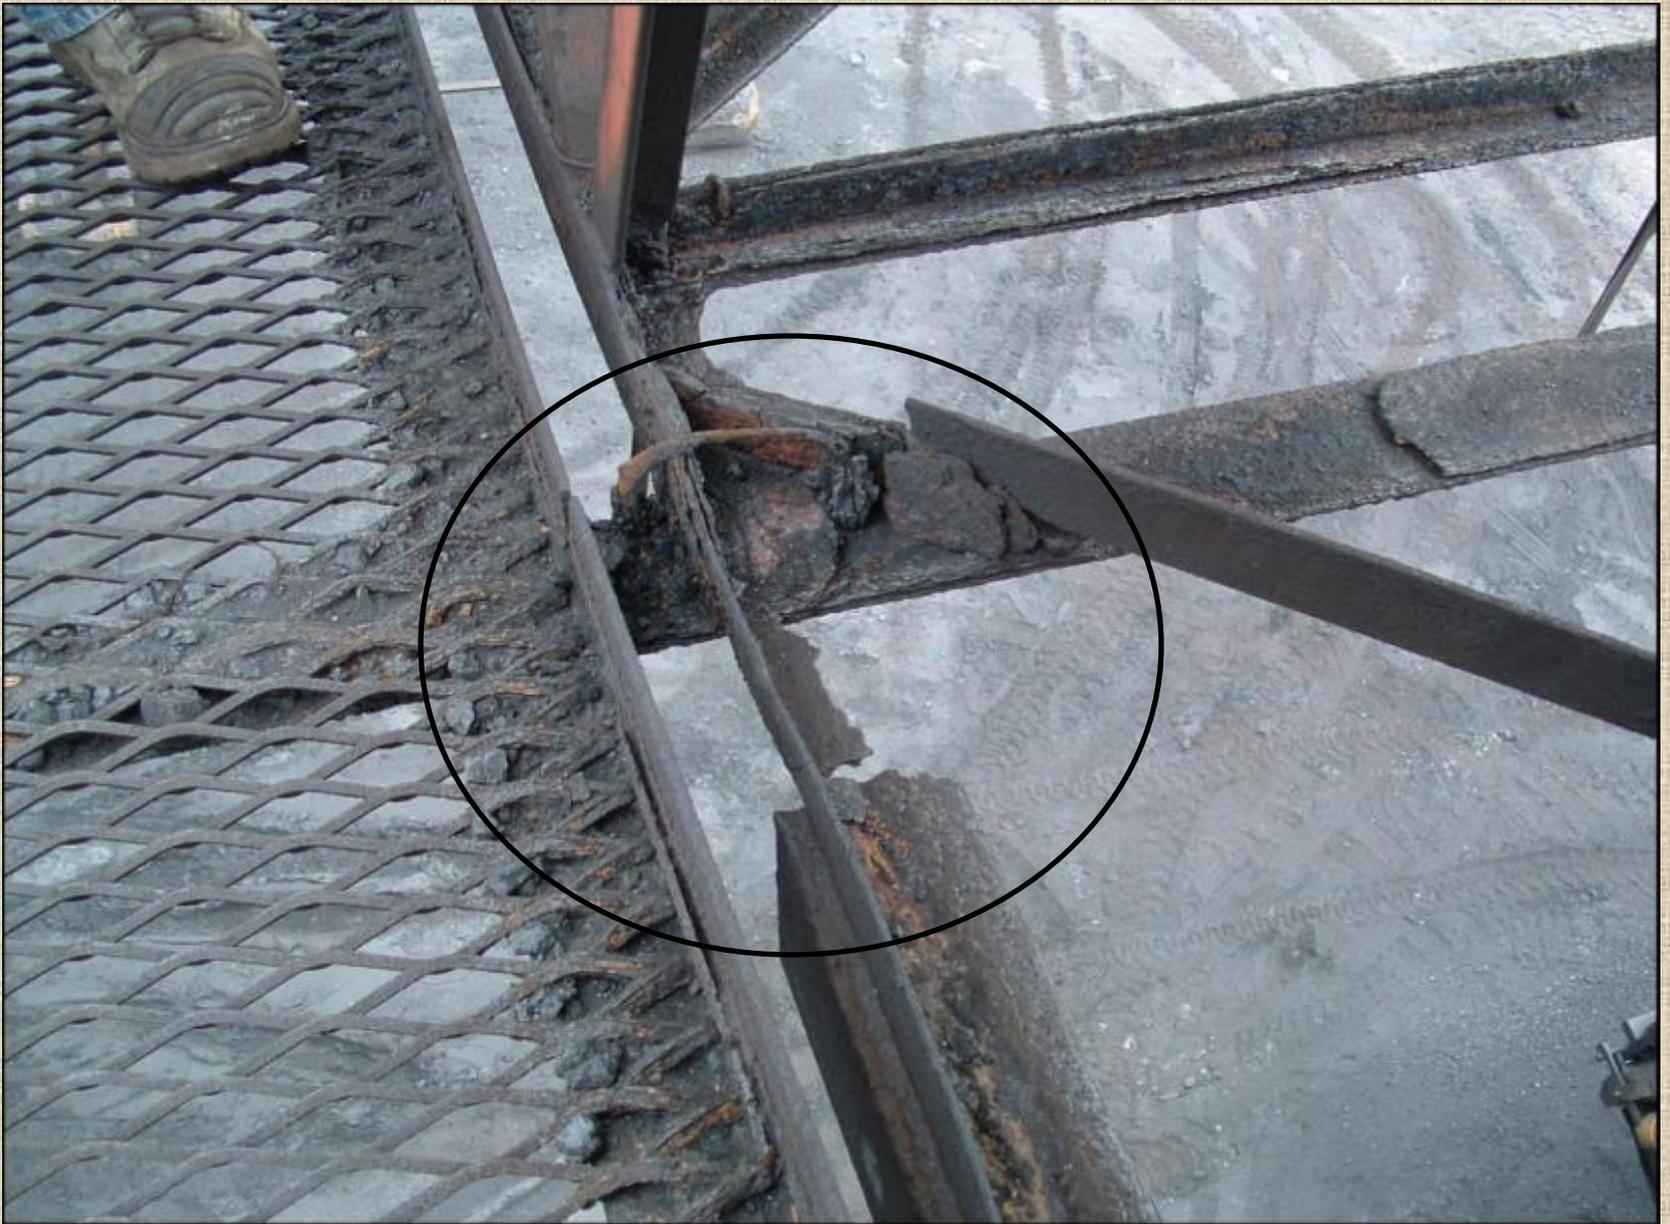
One leg of bottom chord angle corroded through and U-bolt walkway support was also severely corroded
