Mine Surface Structures - Identifying Unsafe Conditions & Avoiding Failures

Plants & Conveyors

Terence M. Taylor, P.E.

November 9, 2017

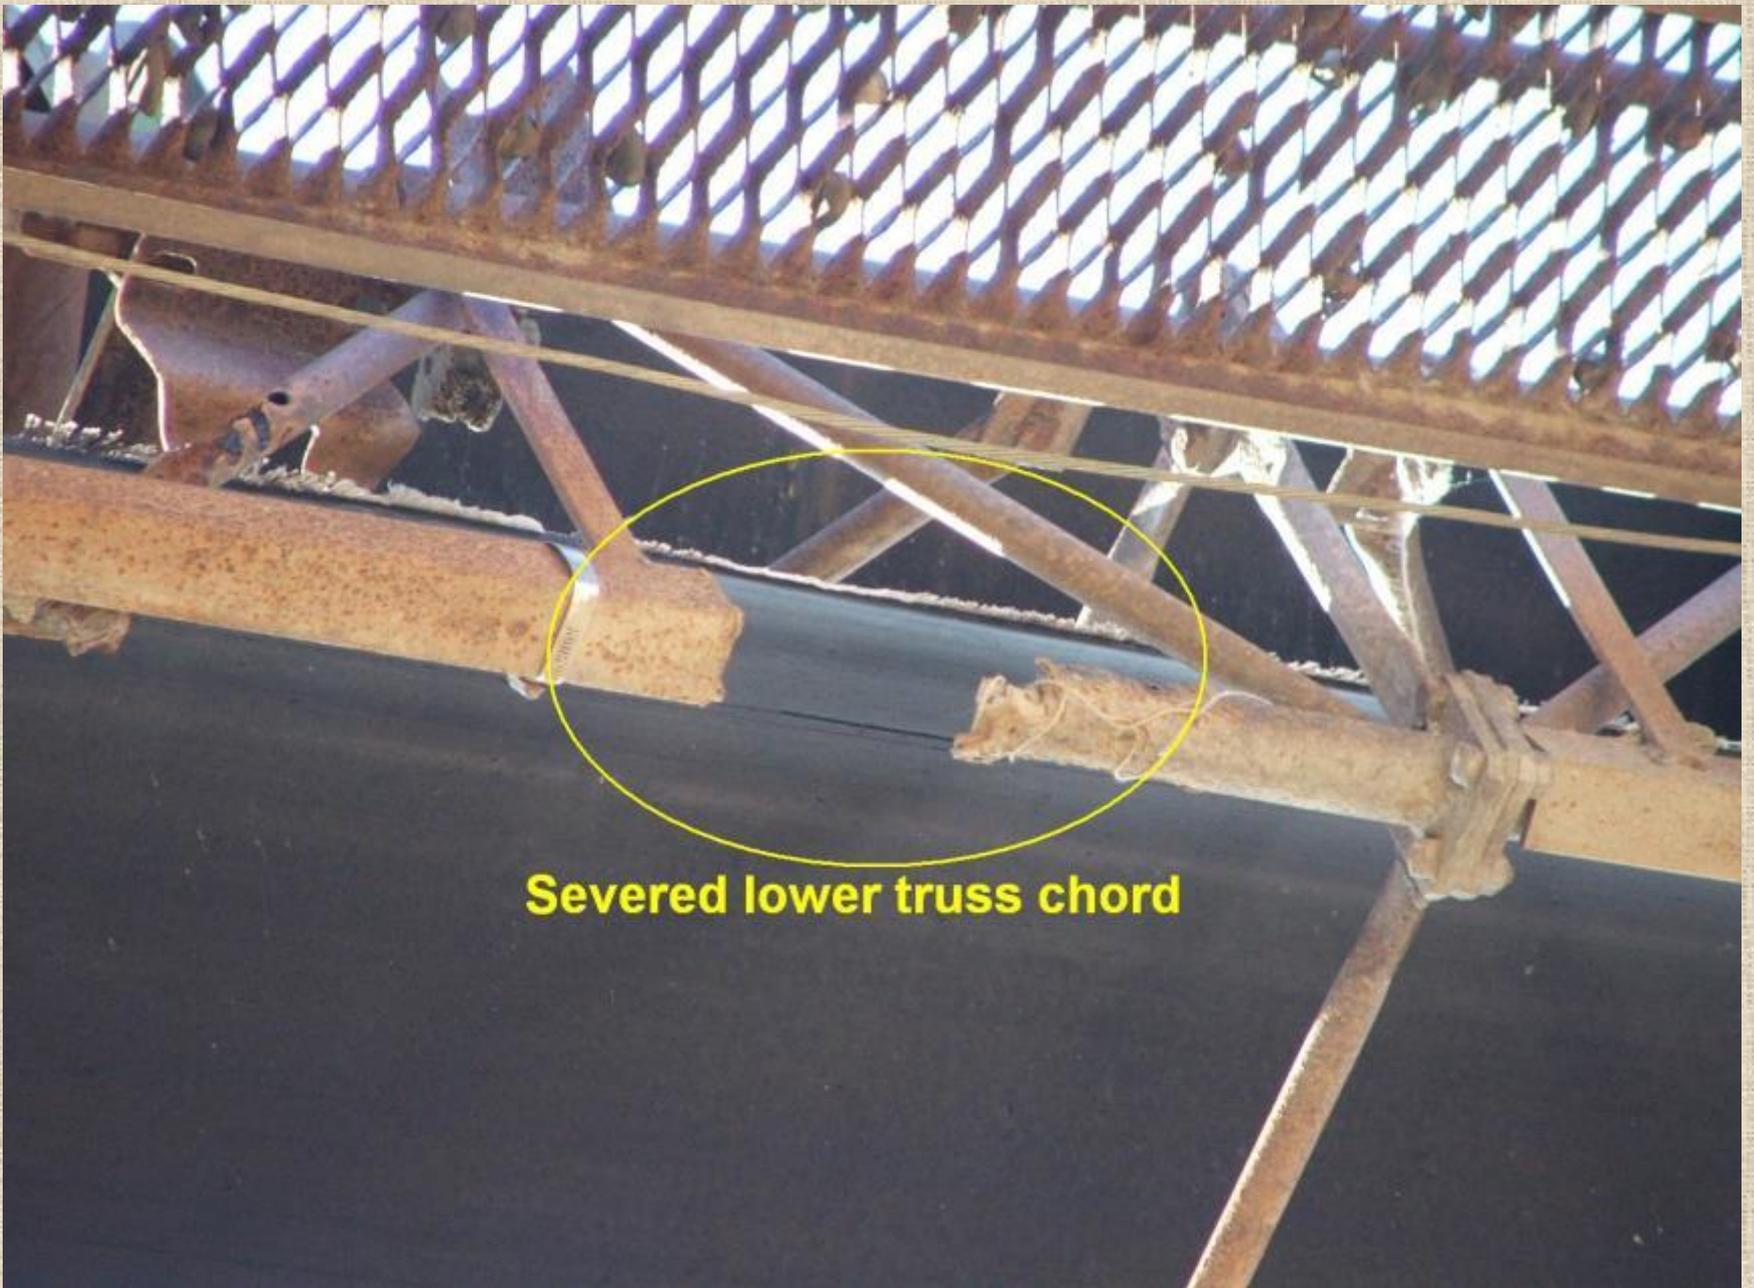
Severed lower truss chord

Fractured bottom truss chord

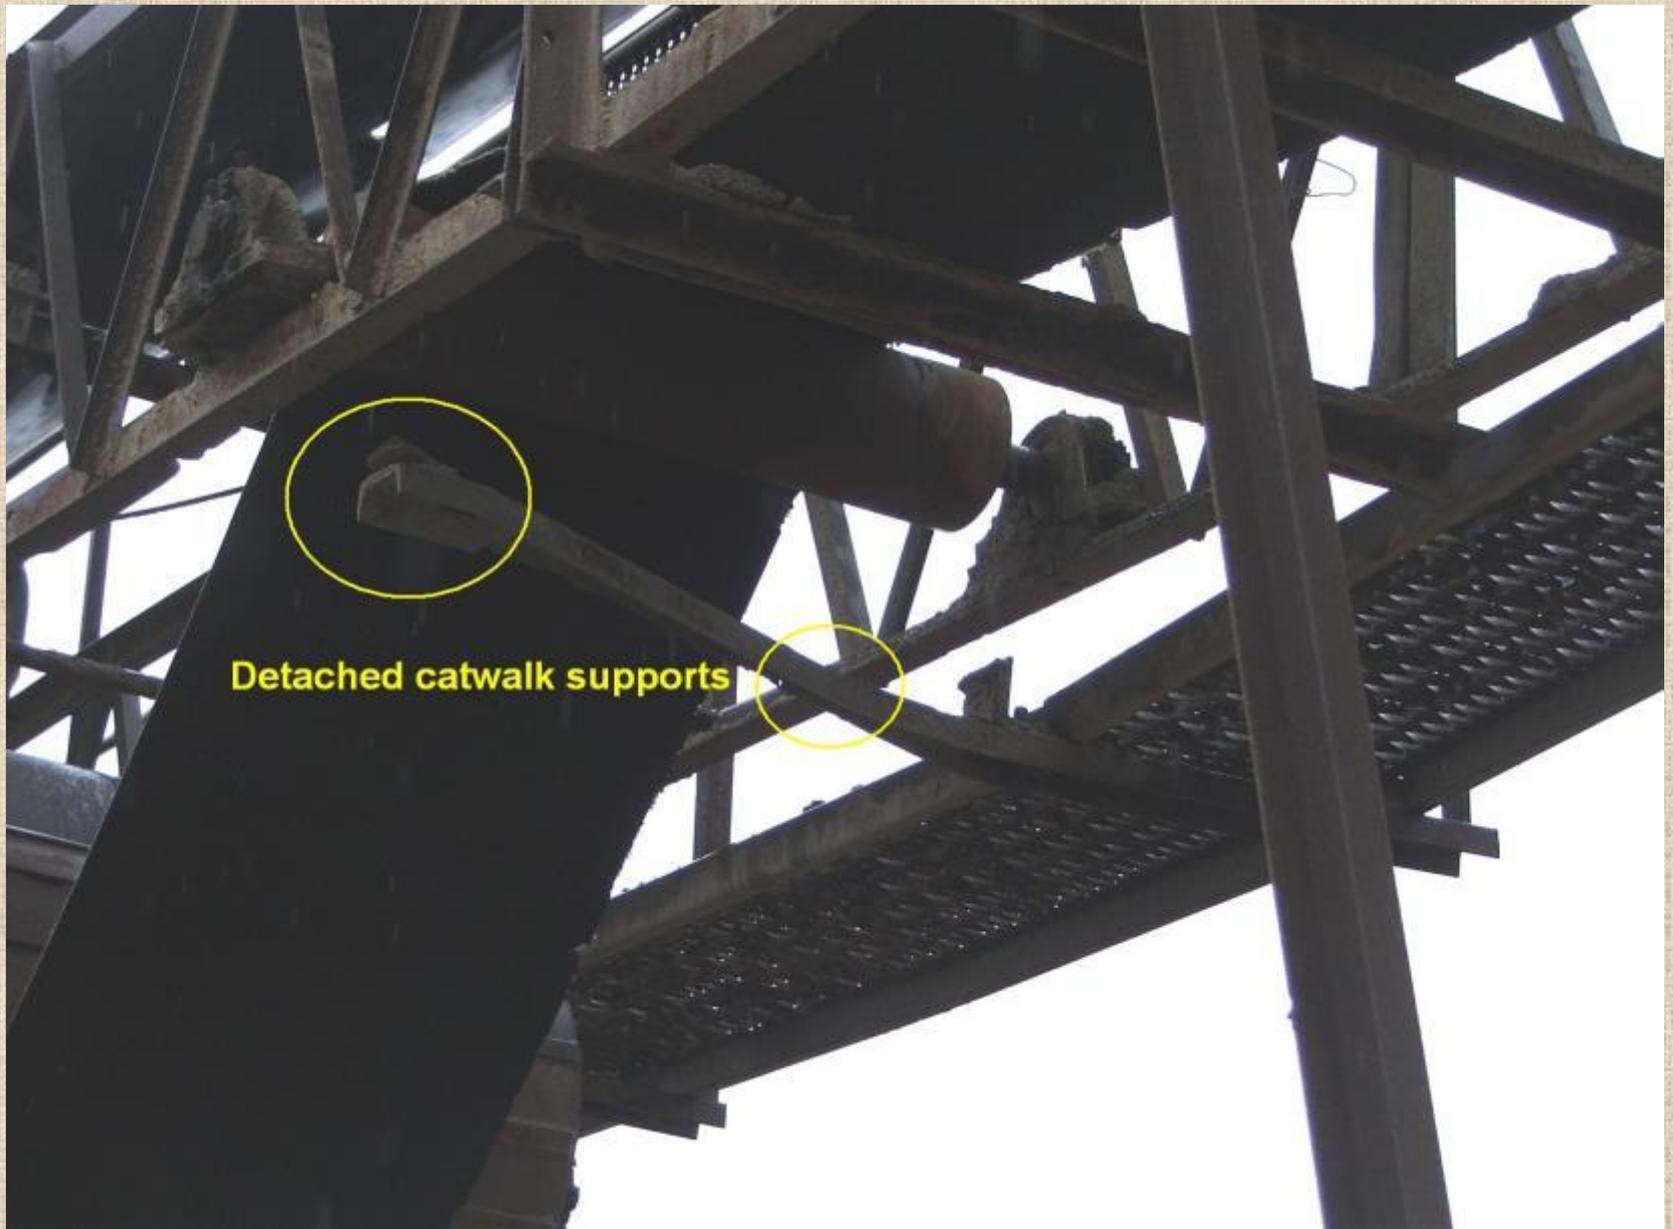
Belt abrasion notch in truss diagonal angle-shaped member. Section loss resulting in 50% loss of capacity!

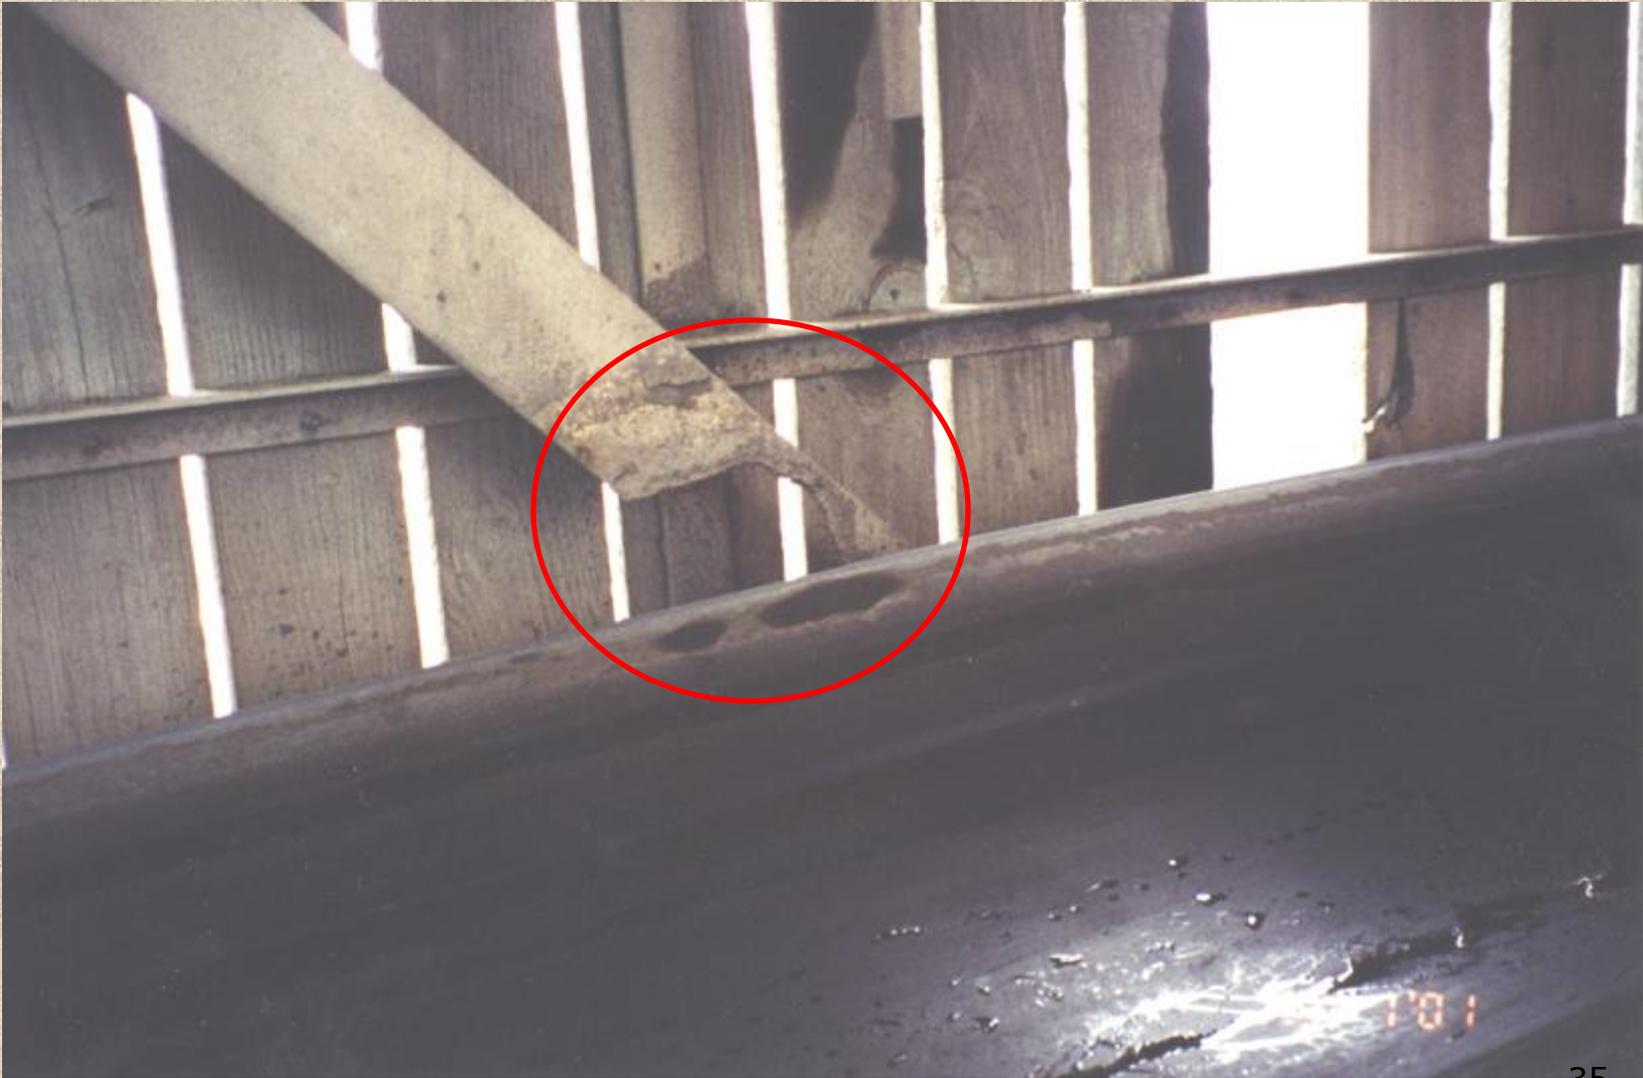
Corroded and severed truss diagonals & chords

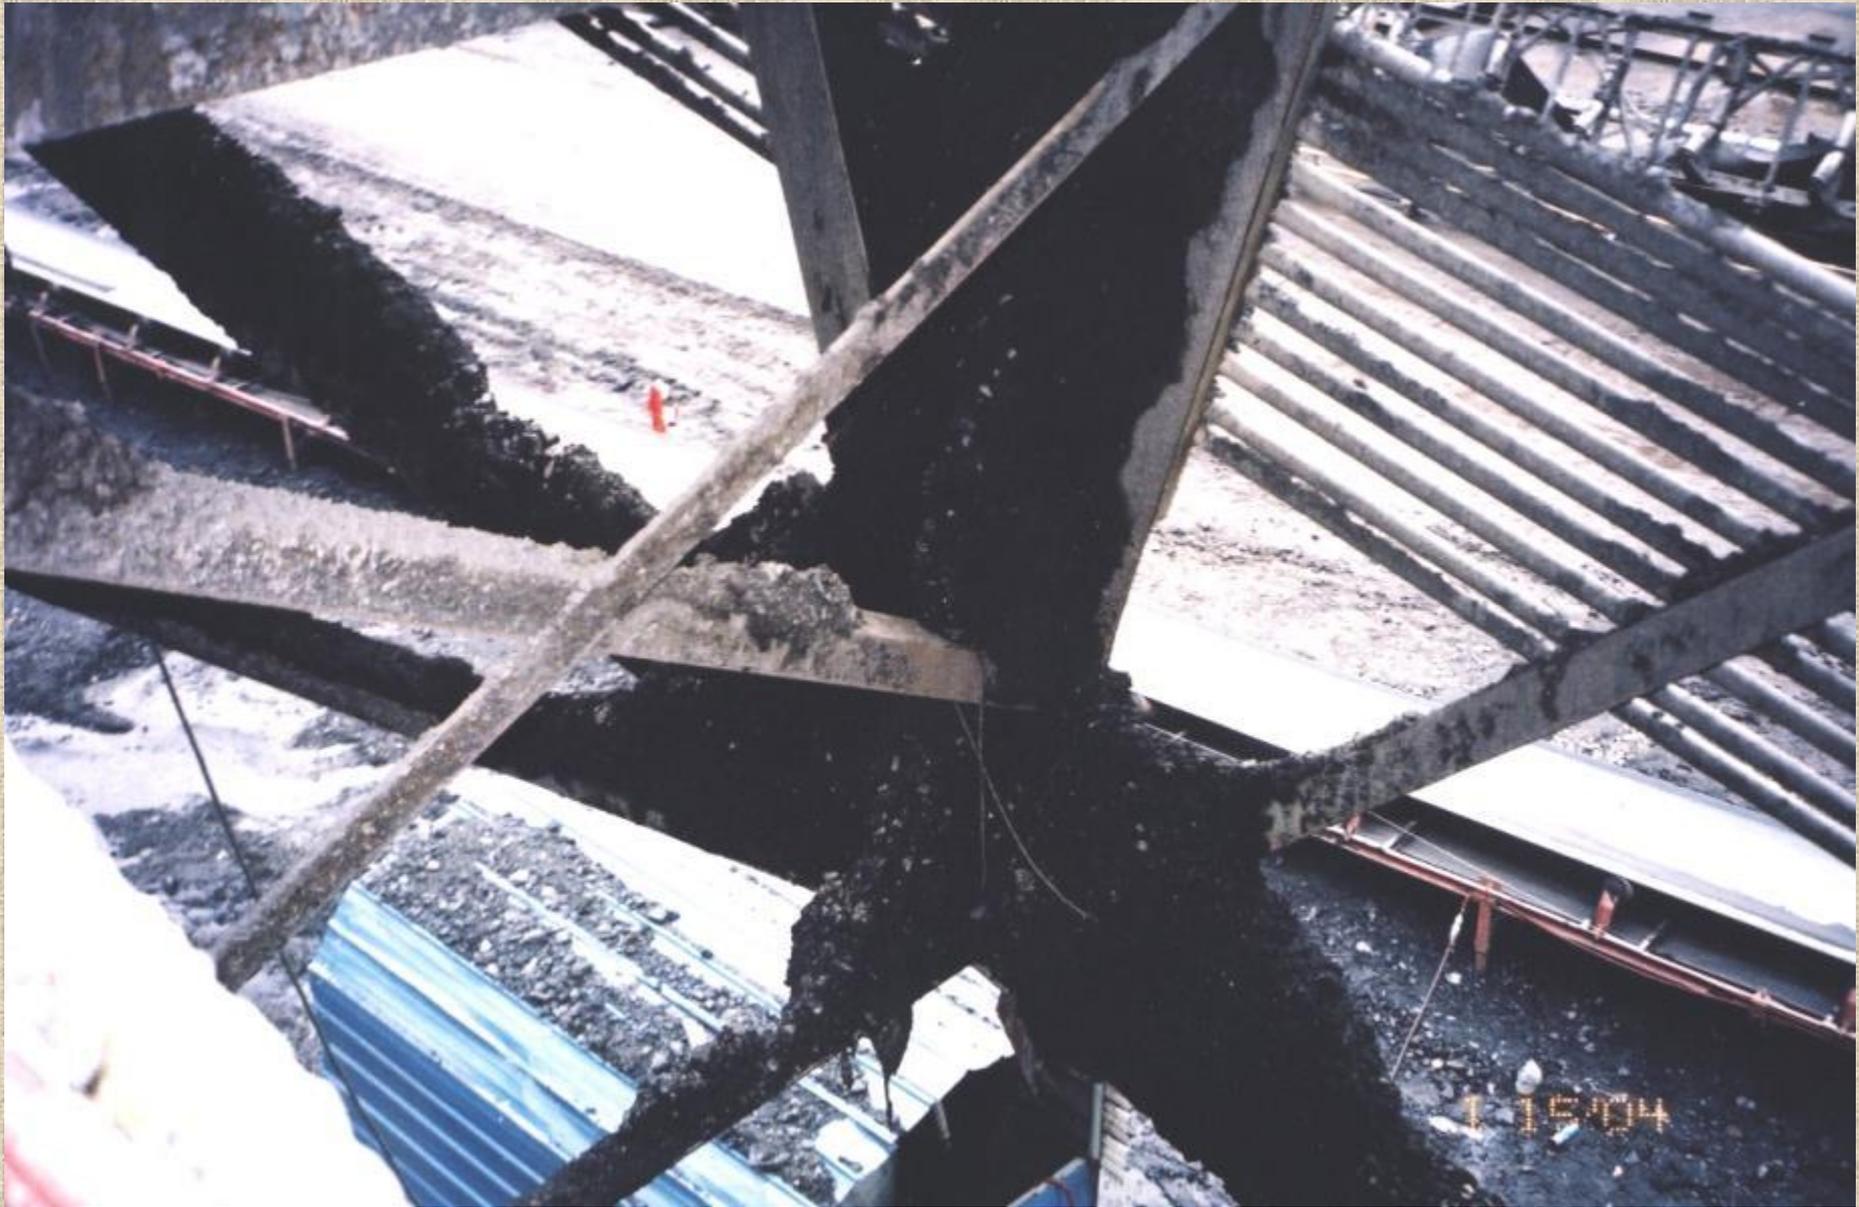
Accumulations on bottom chords and verticals add weight and may³⁸ facilitate corrosion

Corrosion at support edge of walkway grating

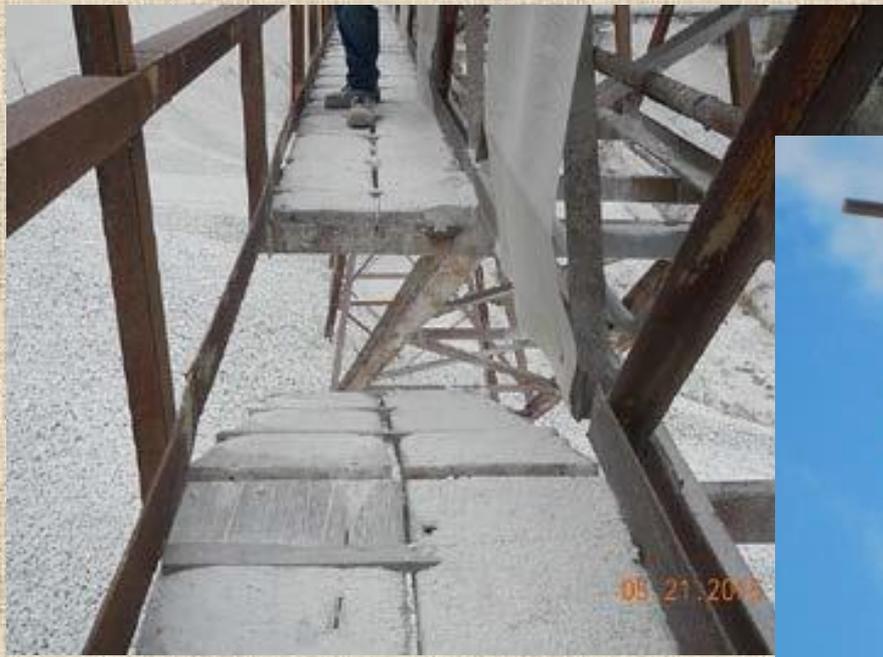
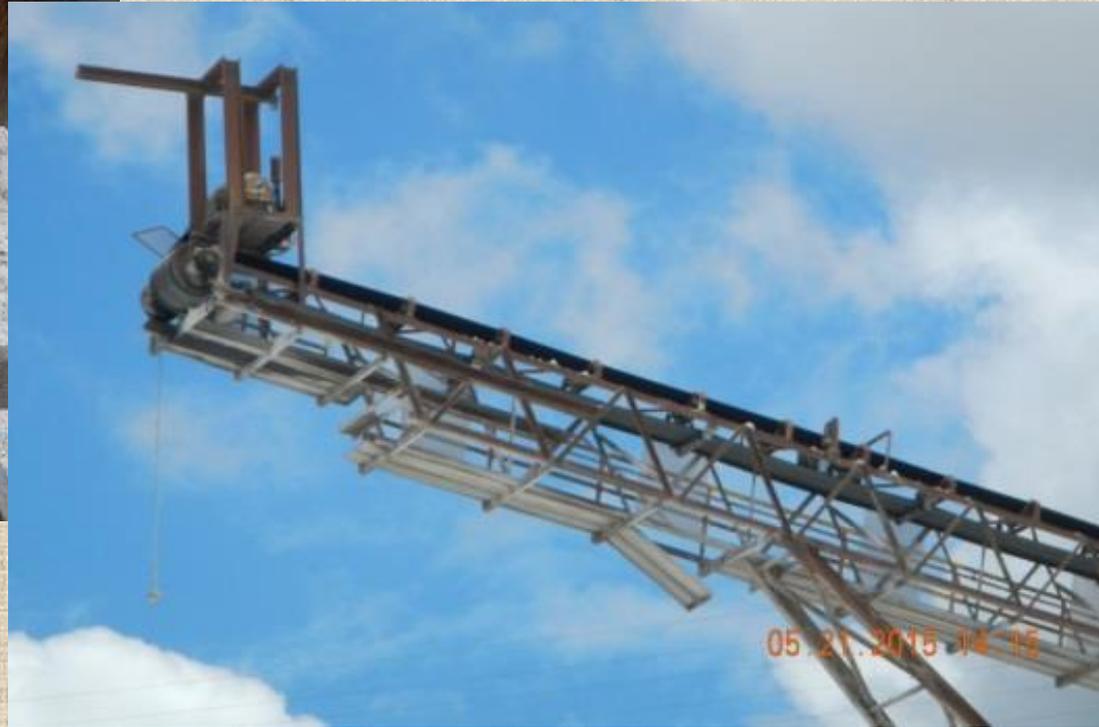
Near Miss - May, 2015 at a sand & gravel mine - An inspection party walked up the wood plank walkway to inspect the conveyor head pulley. As they started back down a section of the walkway unexpectedly dropped out from beneath the MSHA inspector leading the party. He escaped the 30 foot fall to the ground by holding onto the

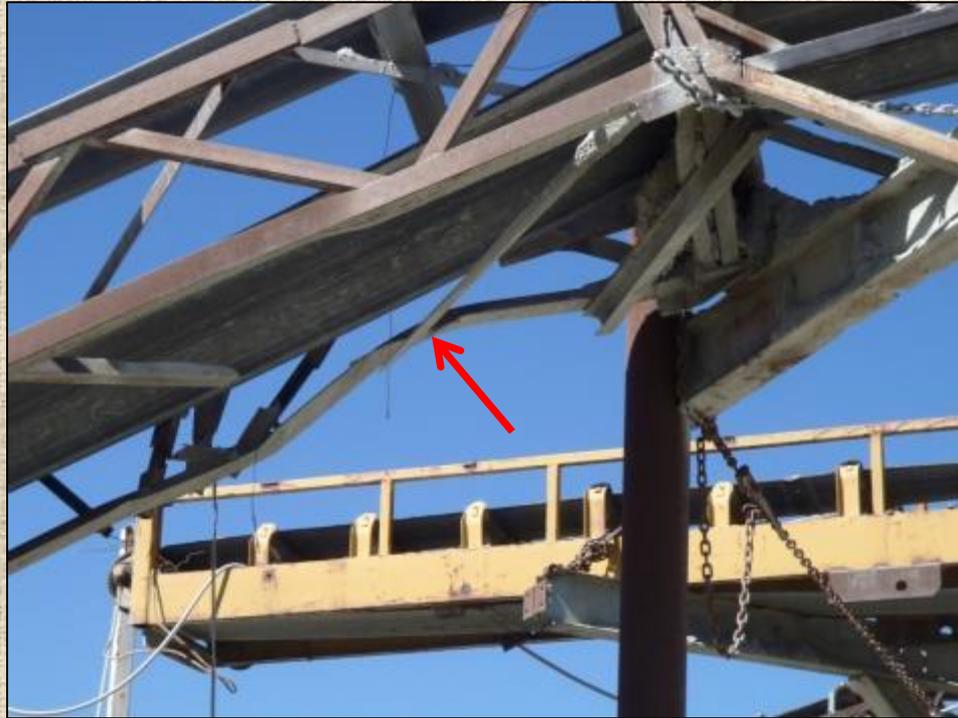
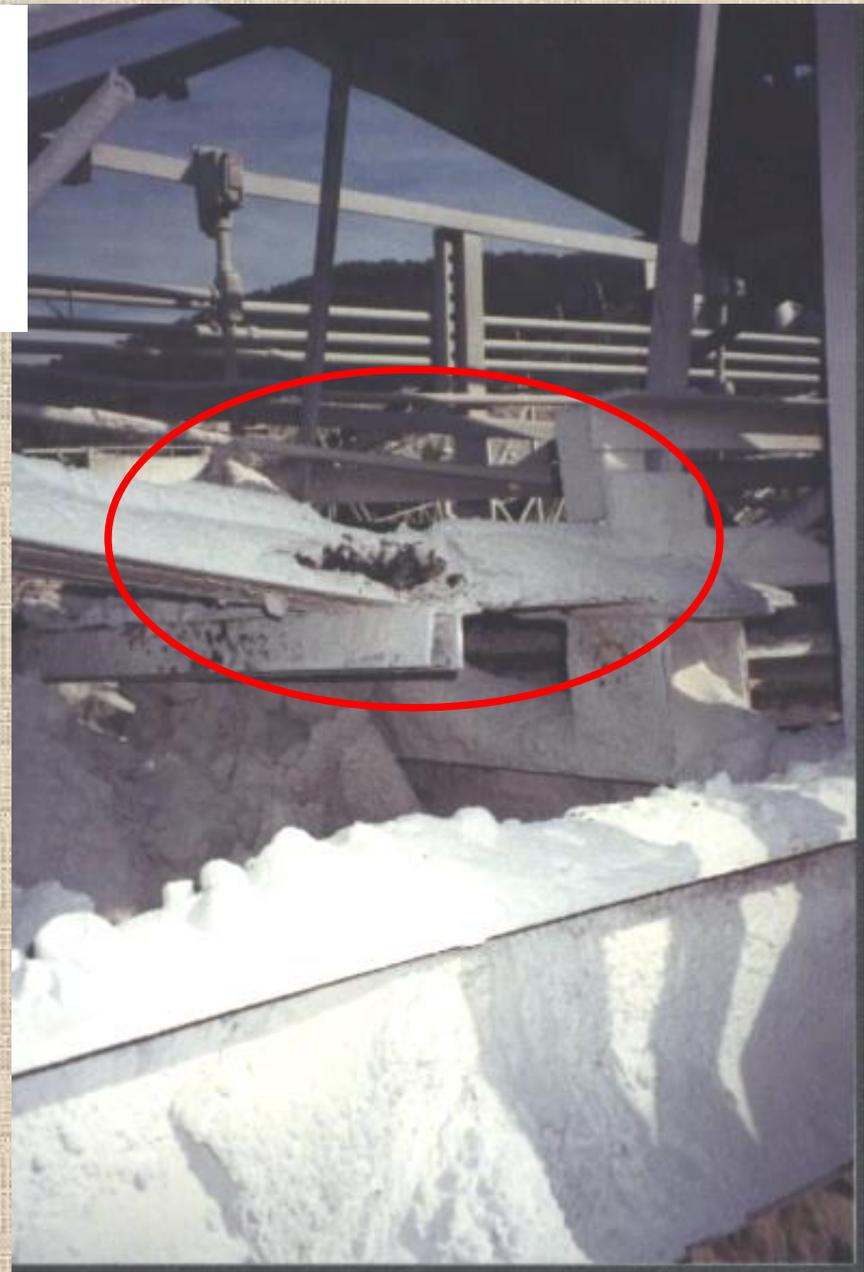
Deflected bottom chord that occurred because an added support post was not located at a joint

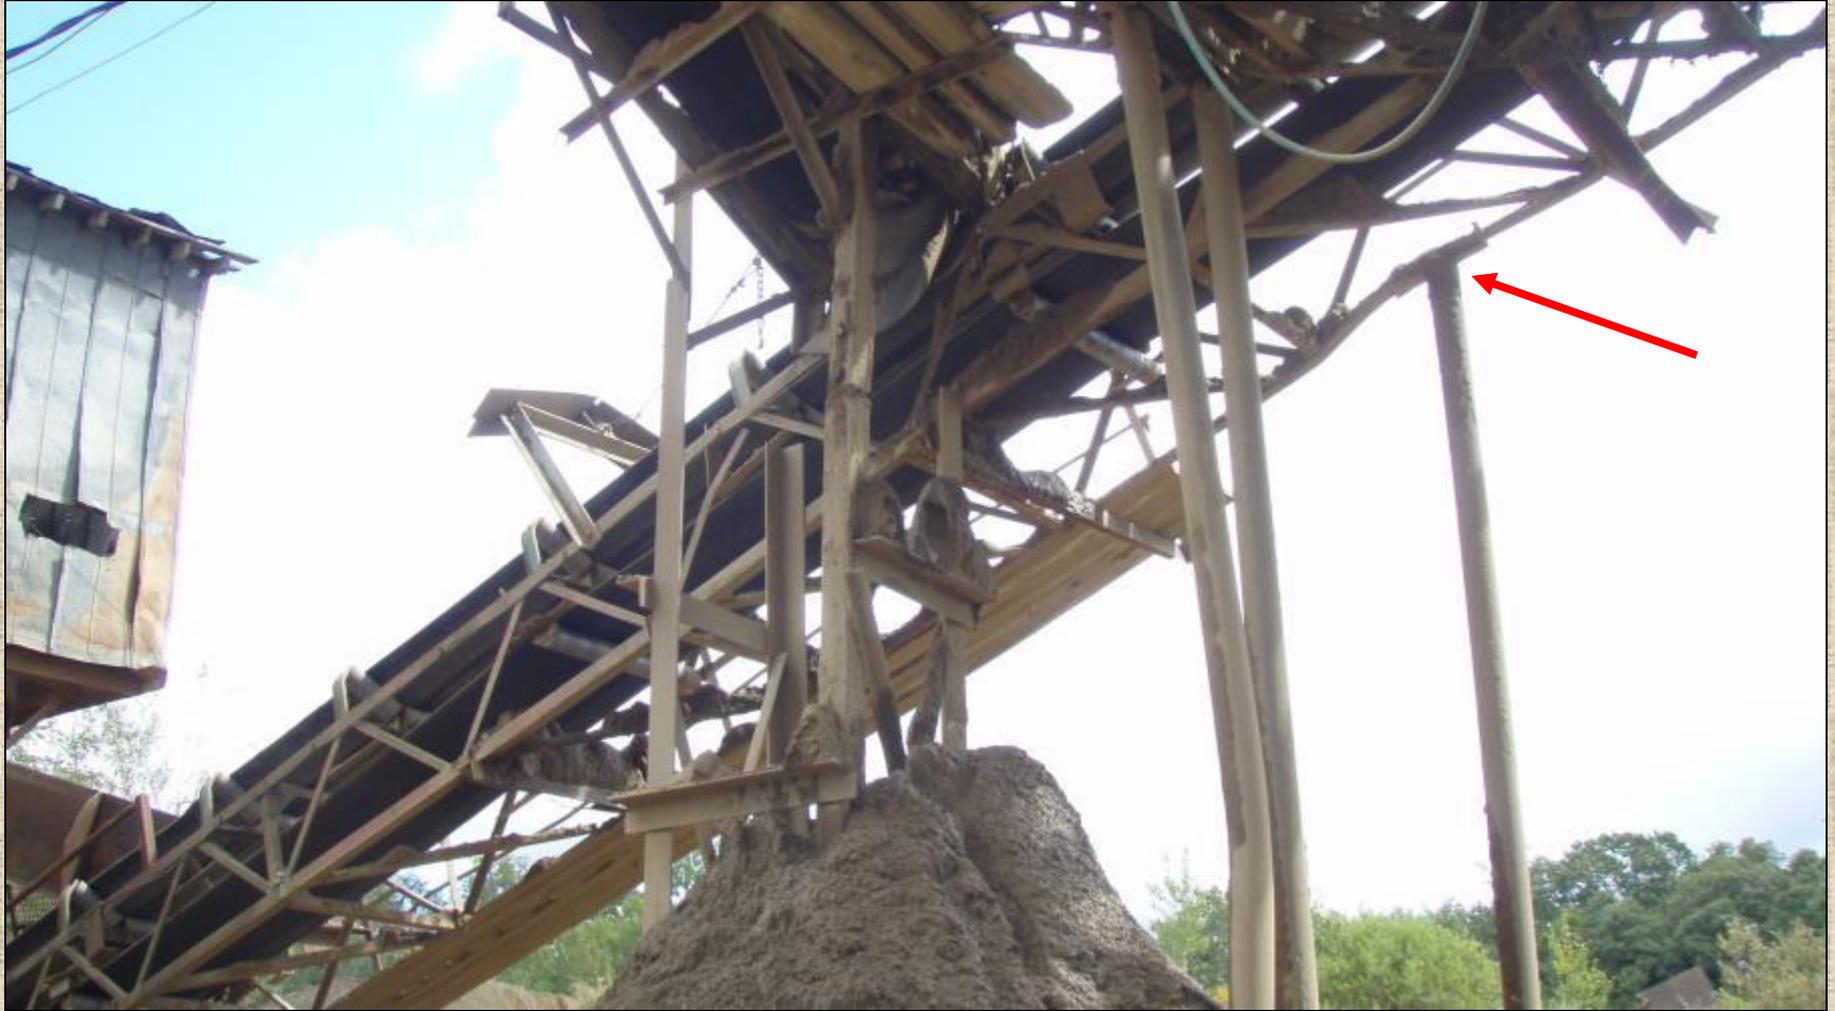
Buckled top chord

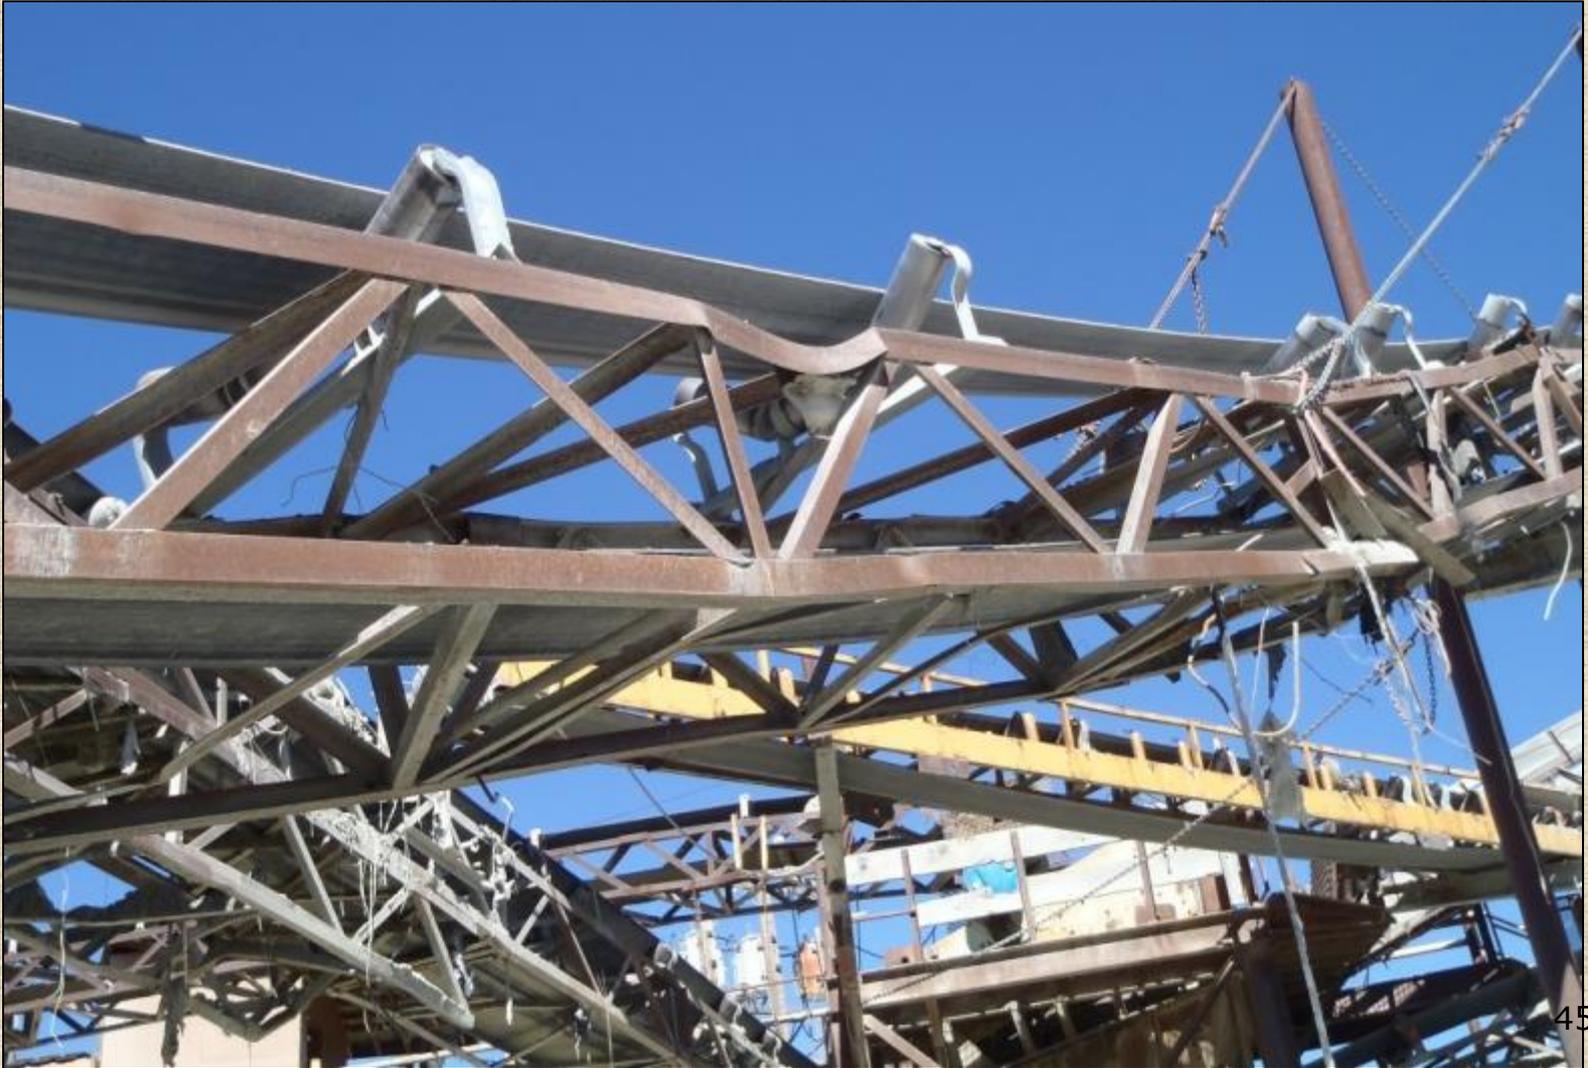
Impact damaged bent w/ inadequate repair

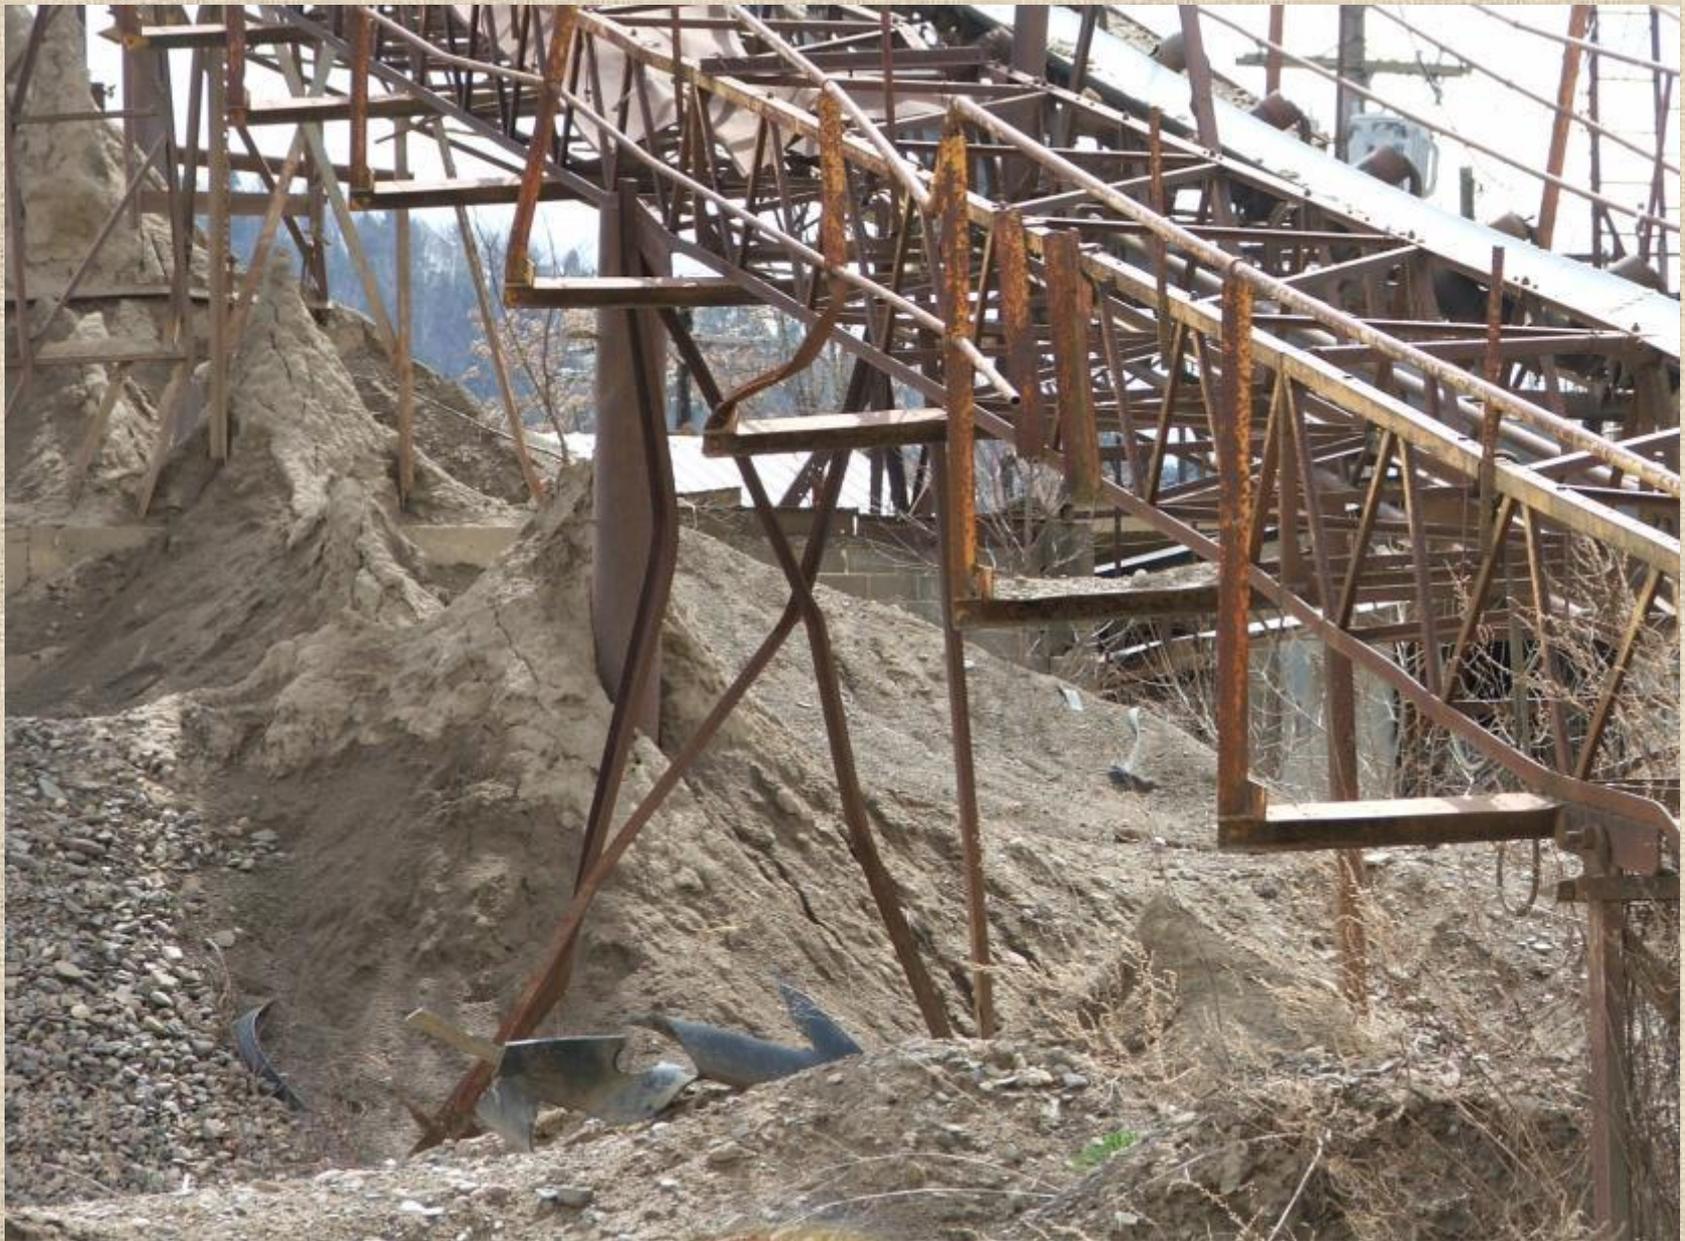
Impact damage to a conveyor bent and excessive material build₄₇up

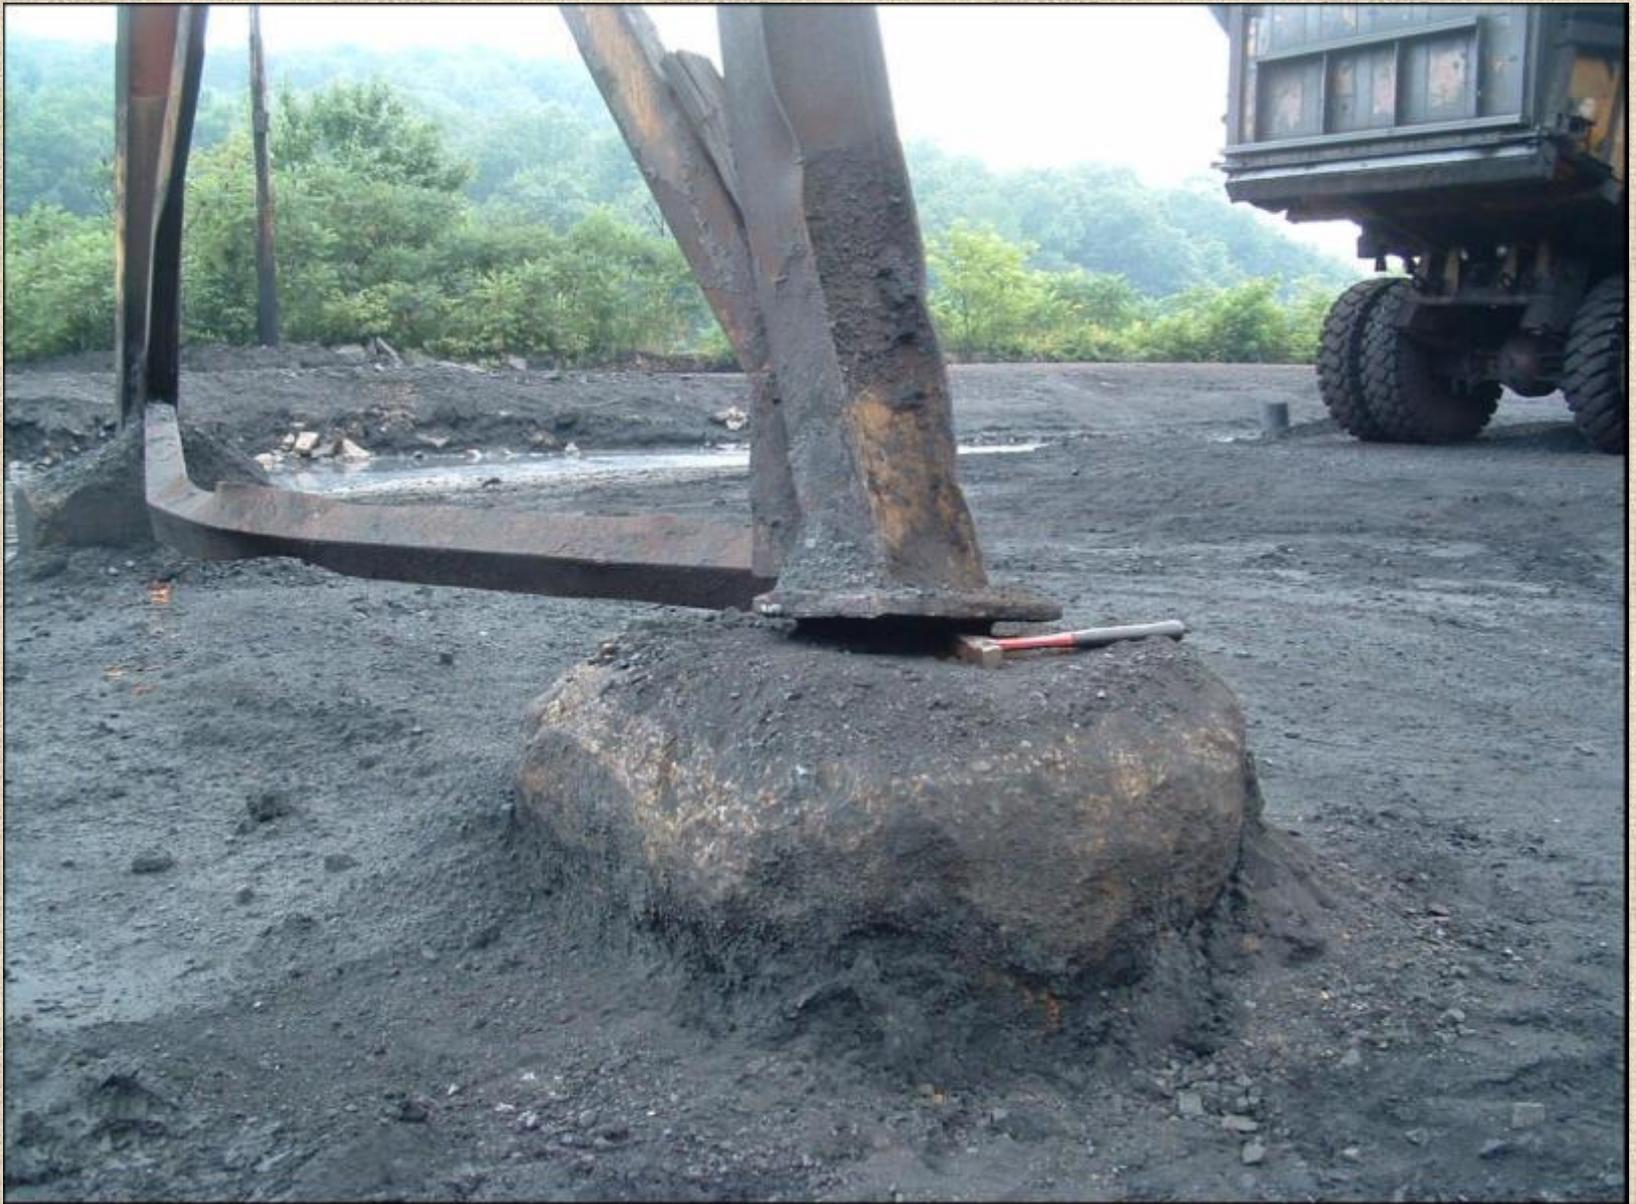
Impact damage - conveyor bent separated from the concrete foundation

Using an old conveyor
truss as a support tower
for another conveyor
truss.

The drip pan stuck to
the tower was a dead
giveaway as to its past
use....

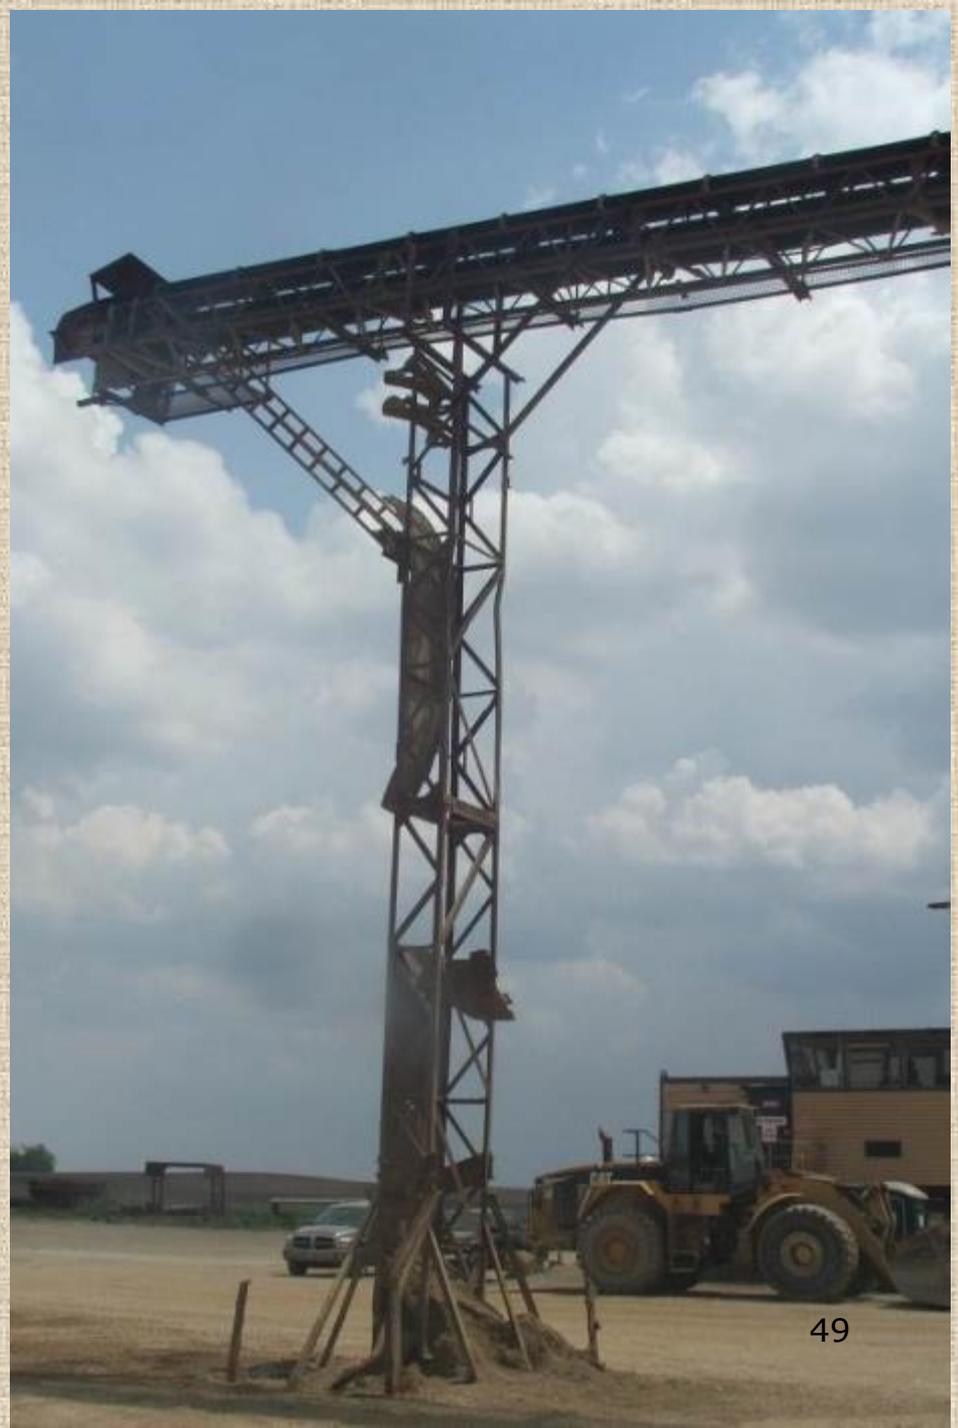
If 1 brace is good, then surely 7 has to be even better!

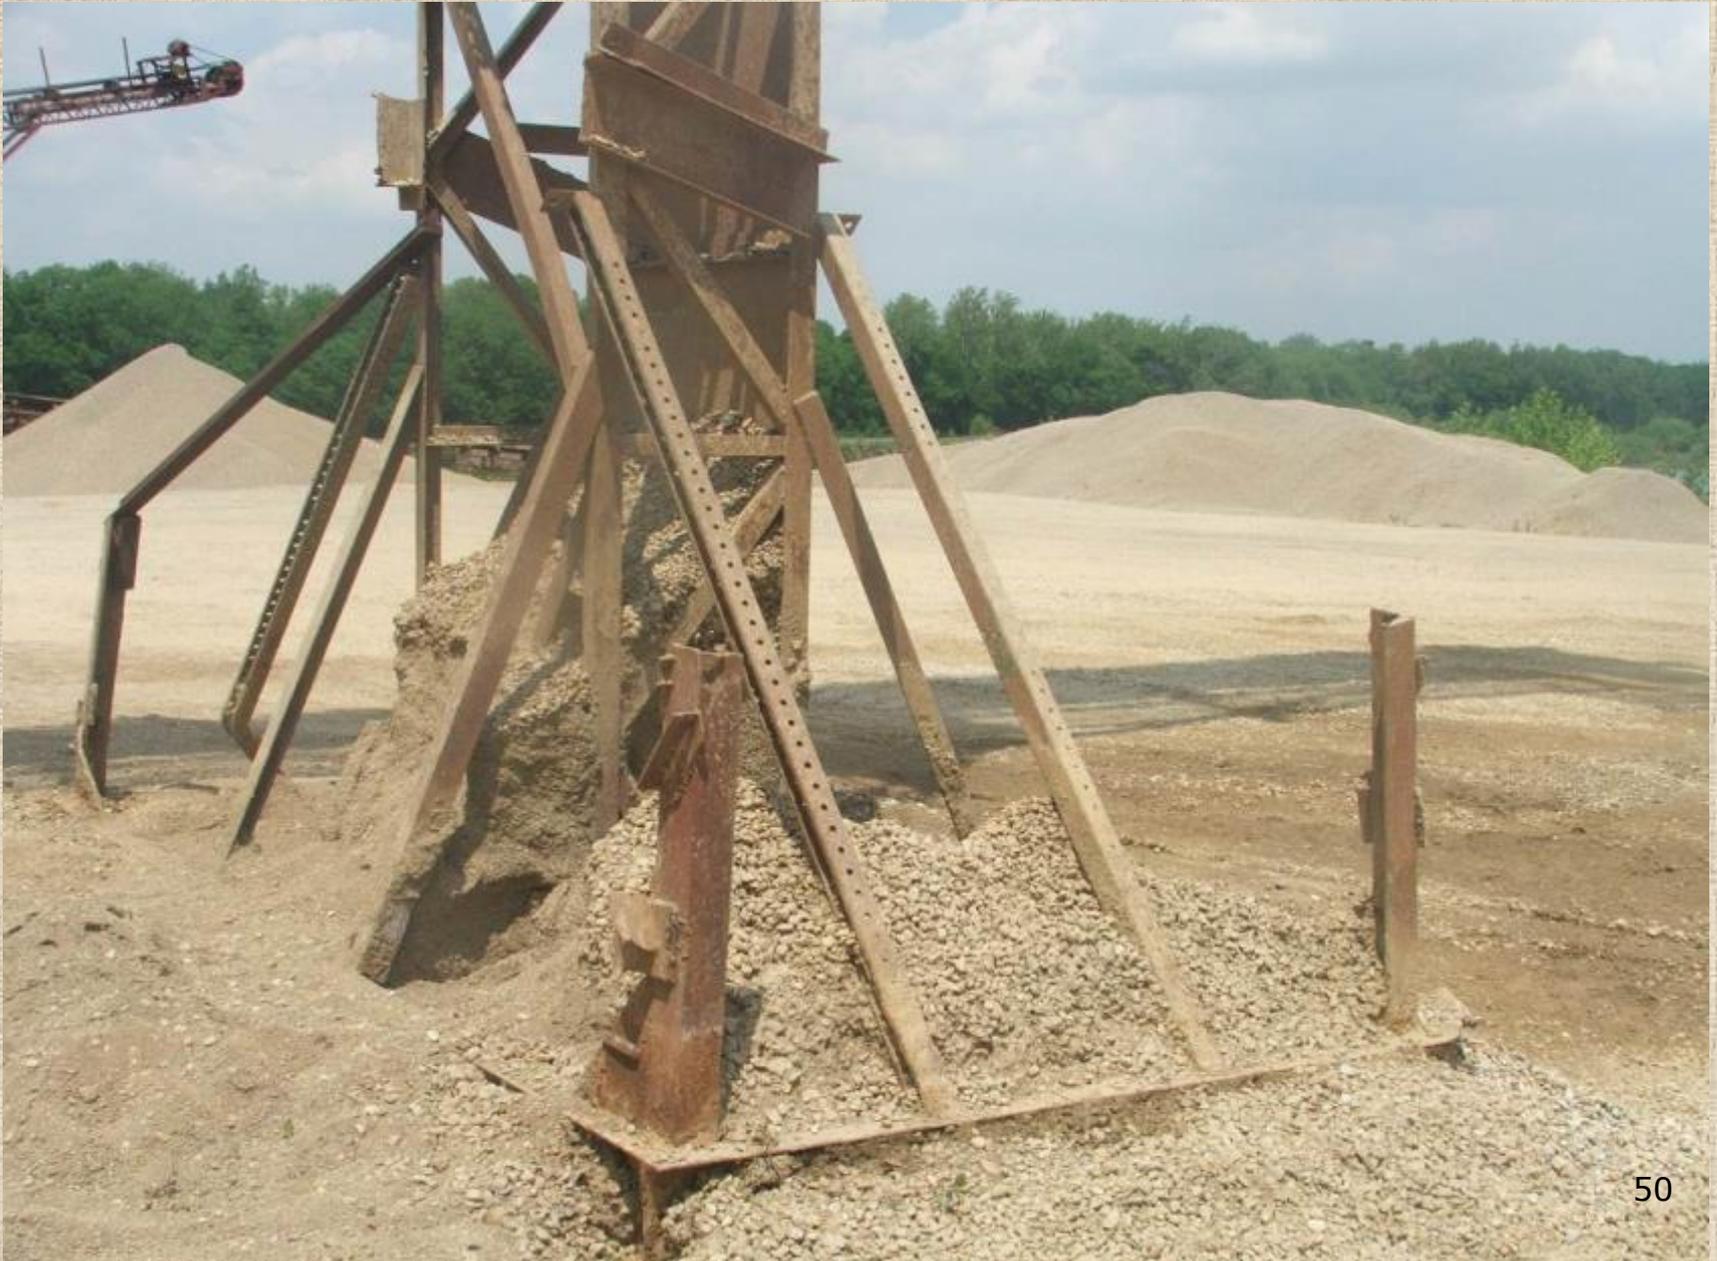
Twisted bent
