Mine Surface Structures - Identifying Unsafe Conditions & Avoiding Failures

Plants & Conveyors

Terence M. Taylor, P.E.

November 9, 2017

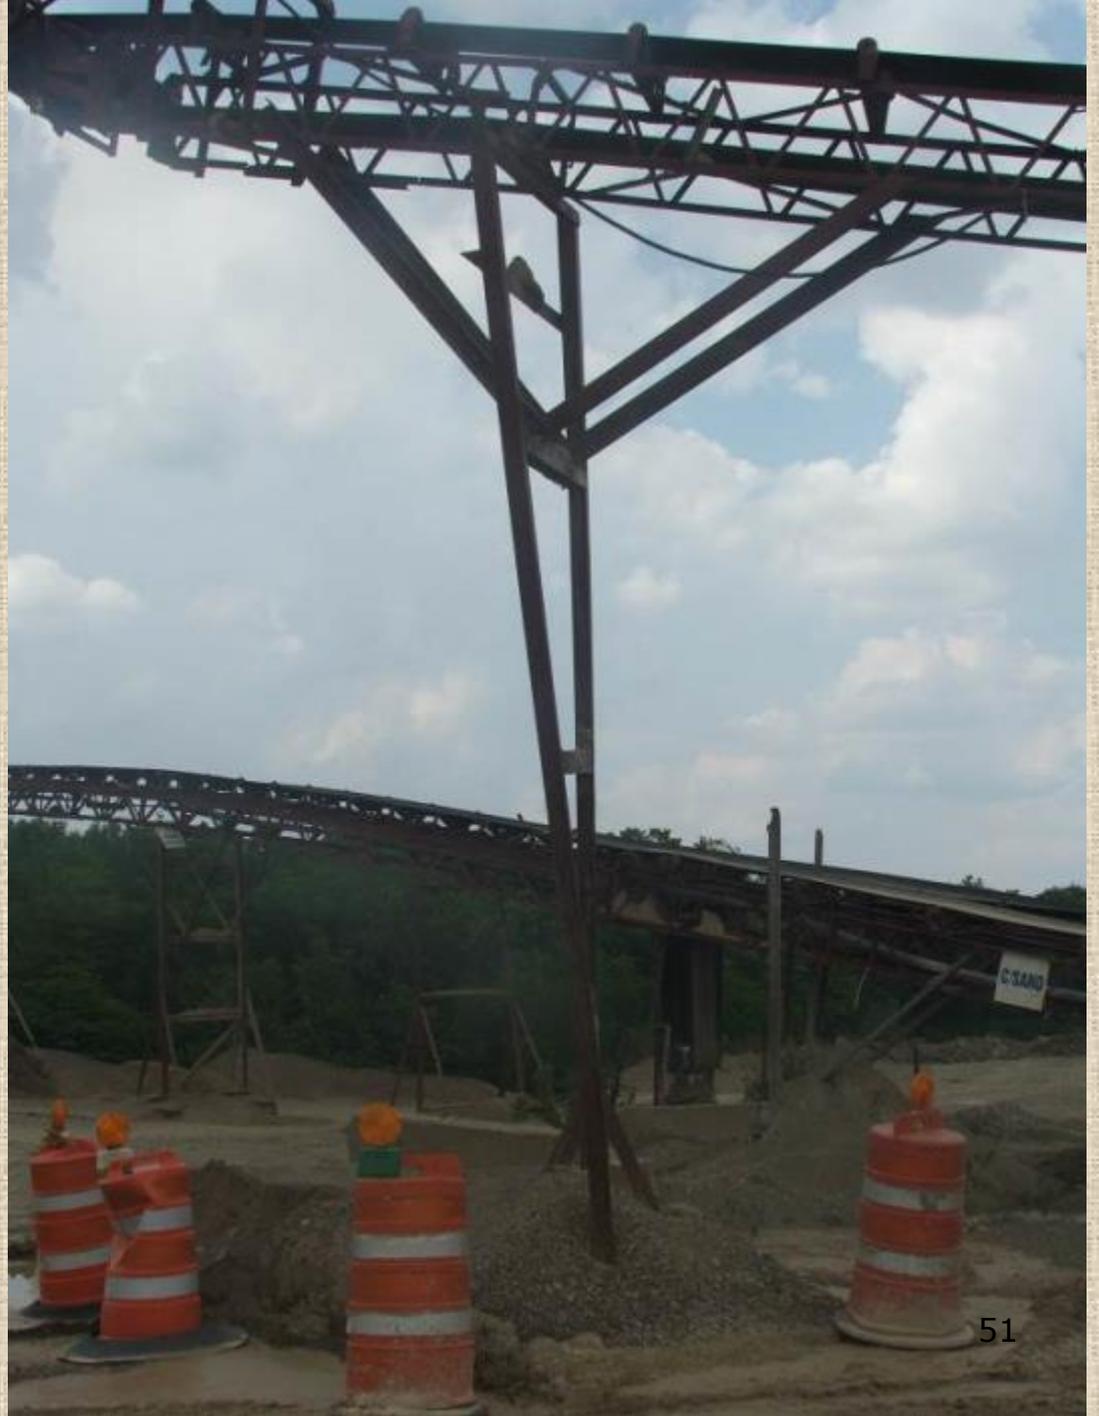
Corroded column at the base of a conveyor support bent.

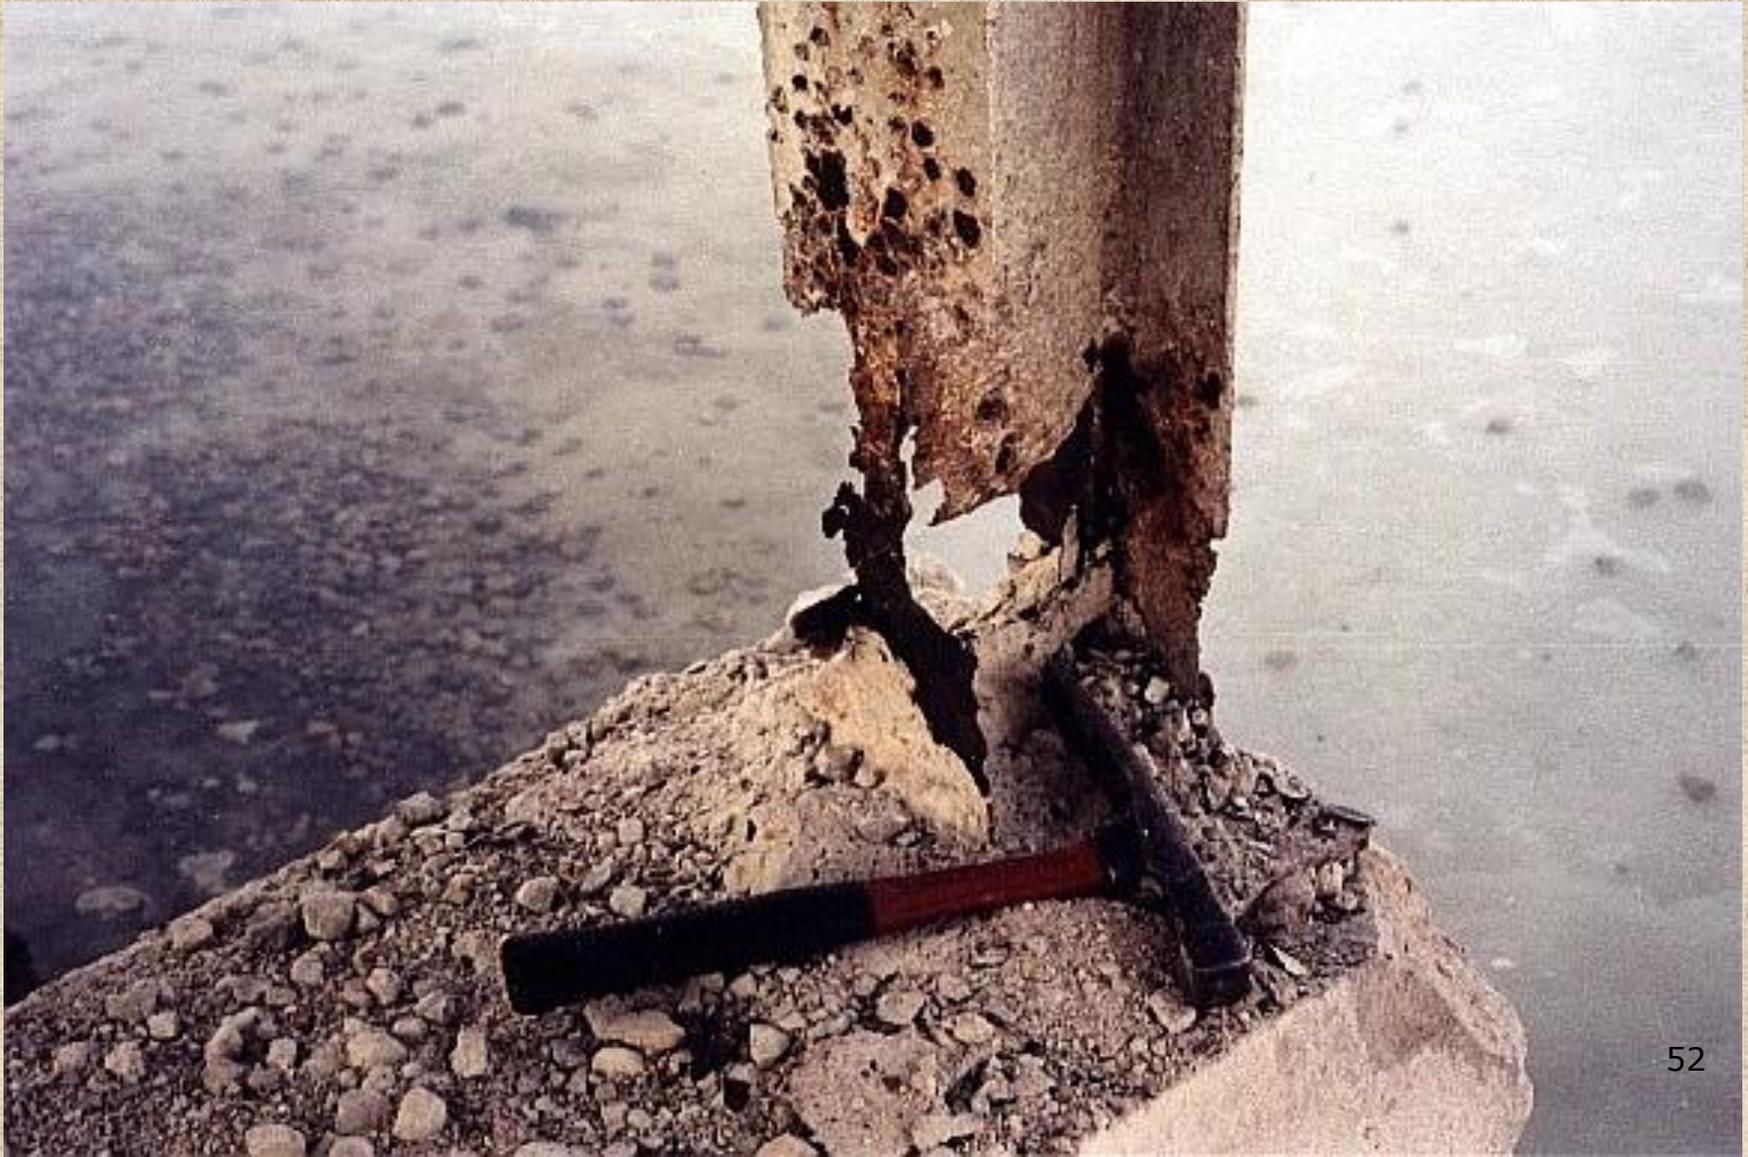
Corroded conveyor belt supports
