Mine Surface Structures - Identifying Unsafe Conditions & Avoiding Failures

Plants, Conveyors, & Bins

Terence M. Taylor, P.E.

April 4, 2017

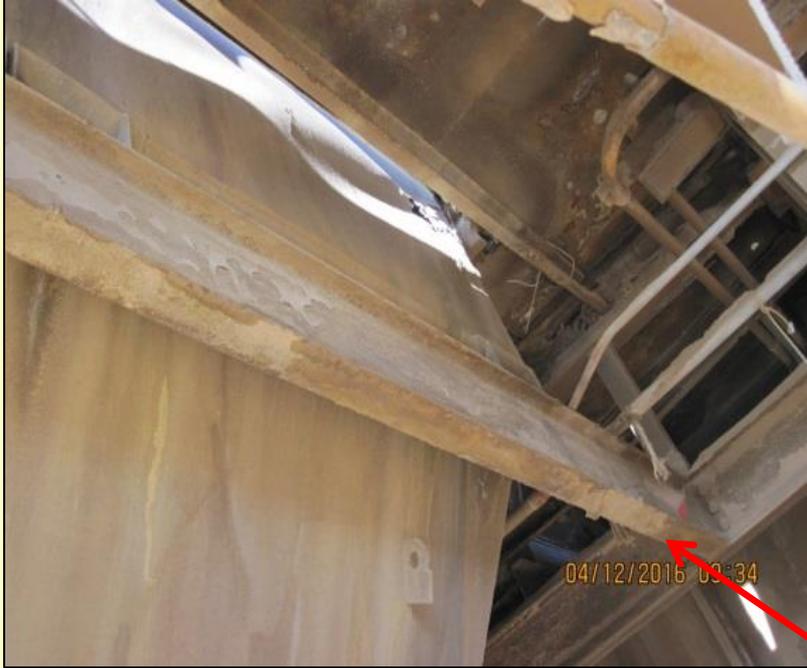
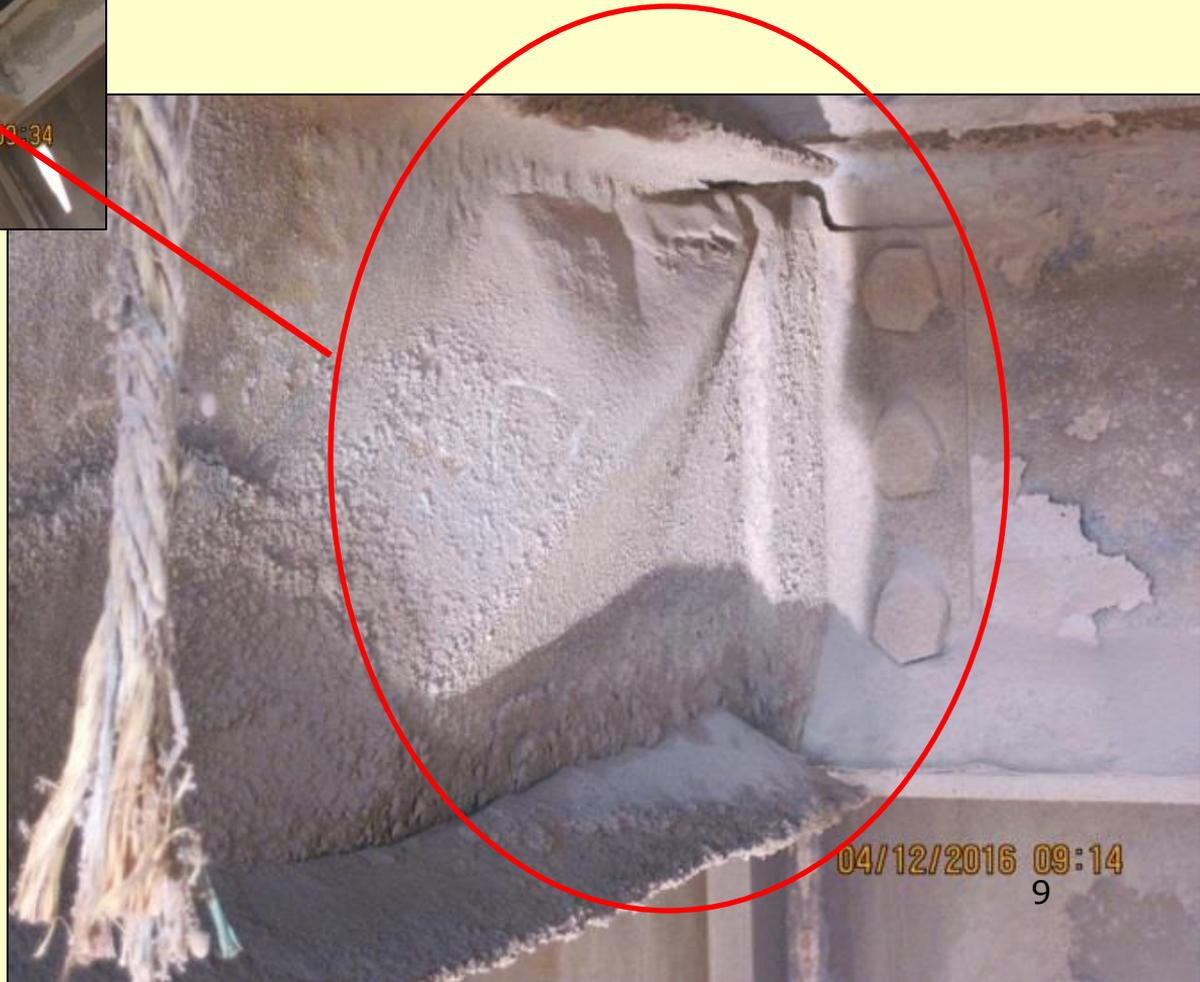
Crack through beam and reinforcing angle on the west side of the primary crusher

Weld has failed along left side of the angle

Note: beam was sagging slightly

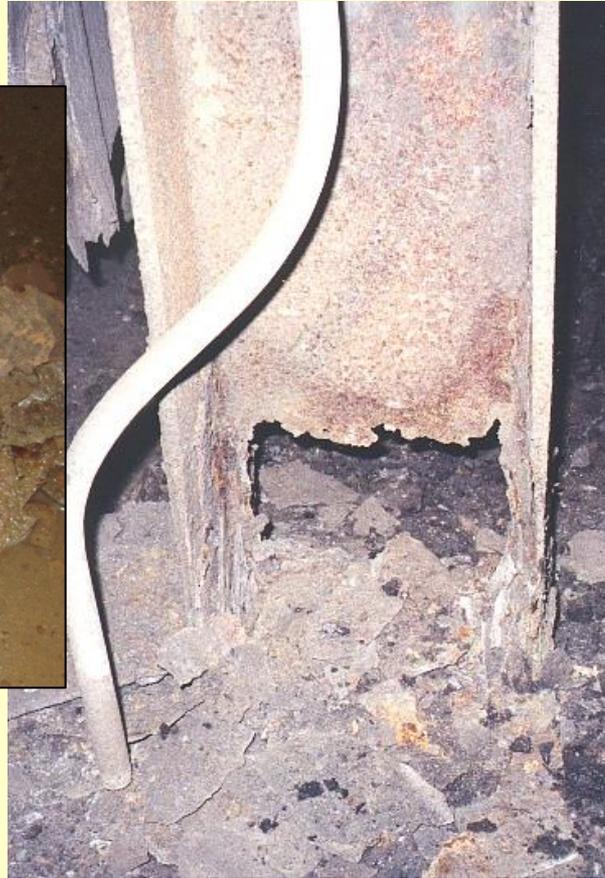
Hole in a column web – well above floor level

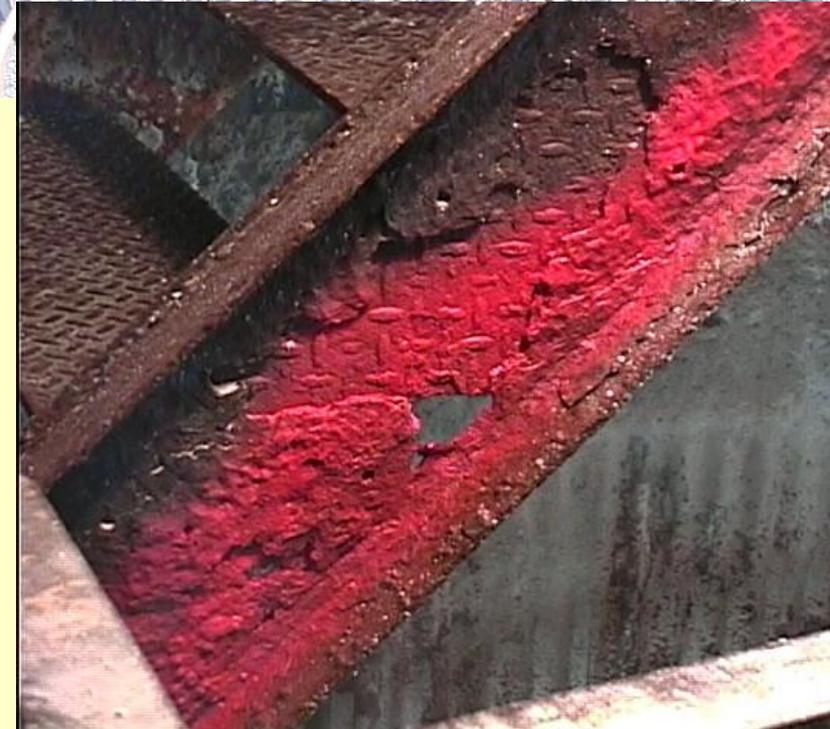
A miner was seriously injured at a limestone mine when the expanded metal walkway suddenly failed. He fell 10 feet to the ground. The expanded metal walkway was covered with conveyor belt to aid in shoveling spillage. The belting allowed corrosive material to accumulate and accelerated the deterioration of the expanded metal. Also the belting masked the signs of deterioration making examination difficult.

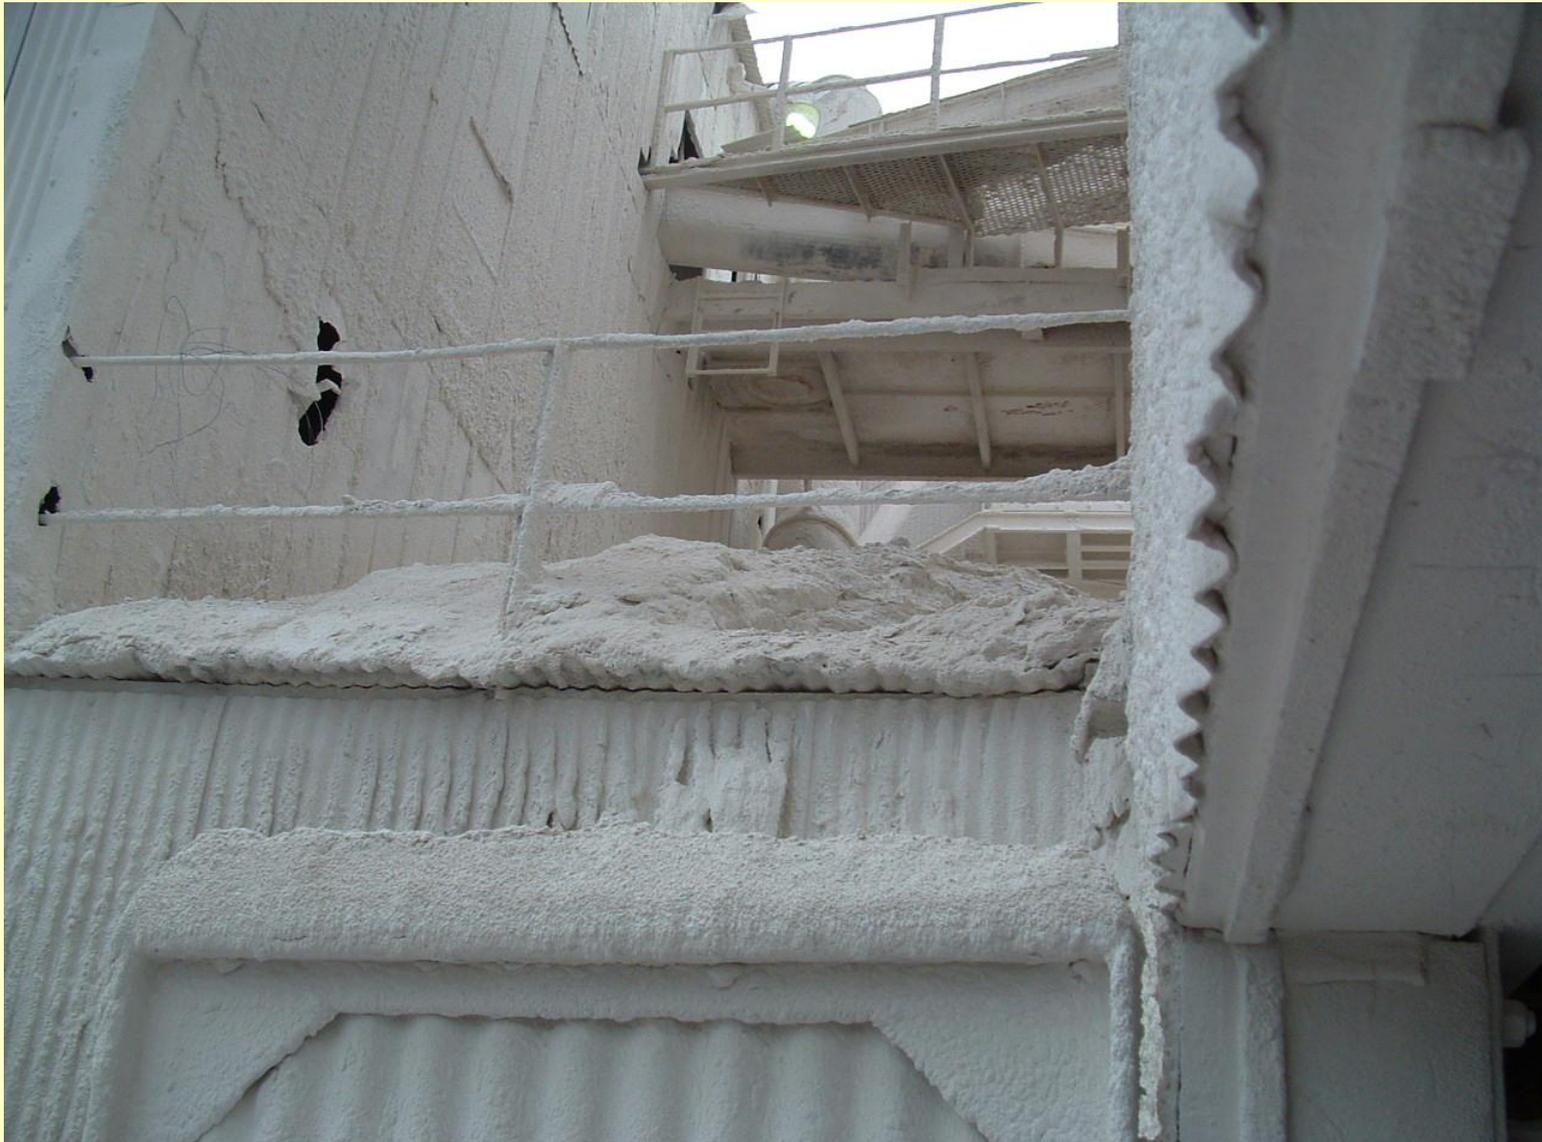
Overloaded sagging roof purlin as a result of material accumulations

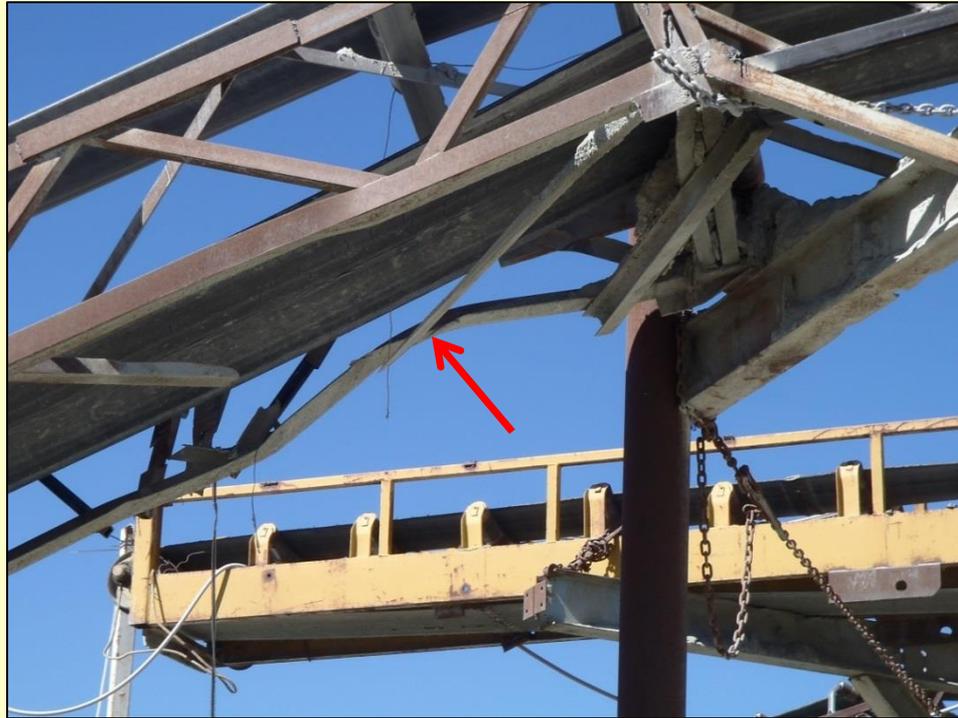
Deflected bottom chord that occurred because an added support post was not located at a joint

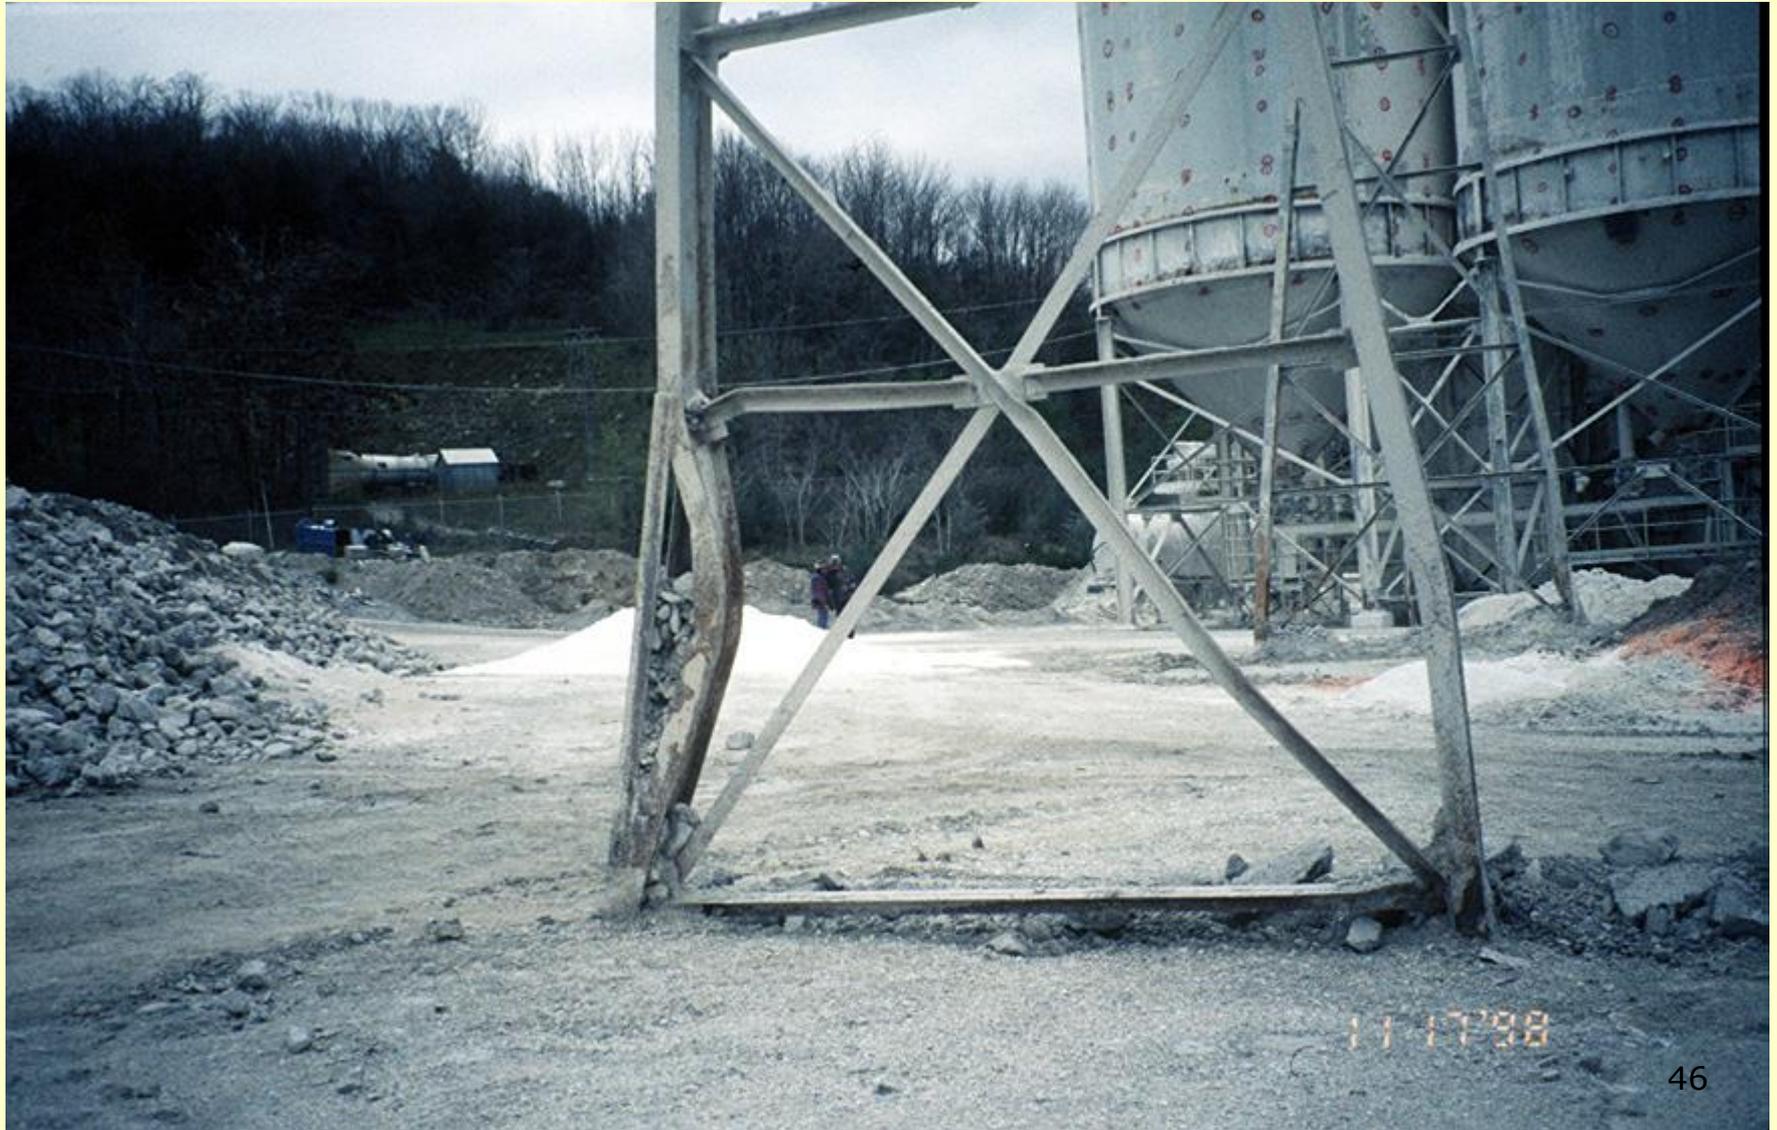
Impact damage to a conveyor bent and excessive material build₄₇up

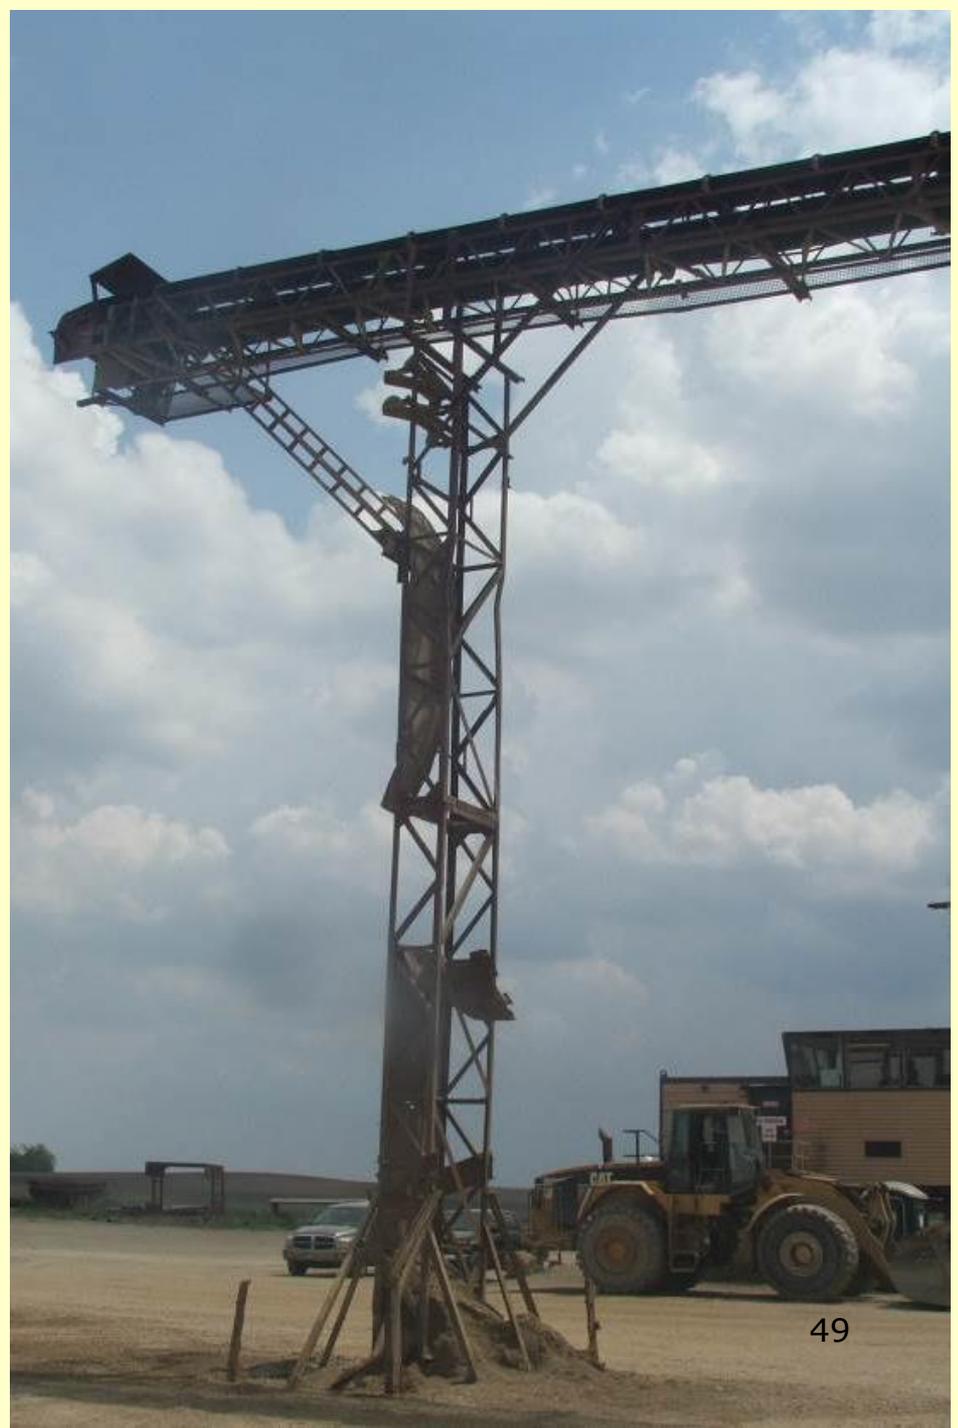
If 1 brace is good, then surely 7 has to be even better!

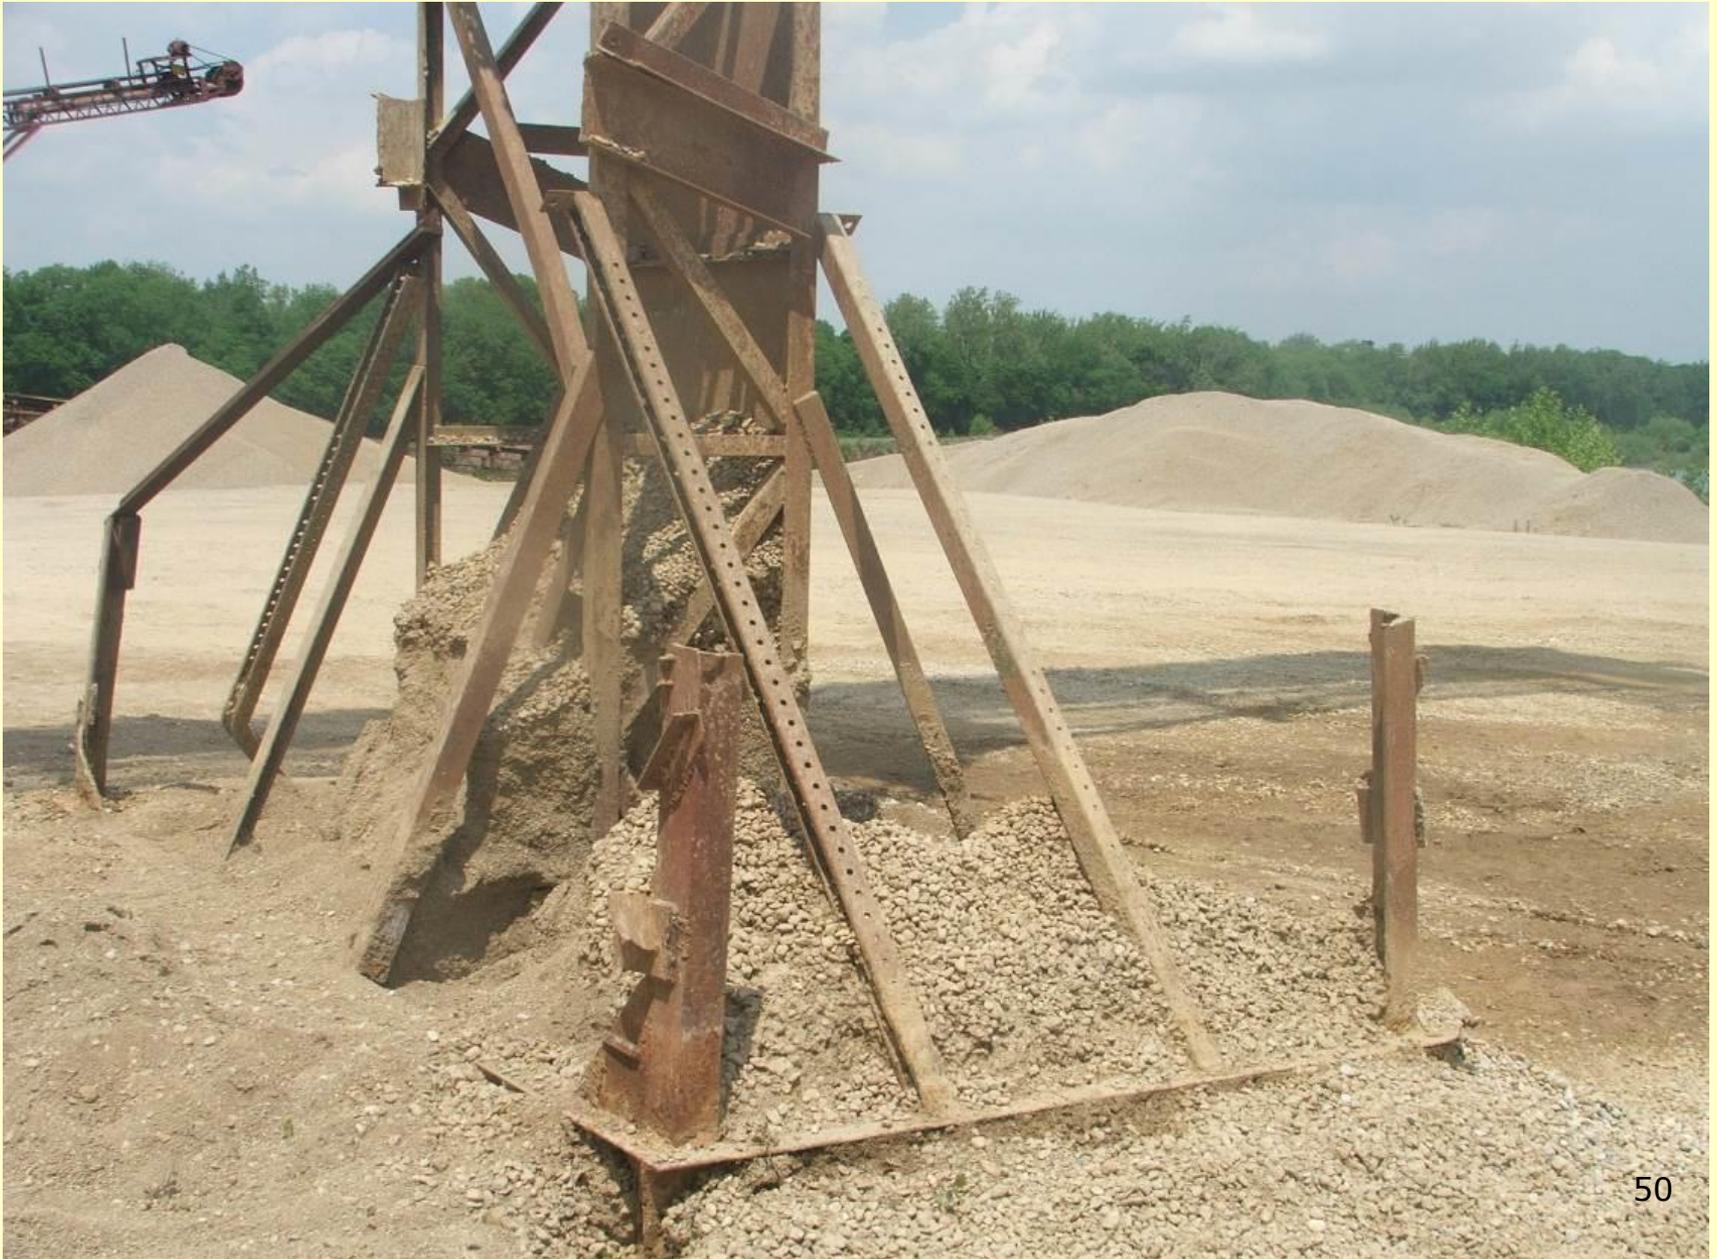
Twisted bent

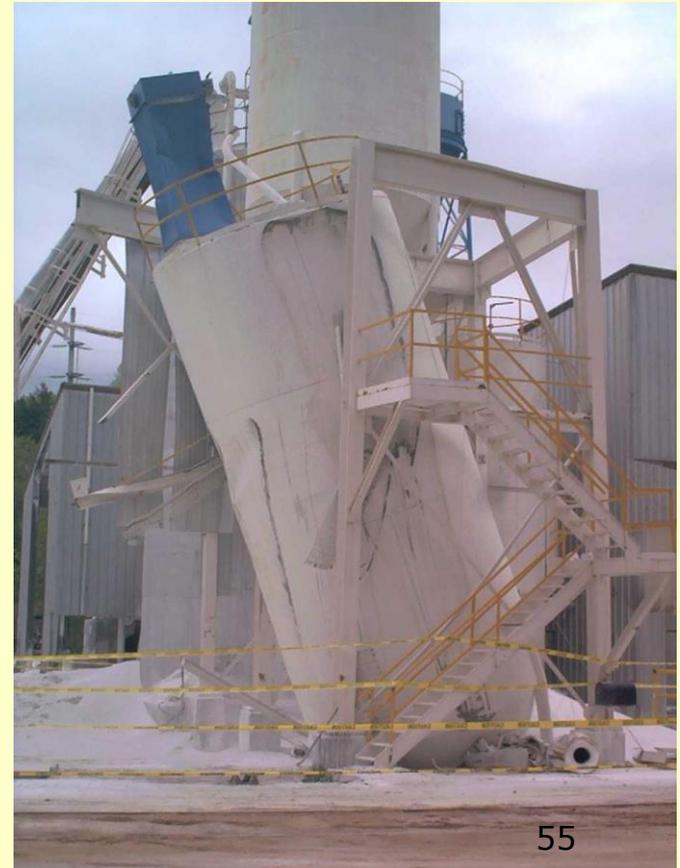
Material flow problems in bins

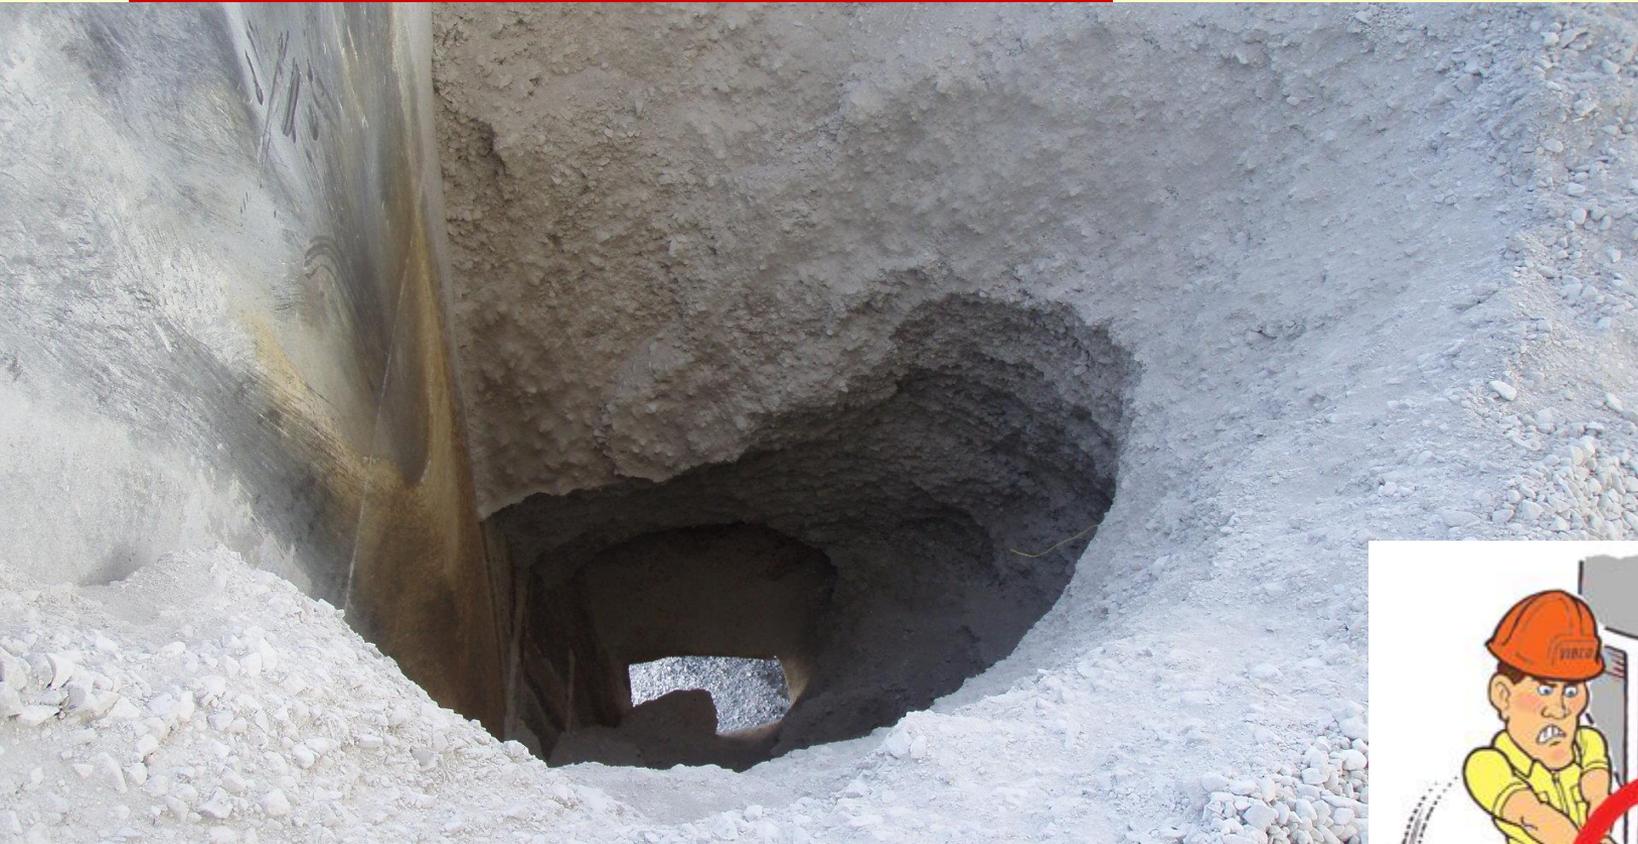
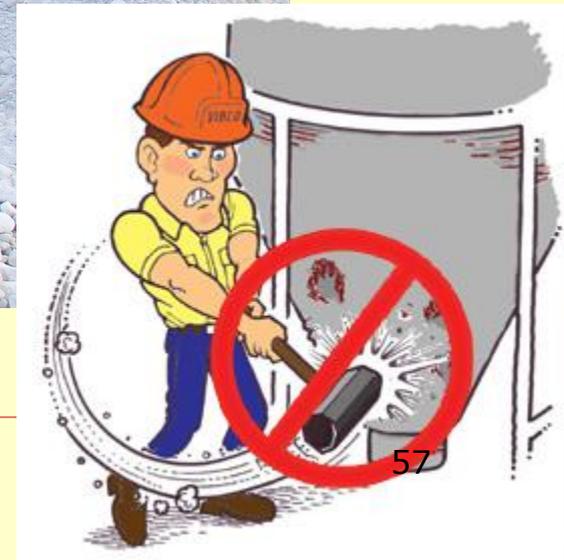
Bin wall buckling of a tall bin

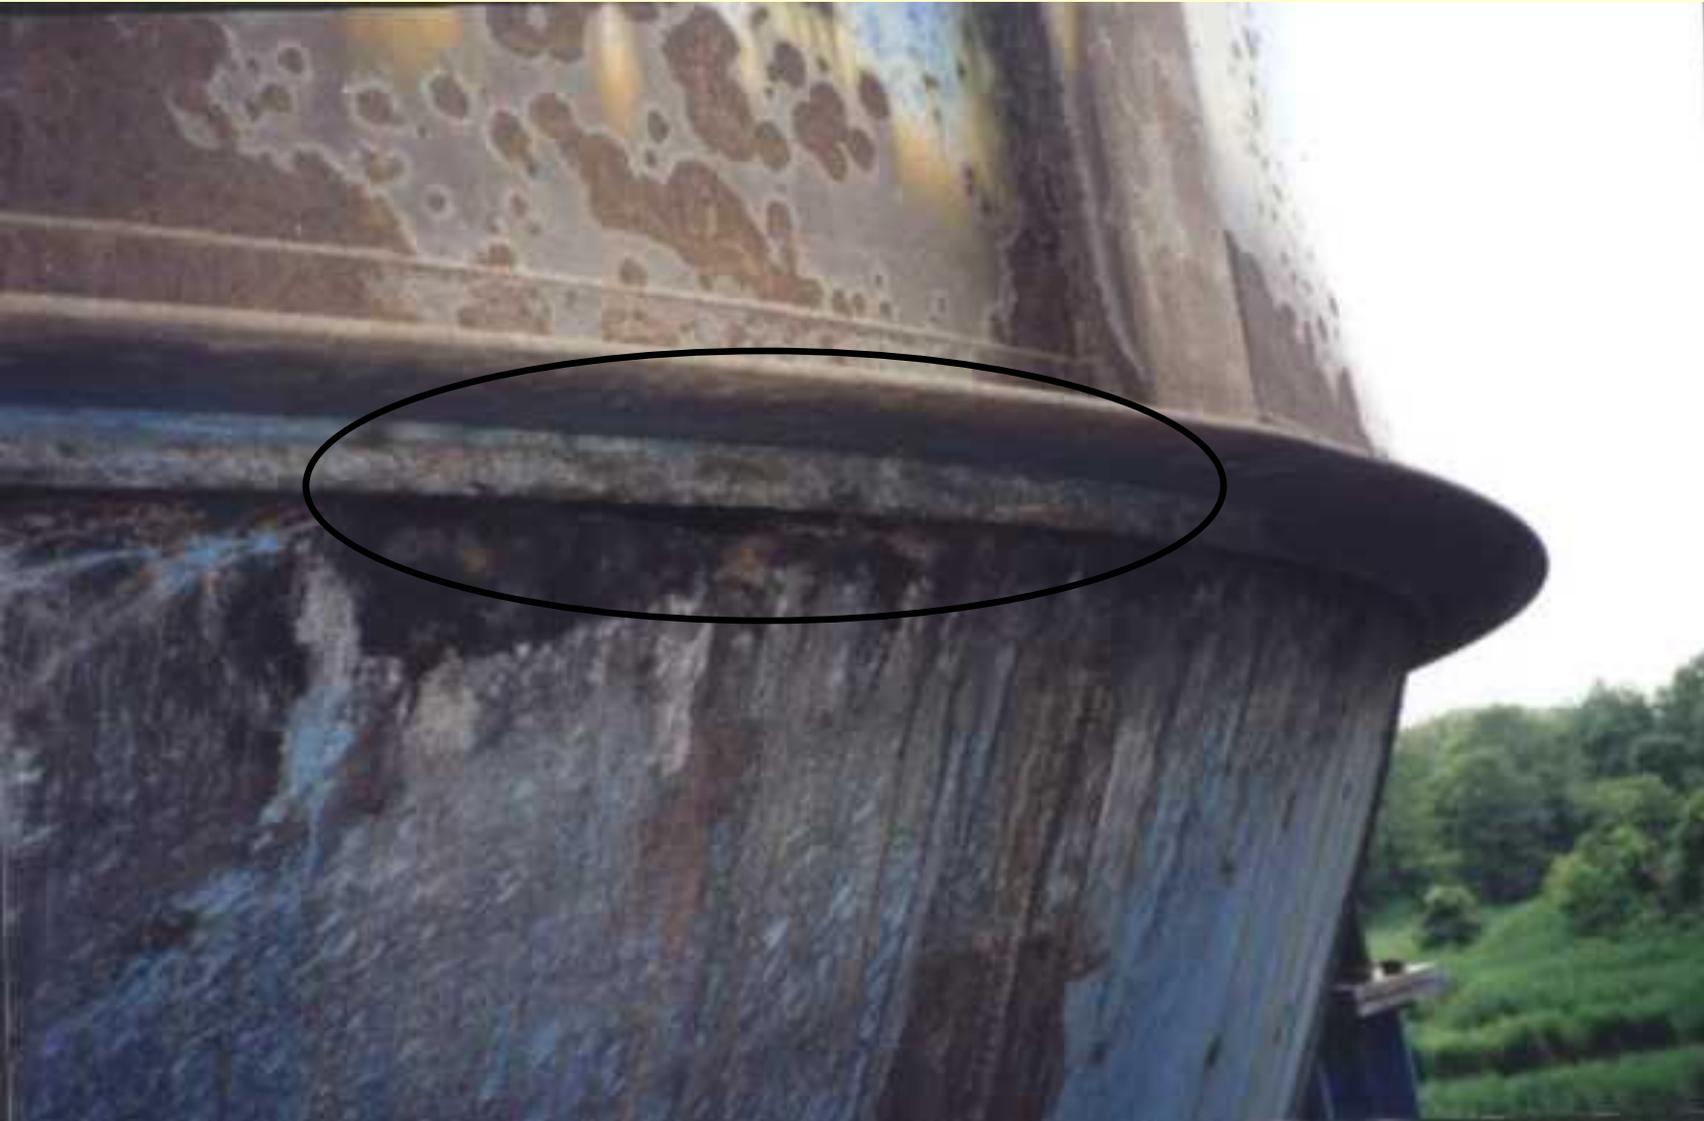
Hopper separation from the bin wall. ⁶²

Light shining through detached bin wall at the hopper connection

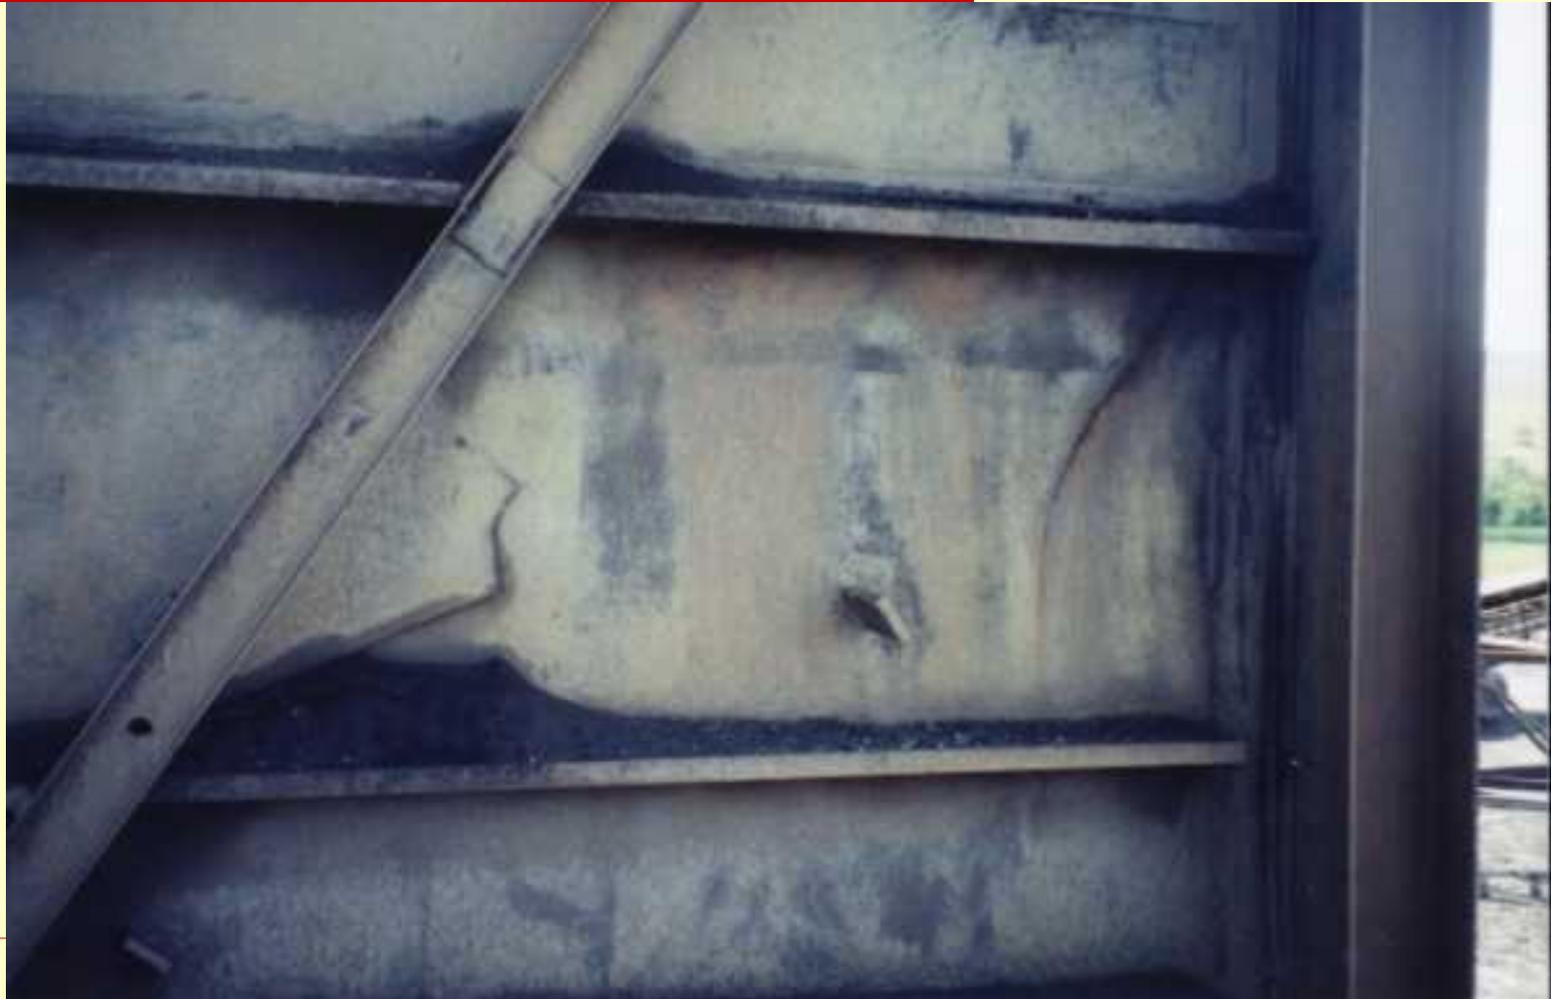
Lines of corrosion in the bin walls that were stuffed with rags and a weak polyurethane foam to prevent aggregate escape and contamination. However, the loss of structural integrity was not re-established.

Replace lateral bracing on bin columns if it has been removed or damaged as a result of equipment impact, or severely corroded - otherwise the column may buckle.

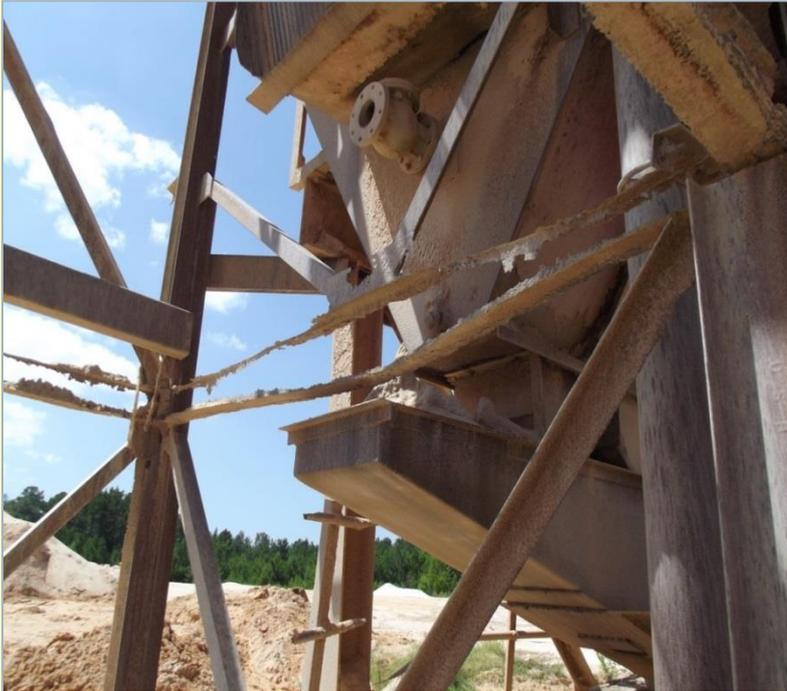
Damaged lateral beam supporting a bin column.

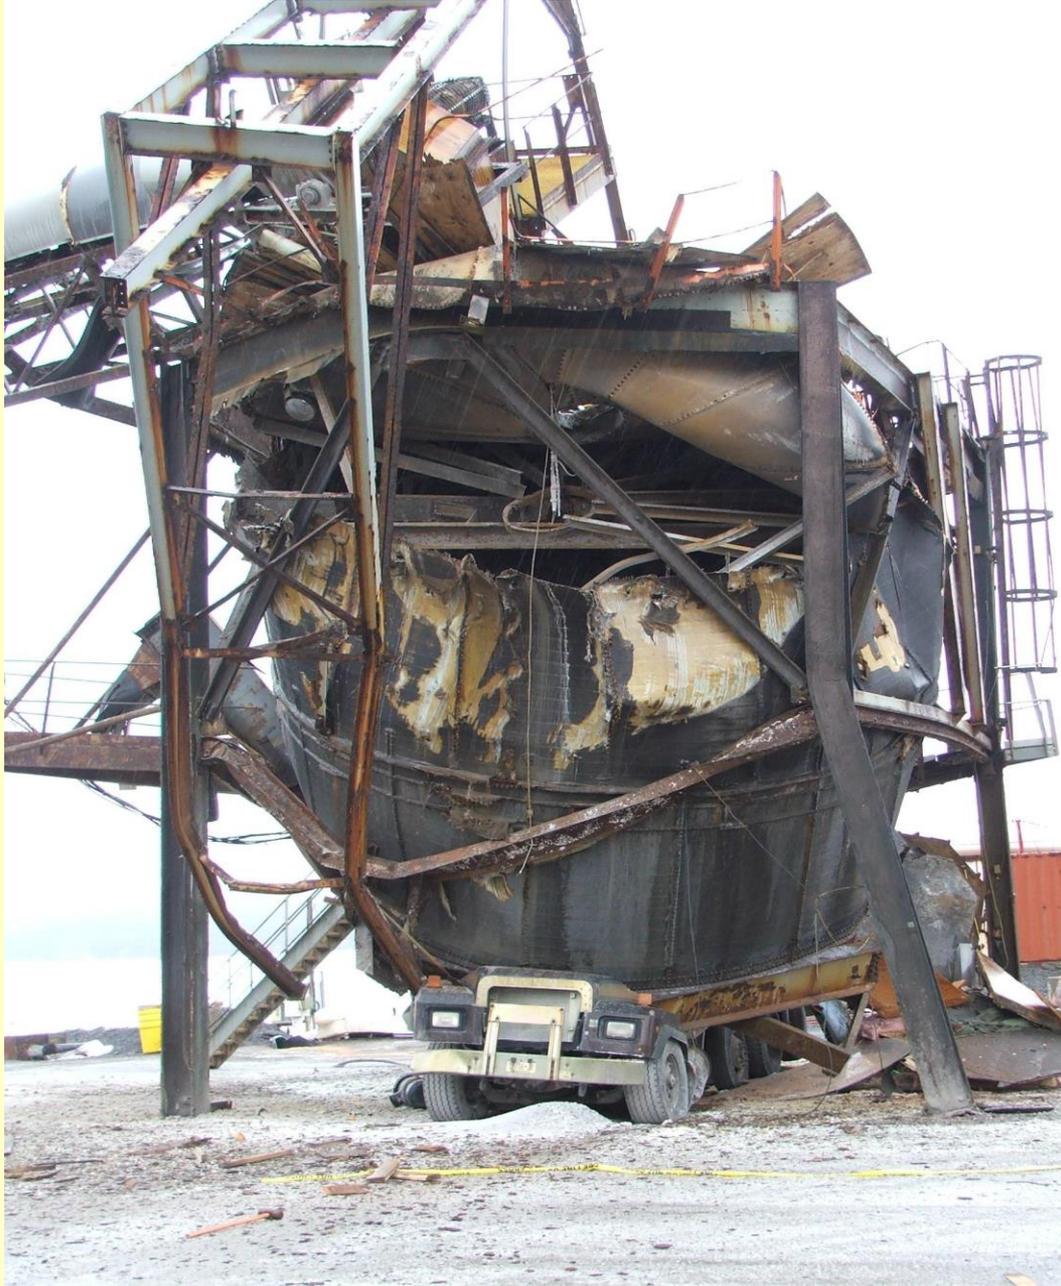
150-ton bin collapse

Elevated octagon frame supporting the bin. Beam failed at connections A and B

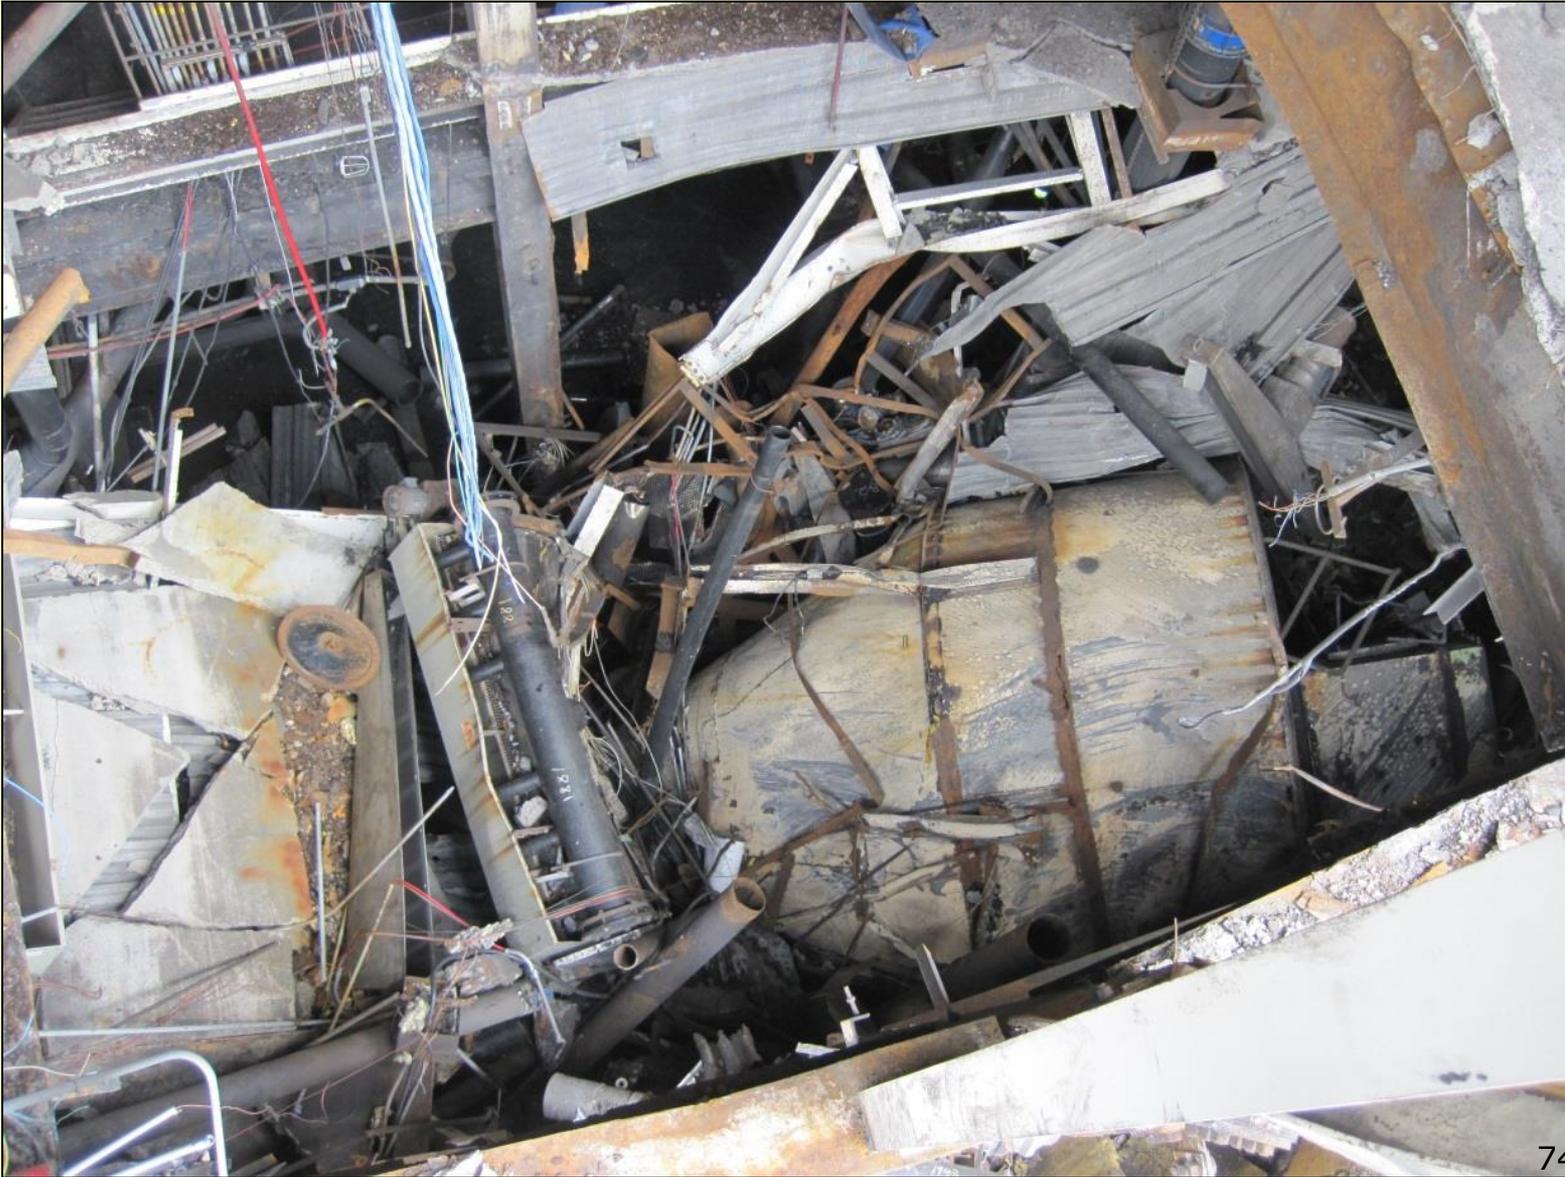
Identical magnetite bin supported by an octagon frame at the same plant.

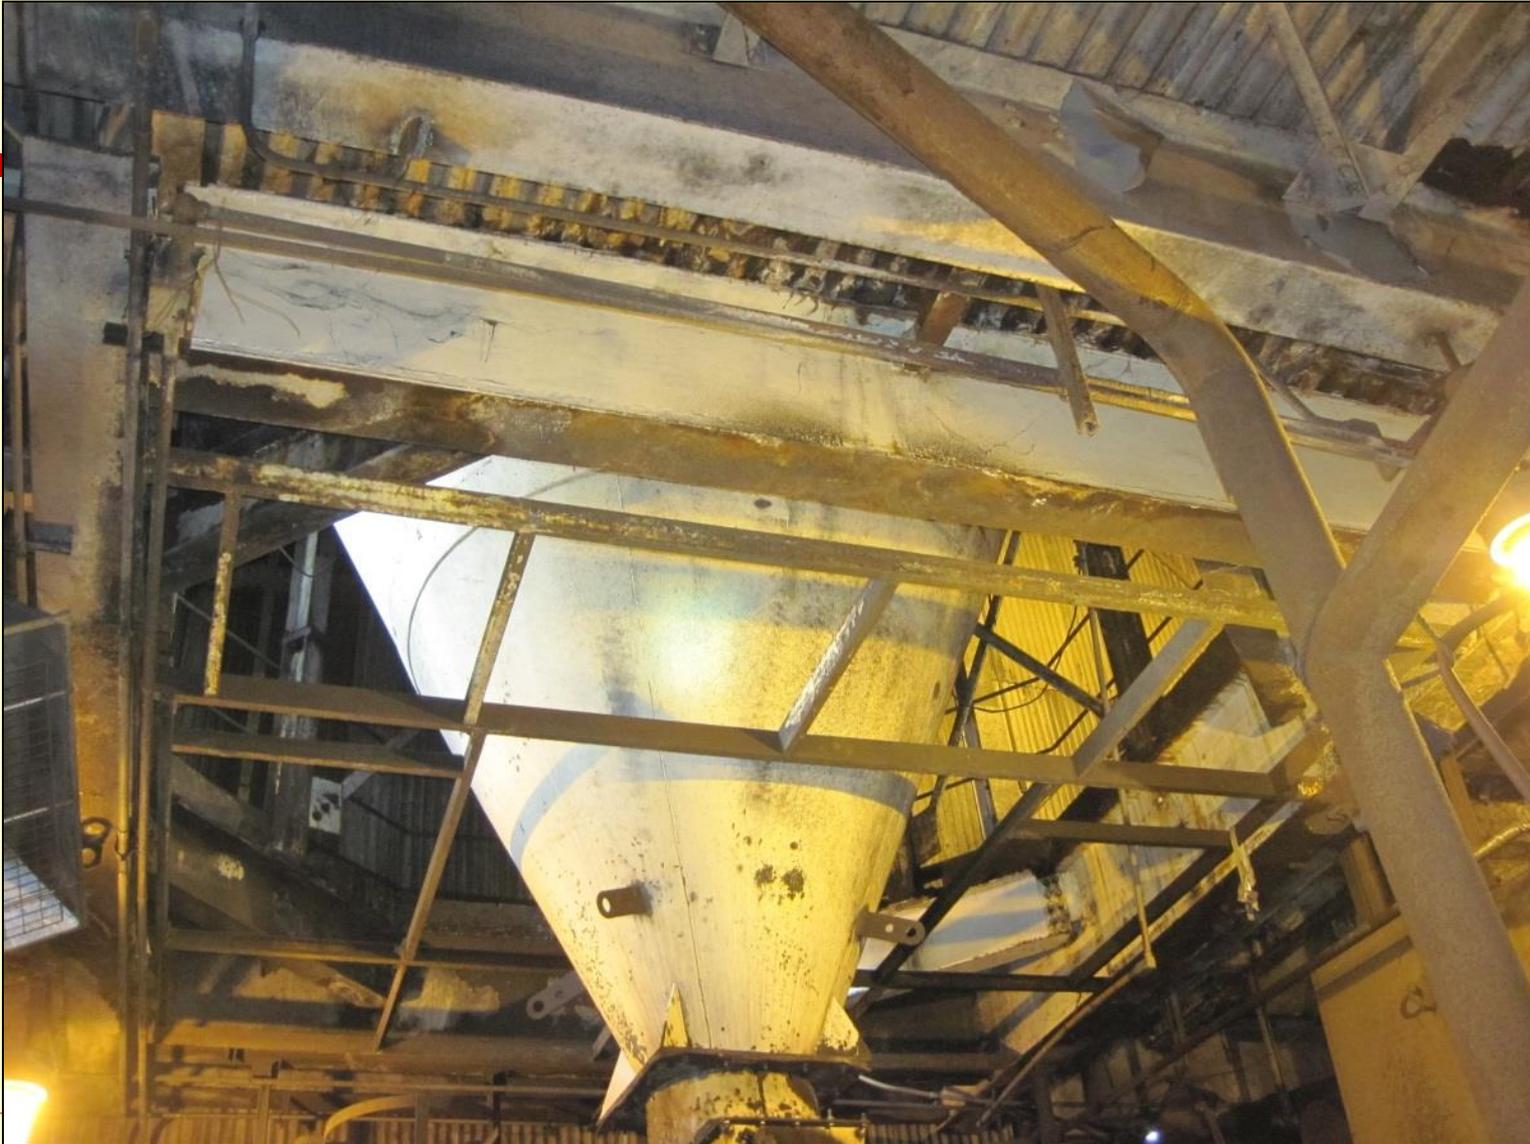
Camp 9 Prep Plant
A-side Bin Support Frame
Elevation 140'-0 T/S
Figure 1

Remnant of northwest shear tab/plate failure. Avg. thickness = 0.1" compared to the original of 0.375"

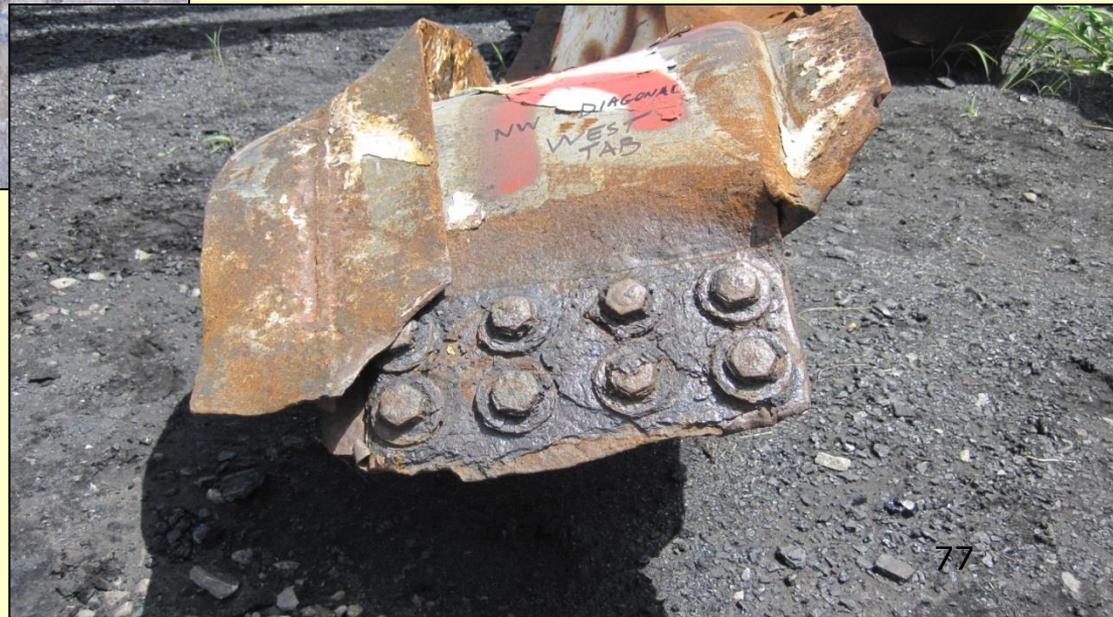
Cement plant – Alabama - September 9, 2015 bin collapse.
Lower section of cylinder and cone tore off a 40 year old bin.
