Mine Surface Structures - Identifying Unsafe Conditions & Avoiding Failures

Plants, Conveyors, & Bins

Terence M. Taylor, P.E.

April 4, 2017

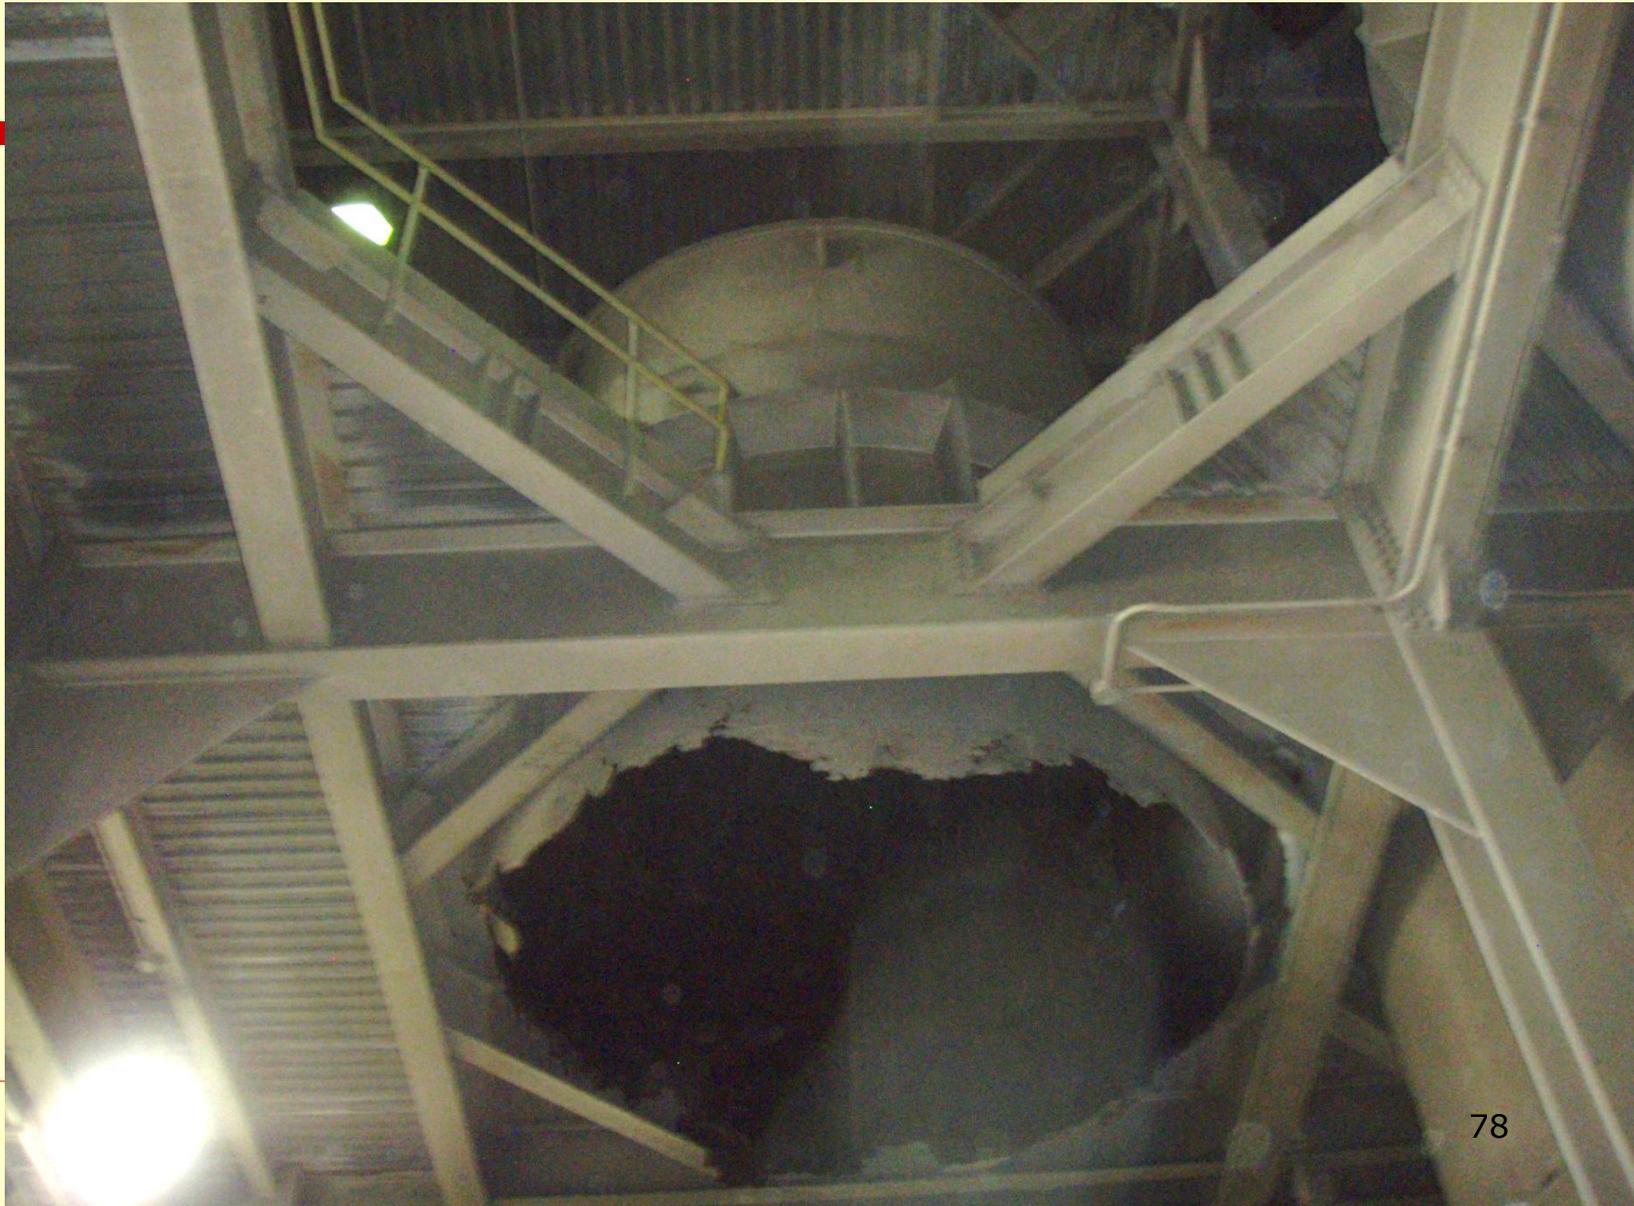
The bin fell through the floor. Just 10 minutes prior, there had been 5 miners under the bin on the bottom level.

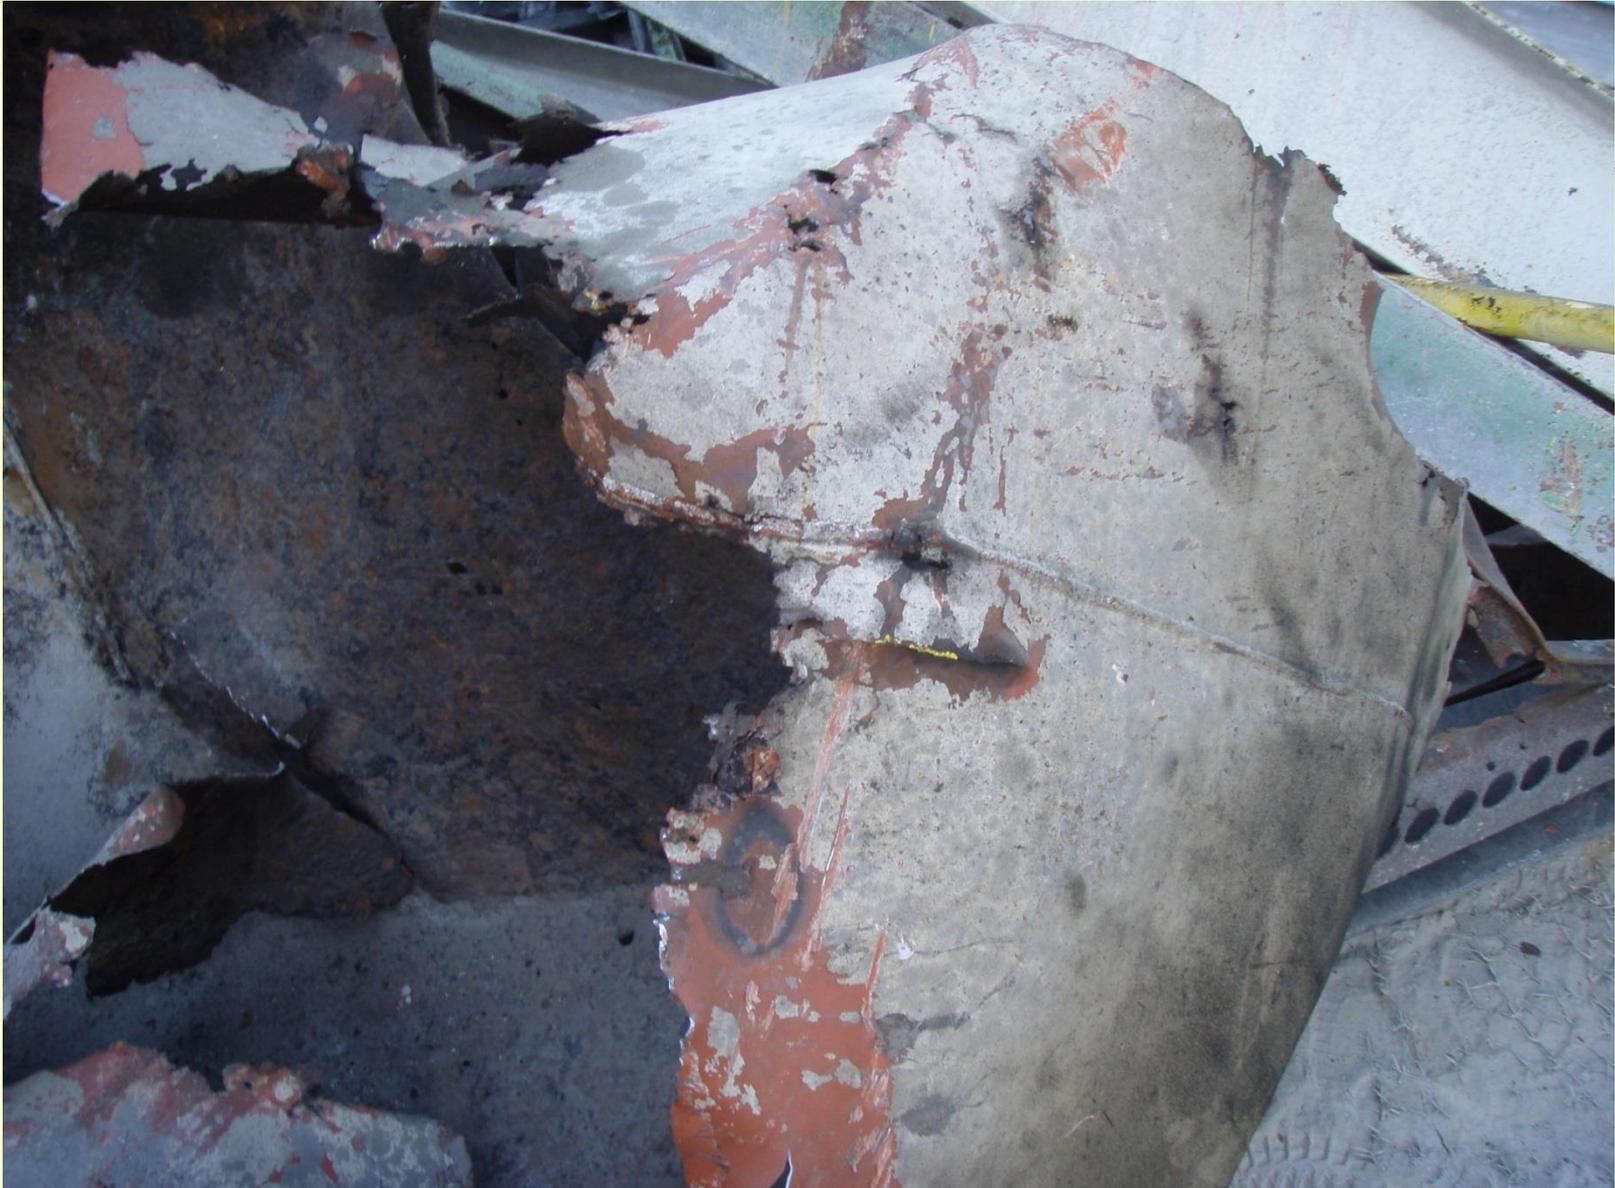
Luck Stone's Plant in Virginia. Fatality at 6:15 am on August 13, 2015

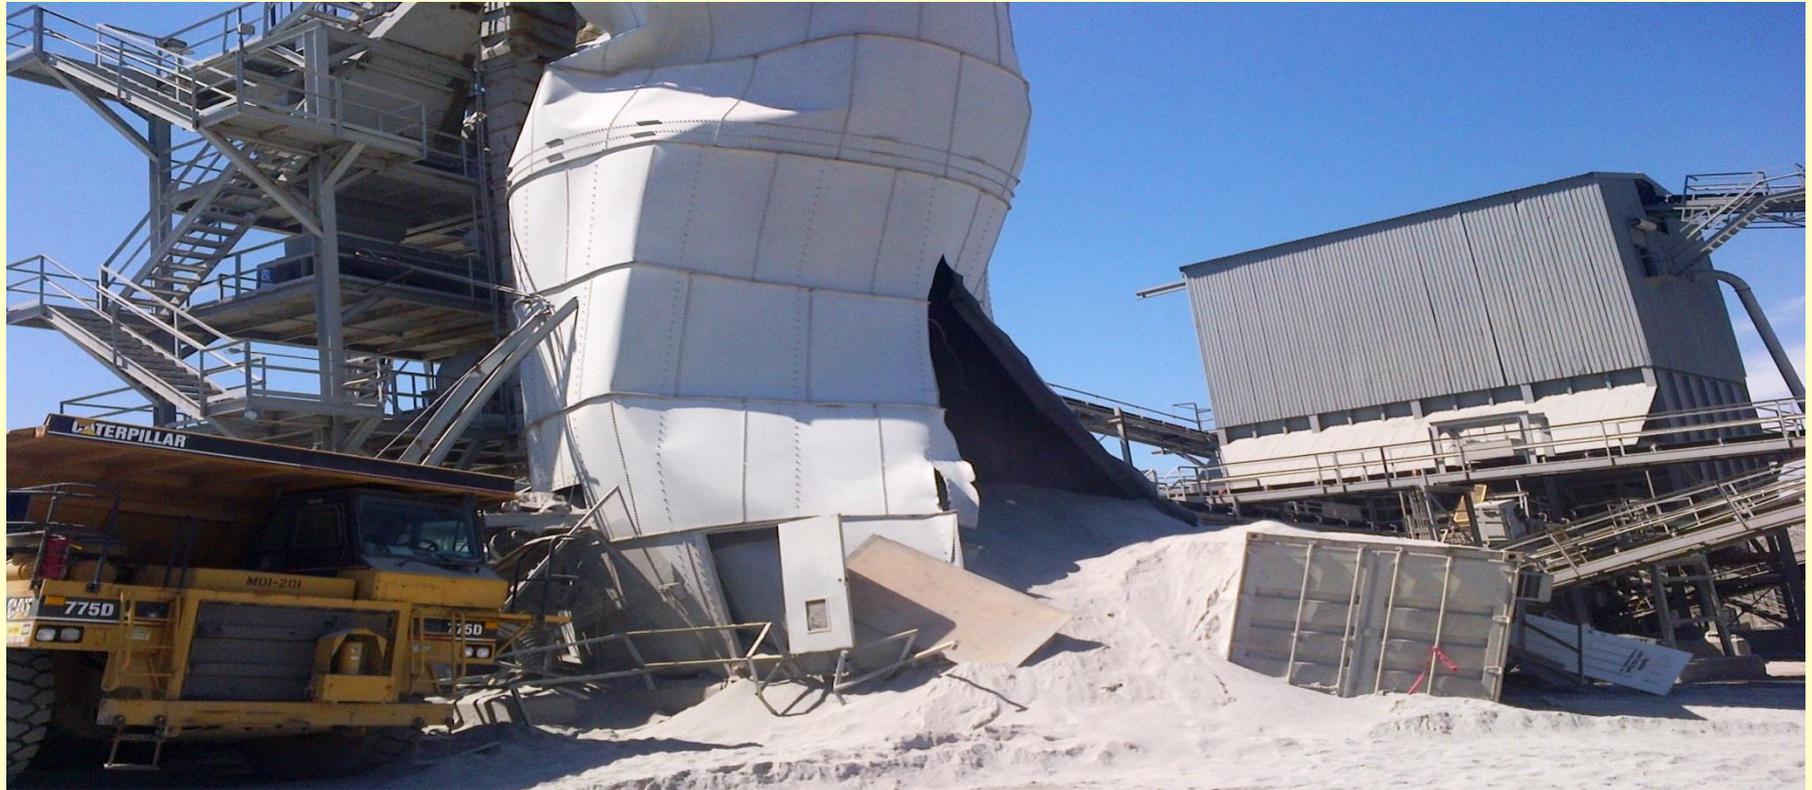
21.5' diameter
56' overall height
17.5' tall conical hopper
23' tall cylinder
Capacity - 734 tons of fine
sands.
Estimated capacity at the time of
failure - 522 tons.

Constructed using bolted
connections in 1993.

A 2012 plate thickness survey by
mine personnel showed nearly
50% section loss of the plates on
the south side of the bin.

There was no abrasion liner in
the cone.

Failed 1.5' below the connection
of the hopper to the cylinder.

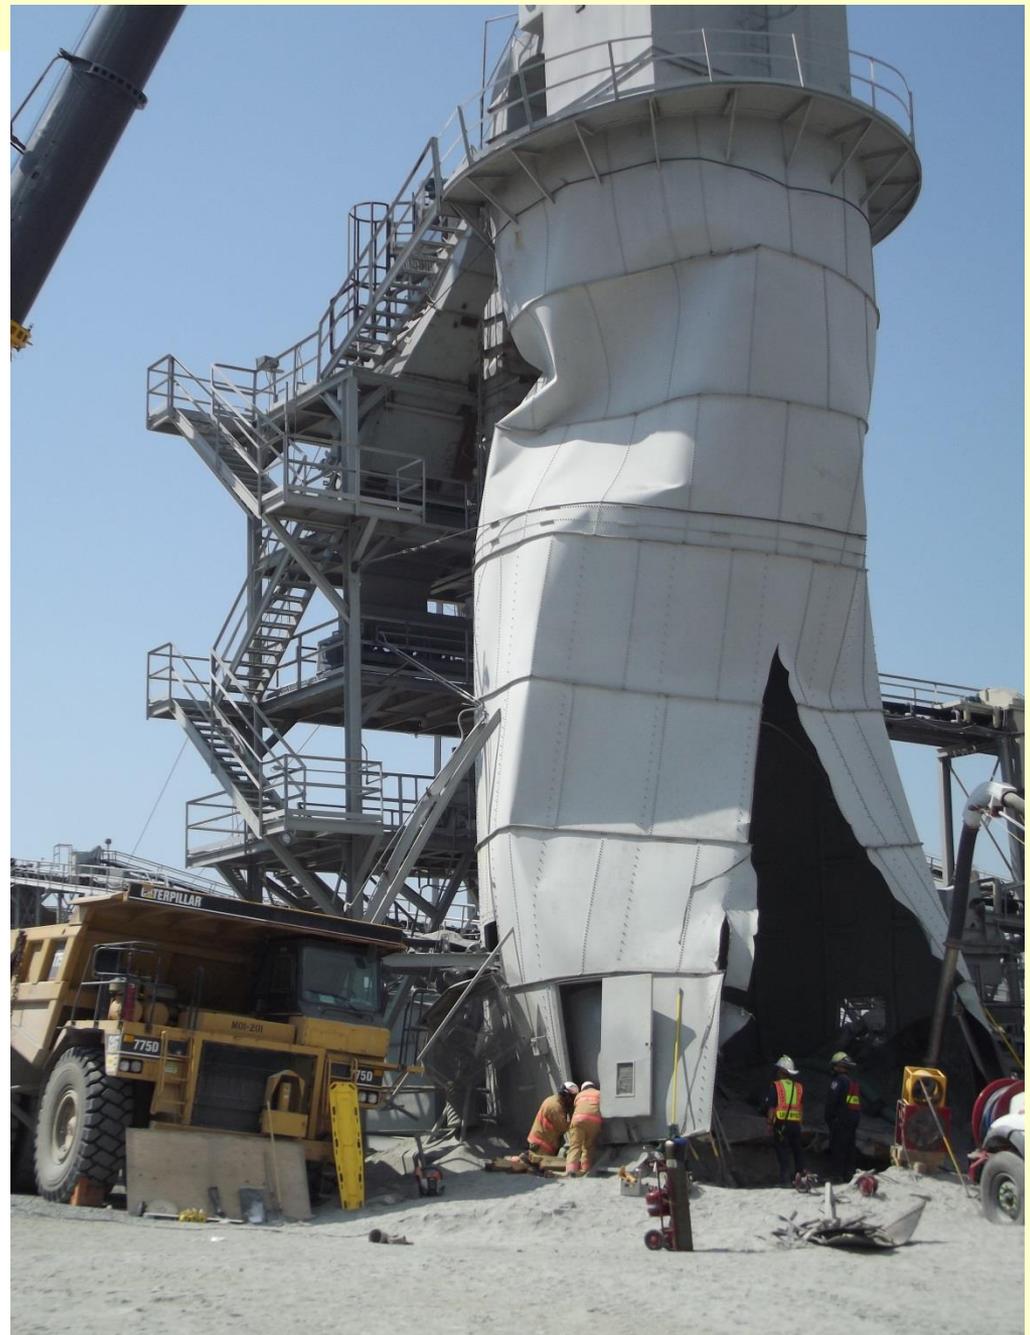
Connecting bolt shanks and nuts on the plate sections looked good on the outside. In 2007, the bottom ring (of 3) of the hopper was replaced. 84

Bolt heads were abraded and corroded off on the inside. They were completely worn off on the south side, but not on the north. Material was static on the north side and flowing on the south side where the abrasion occurred.
