Mine Surface Structures - Identifying Unsafe Conditions & Avoiding Failures

Plants & Conveyors

Terence M. Taylor, P.E.

November 9, 2017

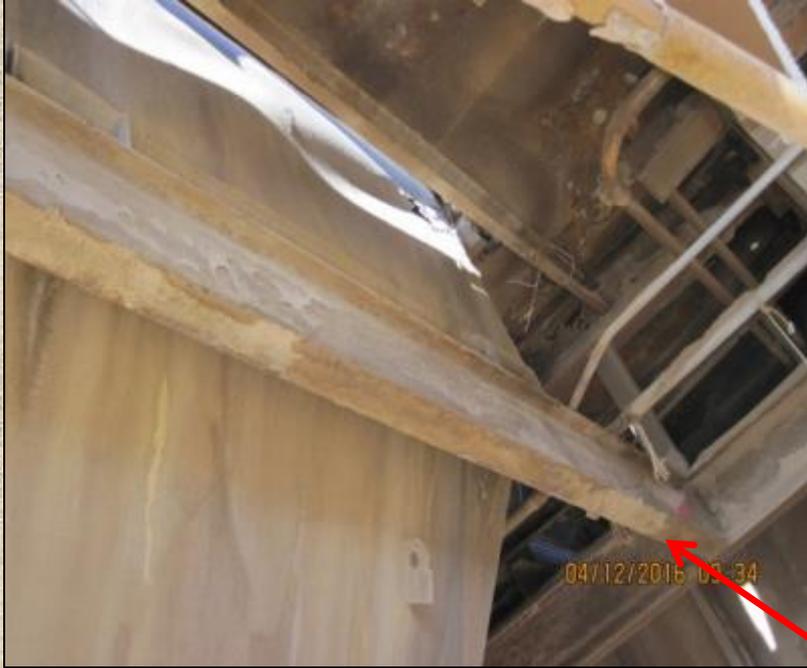
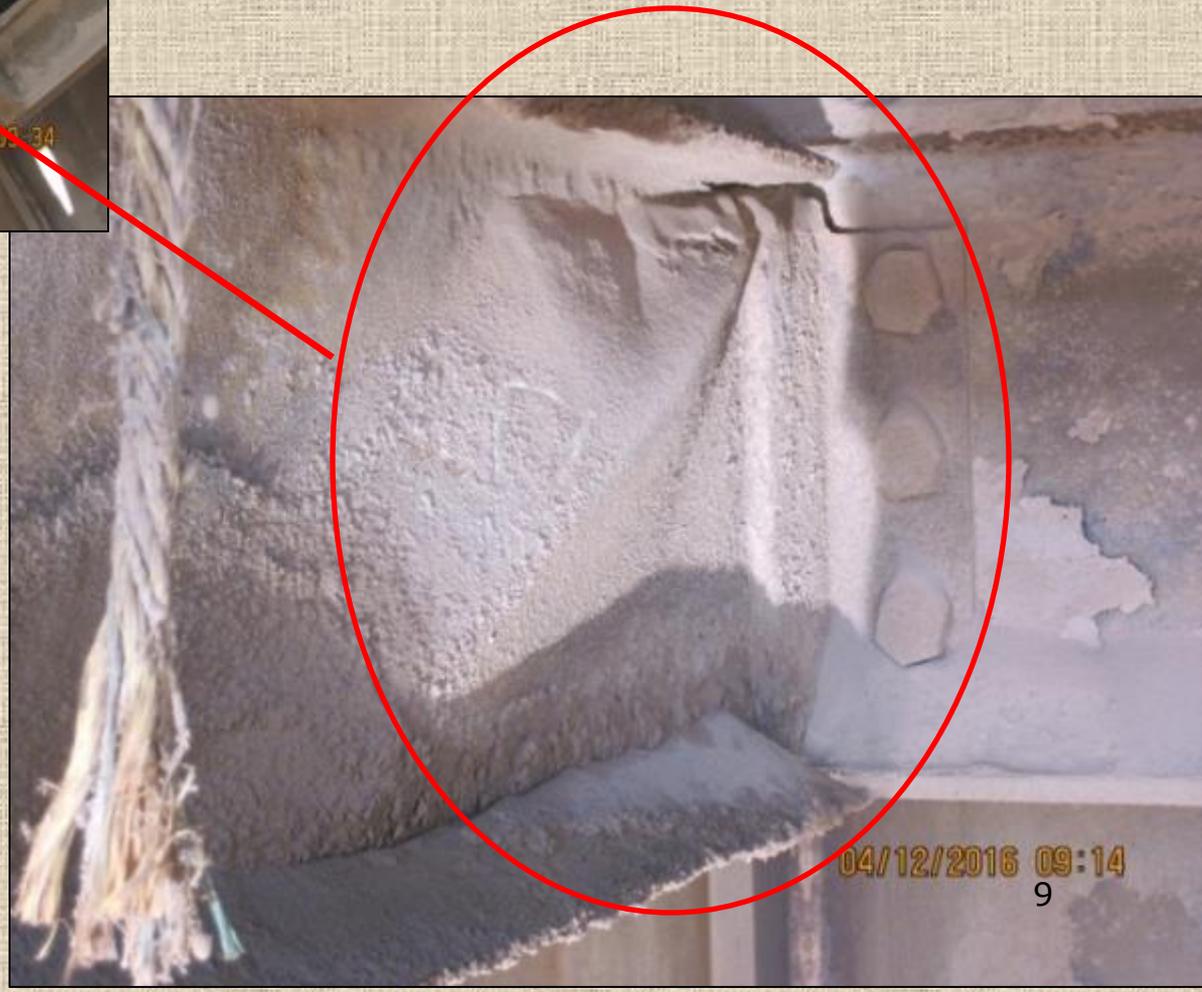
Crack through beam and reinforcing angle on the west side of the primary crusher

Weld has failed along left side of the angle

Note: beam was sagging slightly

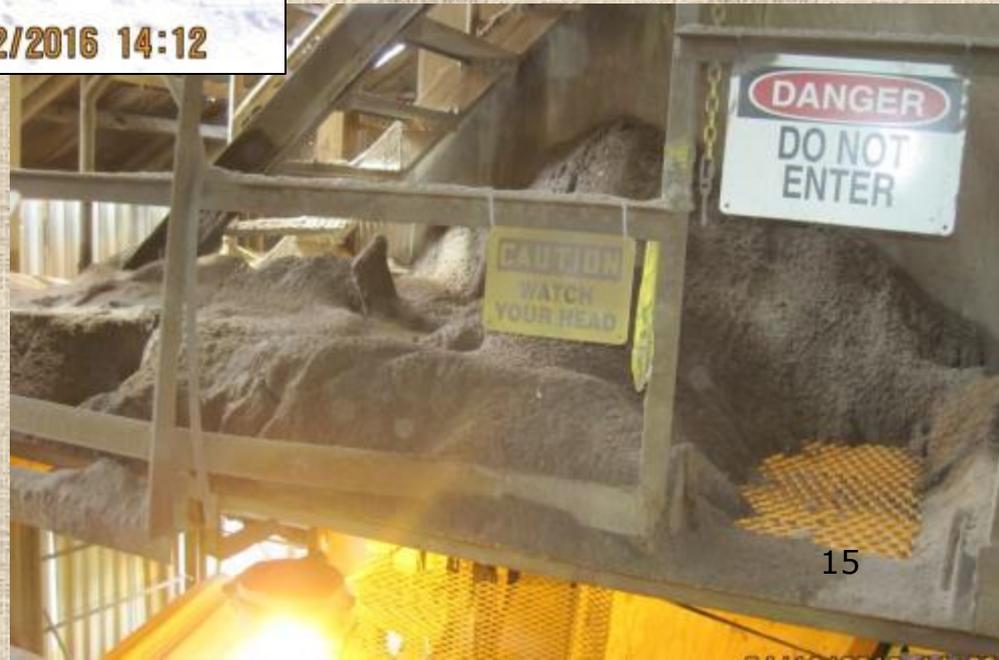
Material build up
and sagging
flooring

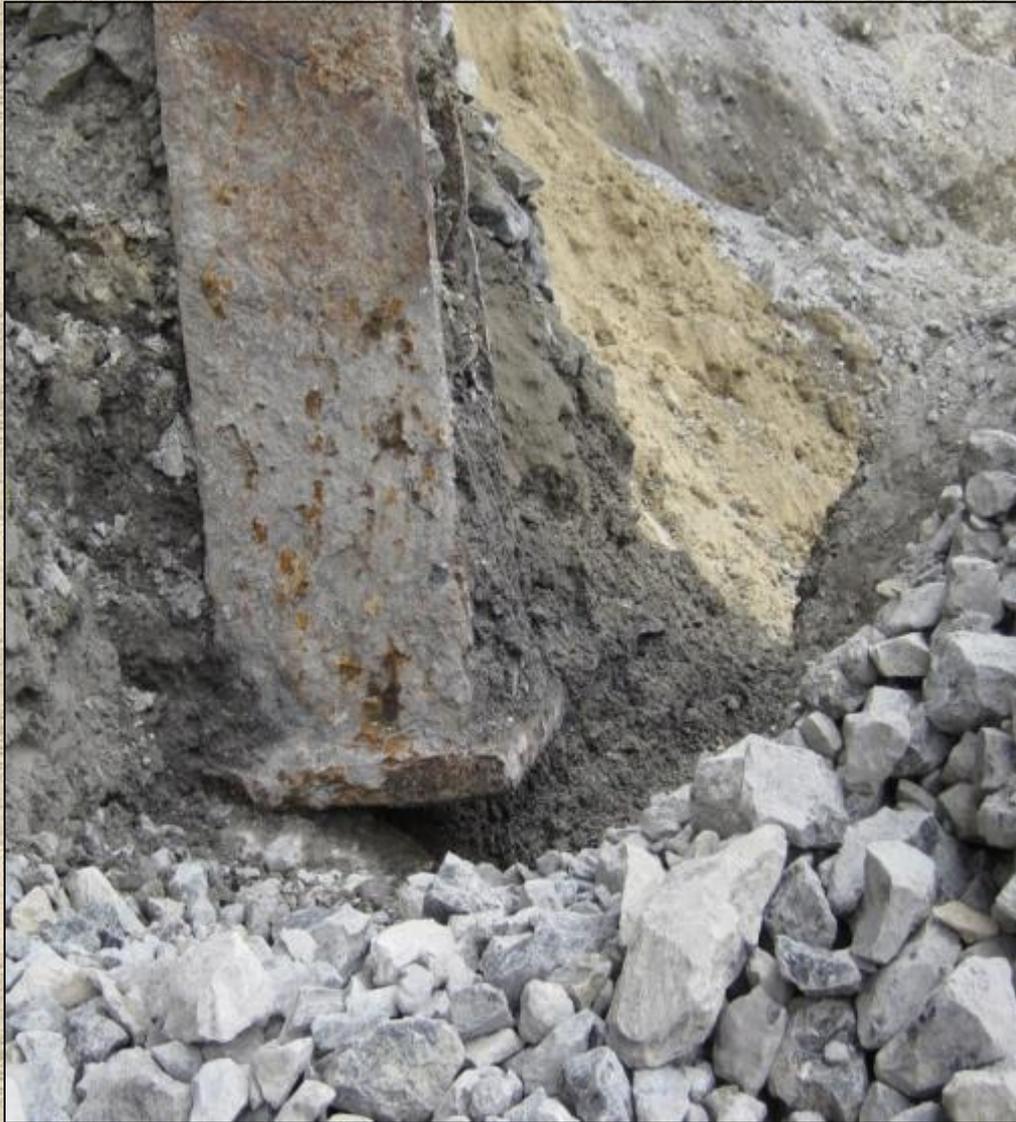
Expose column bases if surrounded by accumulations to assess their condition.

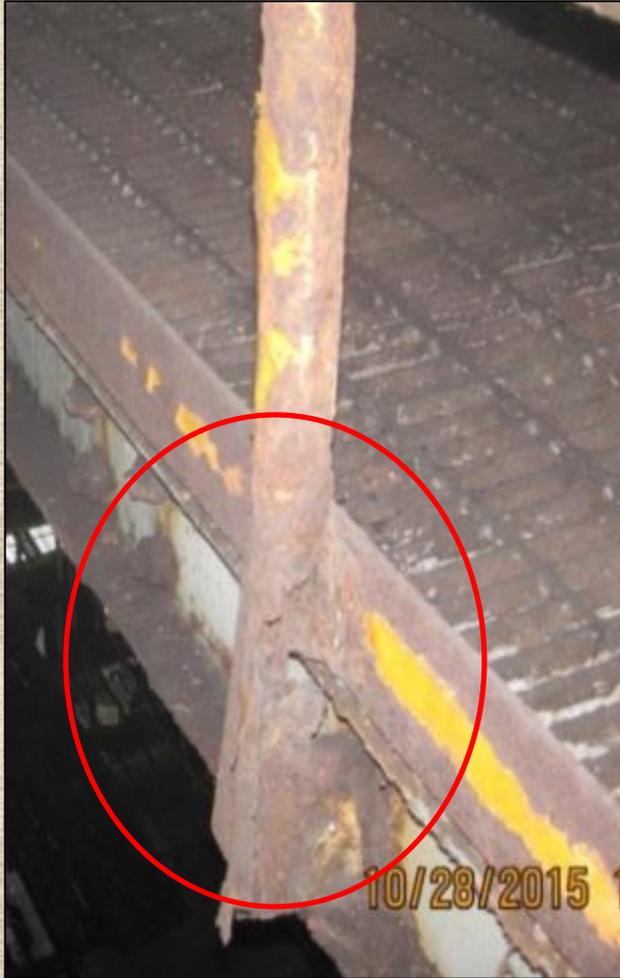
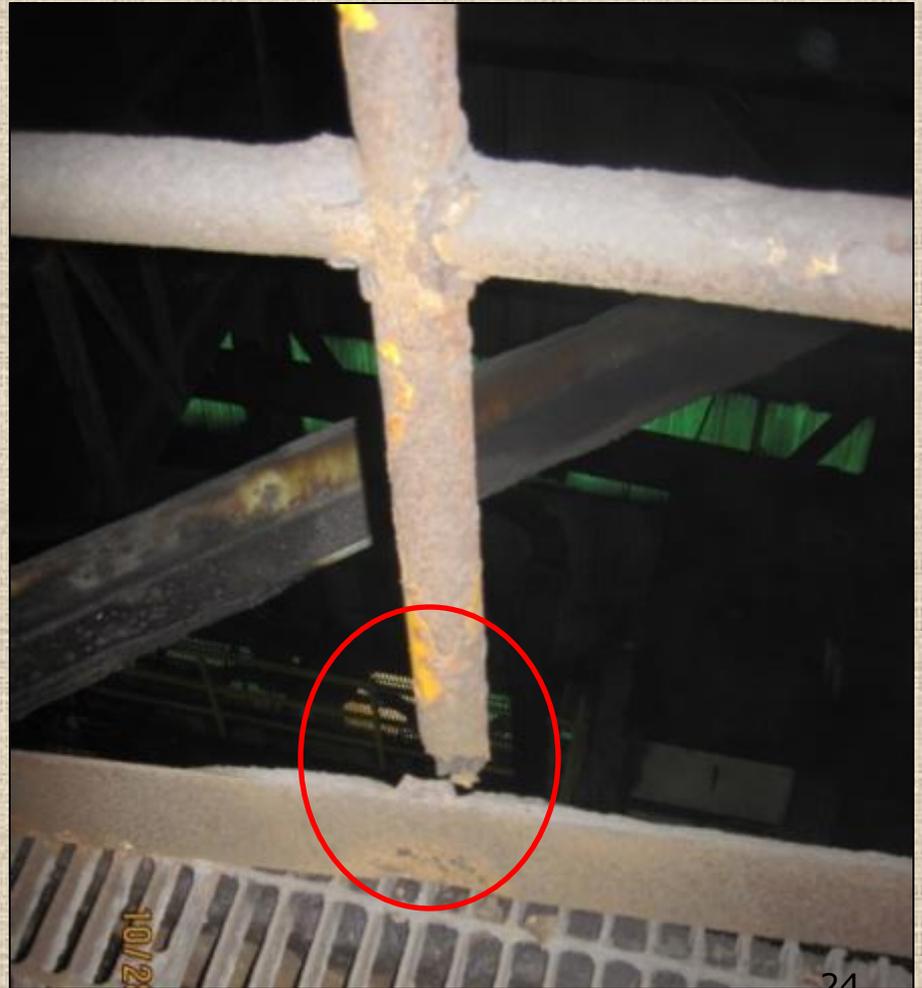
Structural modifications need to be engineered.

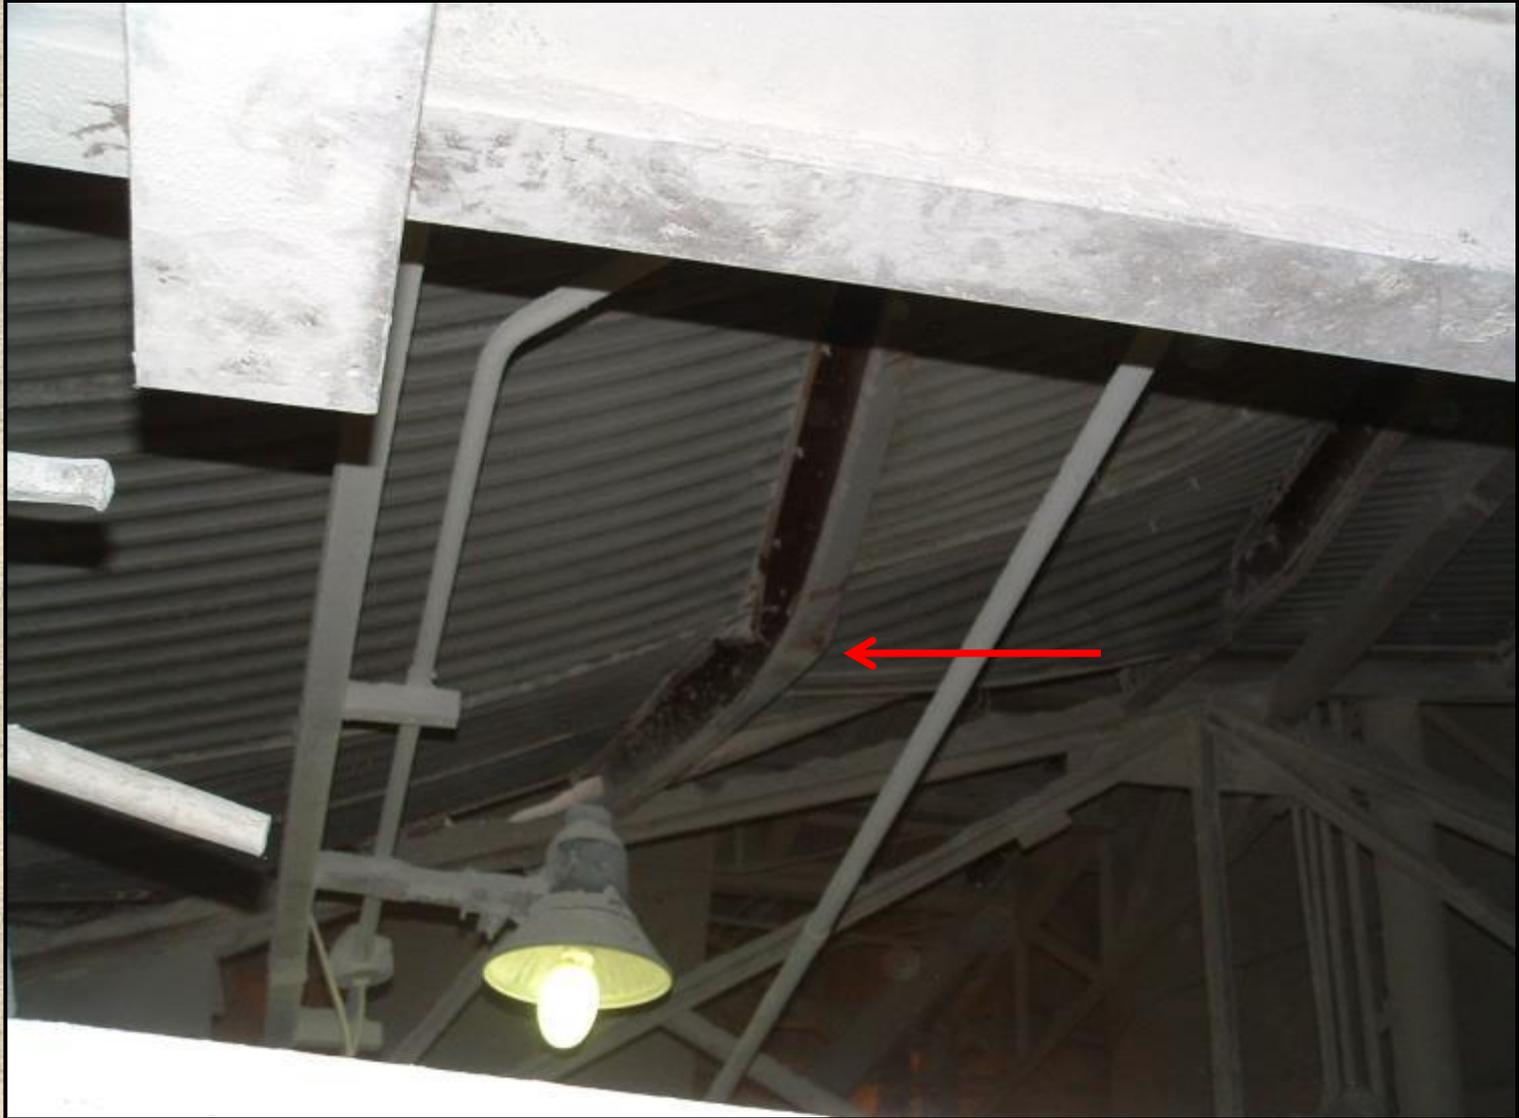
Overloaded sagging roof purlin as a result of material accumulations

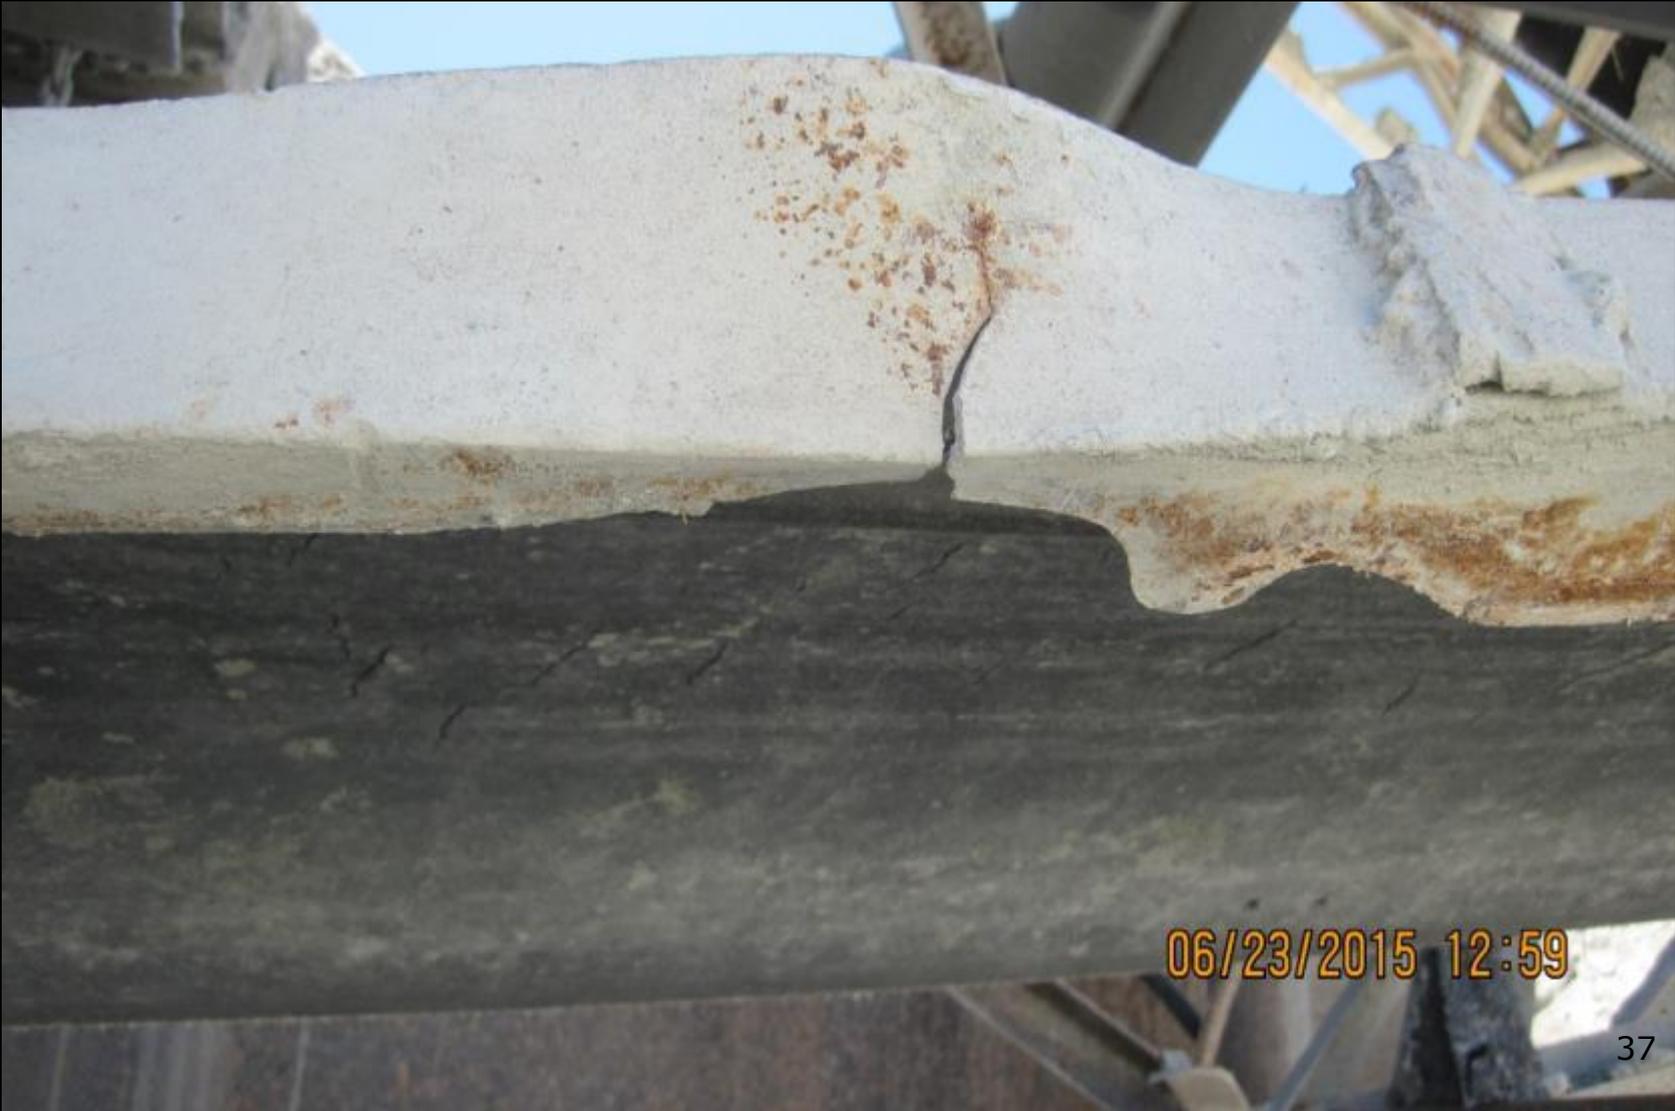
Fractured bottom chord angle section

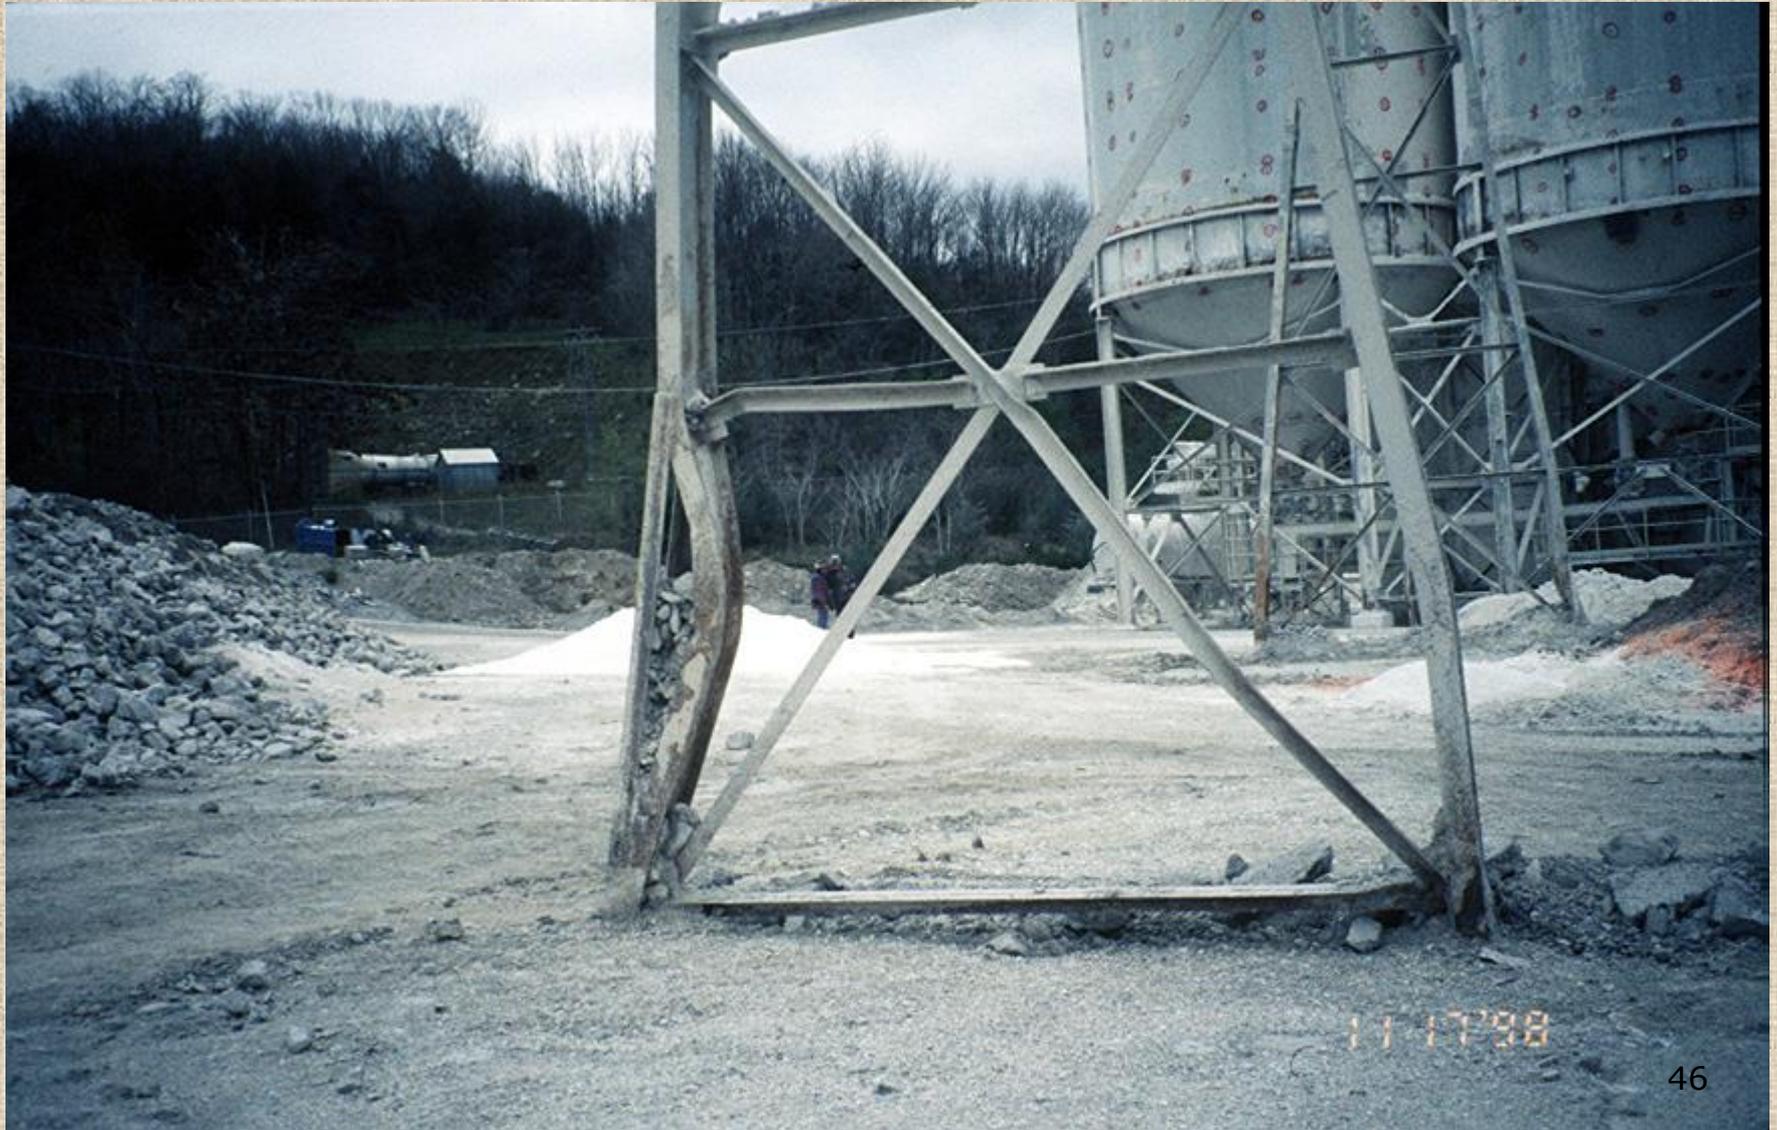
Impact damaged bent w/ inadequate repair
